**ENGINE FUEL AND CONTROL - LP/HP FUEL PUMPS - INTRODUCTION OF A REVISED LP/HP
FUEL PUMP WITH REDUCED GEARSHAFT BENDING**

V2500-ENG-73-0143

NO. 5008735-73-003

ENGINE - FUEL AND CONTROL - MODIFICATION OF LP/HP FUEL PUMPS IMPELLER/INDUCER AND CENTER PLATE

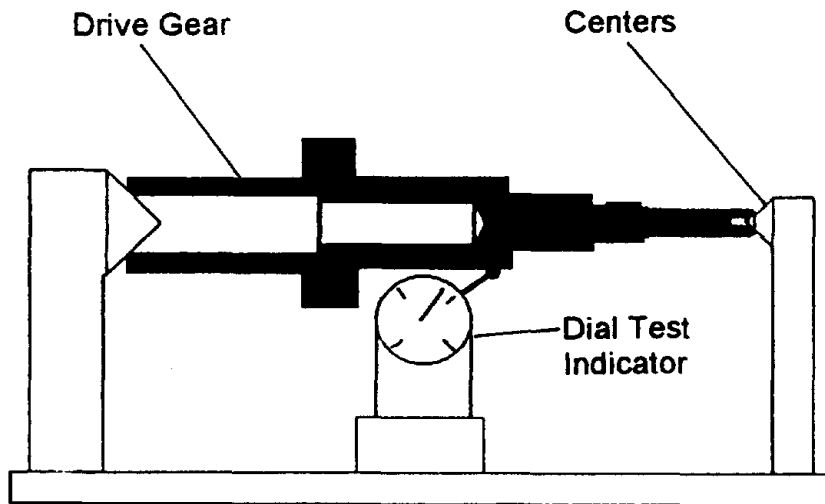
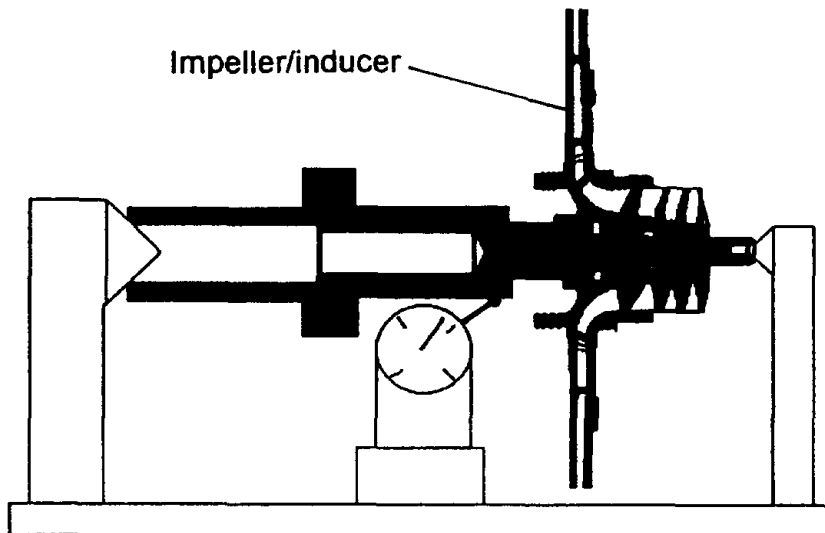
Drive Gear bending inspection
without LP Impeller/inducer installed

Drive Gear bending inspection
with LP Impeller/inducer installed

- (1) Assemble the drive gear on centers and measure the run-out of the journal nearest the impeller/inducer mounting thread, per Figure 5.
- (2) Attach the impeller/inducer to 170 in-lb torque above run-on torque and repeat (1).
- (3) If the run-out in step (2) is greater than step (1) by .0005 inch, replace the impeller/inducer and repeat the above.
- (4) If another impeller/inducer is not available, machine out the impeller sleeve ID to .8012 inch max. and repeat (1) to (3).
- (5) If the run-out is still bad, repeat (1) to (3) with a drive gear from another matched set. If the run-out is still bad, re-machine the impeller face and replace the washer. Repeat above. If the run-out is good with the different drive gear, then return the original gear set for investigation.

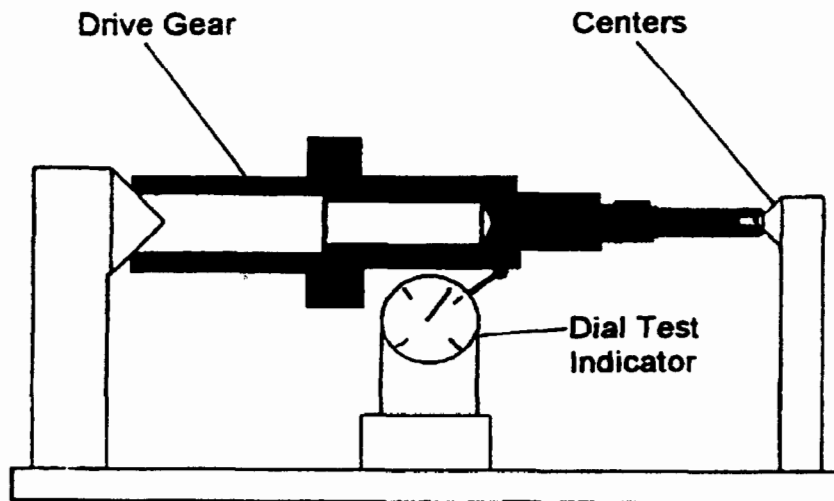
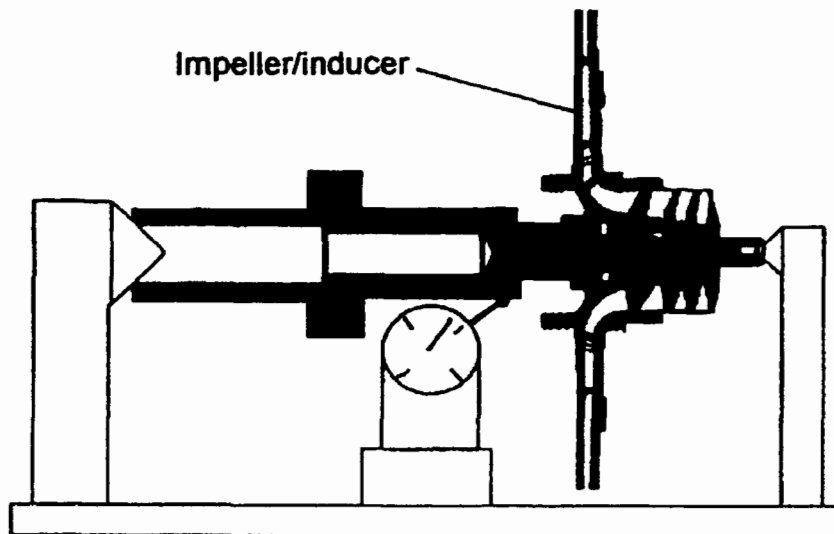
**Inspection of Drive Gear and Impeller/Inducer
Figure 5**

**Drive Gear bending inspection
without LP Impeller/inducer installed**

**Drive Gear bending inspection
with LP Impeller/inducer installed**

- (2) Attach the impeller/inducer to 170 pound-inches (19.3 Newton meters) torque above run-on torque and repeat step (1).
- (3) If the run-out in step (2) is greater than step (1) by 0.0007 inch (0.0178 millimeter), replace the impeller/inducer and repeat the above.

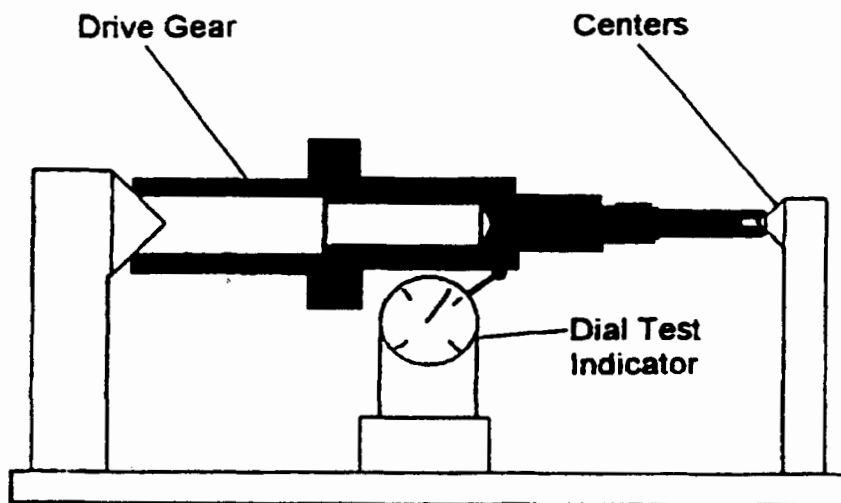
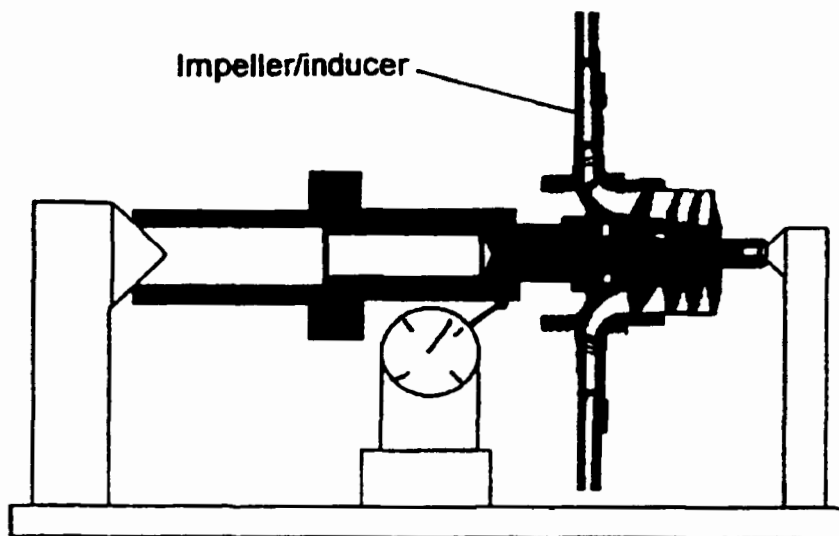
**Inspection of Drive Gear and Impeller/Inducer
Figure 5**

**Drive Gear bending inspection
without LP Impeller/inducer installed**

**Drive Gear bending inspection
with LP Impeller/inducer installed**

- (2) Attach the impeller/inducer to 170 pound-inches (19.3 Newton meters) torque above run-on torque and repeat step (1).
- (3) If the run-out in step (2) is greater than step (1) by 0.0007 inch (0.0178 millimeter), replace the impeller/inducer and repeat the above.
