DATE ~~R~~ Jun. 3/03**V2500-A1/A5 SERIES PROPULSION SYSTEMS SERVICE BULLETIN**

ENGINE FUEL AND CONTROL – FUEL NOZZLE – INTRODUCTION OF REVISED SUPPORT BRACKETS FOR  
THE TURBINE COOLING AIR PIPE

V2500-ENG-73-0144

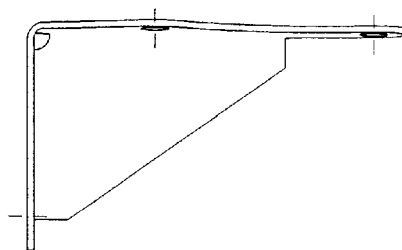
VIEW OF BRACKET 6A6559 BEFORE REWORK

On the diffuser case, insufficient clearance can exist between two support brackets for the turbine cooling air (TCA) pipe and adjacent fuel manifold tubes.

(3) The existing TCA No. 1 bracket can be reworked. (Refer to Figure 1).

PROCEDURE	RELATED DATA
(a) Chemically clean the bracket.	Use chemical cleaning equipment. Refer to the Standard Practices Manual (SPM), TASK 70-11-03-300-503.
(b) Apply marking ink in the area(s) of the bracket to be reworked.	Use standard workshop equipment. Refer to Fig 1.
(c) Mark off the area(s) of the bracket to be removed.	Use standard workshop equipment. Refer to Fig 1.
(d) Rework the bracket in the area(s) shown.	Use standard workshop equipment. Refer to Fig 1.
(e) Remove sharp edges.	Use standard workshop equipment. Refer to Fig 1.
(f) Chemically clean the bracket.	Use chemical cleaning equipment. Refer to the Standard Practices Manual (SPM), TASK 70-11-03-300-503.

- (g) Do a local penetrant crack test on the reworked area. Use CoMat 06-22 fluorescent penetrant, with penetrant crack test equipment. Refer to the Standard Practices Manual (SPM), TASK 70-23-05-230-501.
- (i) Reject the bracket if cracks are found.
- (h) Visually examine and measure the dimensions of the reworked area(s). Refer to Fig 1.
- (i) Cancel the existing part number and identify with the new part number. Use vibro-engraving equipment. refer to the Standard Practices Manual (SPM), TASK 70-09-00-400-501, SUBTASK 70-09-00-400-001.

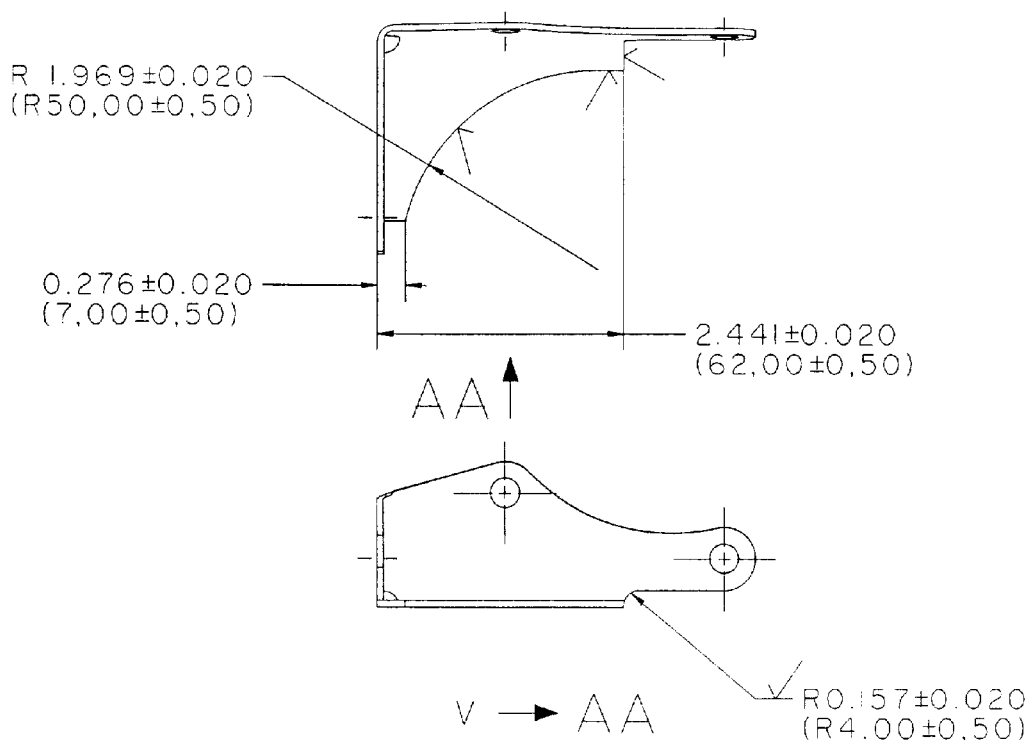
VIEW OF BRACKET AFTER REWORK

(a) The side adjacent to the fixing holes is scalloped.

(b) The length of the side adjacent to the fixing holes is reduced.

DIMENSIONS ARE IN INCHES (MILLIMETRES).  
MACHINE WHERE MARKED ✓  
SURFACE FINISH TO BE 125 MICROINCHES (3.2 MICROMETRES) UOS.  
BREAK SHARP EDGES 0.012±0.008 (0.30±0.20).
