V2500-A1/A5 PROPULSION SYSTEMS SERVICE BULLETIN

V2500-ENG-73-0166
 Transmittal - Page 1 of 2

ENGINE FUEL AND CONTROL – FUEL SYSTEM AIR TUBES – INTRODUCTION OF NON-VENTED BURNER
TO EEC PRESSURE (PB) SENSE LINE TUBE ASSEMBLIES

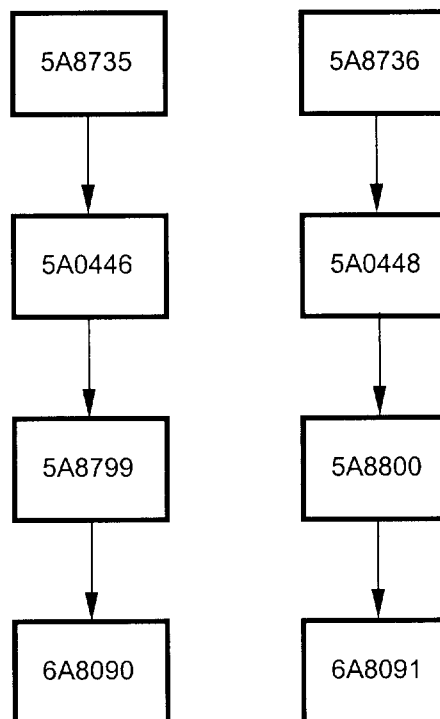
Family Tree
Fig.1

Pb Sense Line Tube Assemblies

V2500-A1 Engines only

Fuel and Control - Rework the PS3 burner air tube assembly to incorporate enlarged moisture trap drain holes.

Fuel and Control - Incorporate burner pressure (Pb) sensor tubes with revised holes.

Engine Fuel and Control - Fuel System Air Tubes - Introduction of non-vented burner to EEC pressure (Pb) sense line tube assemblies.

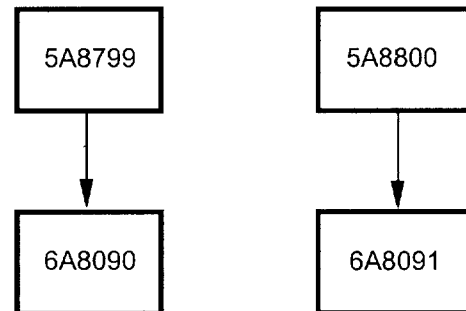
Family Tree
Fig.2

Pb Sense line tube assemblies

V2500-A5 Engines only

Engine Fuel and Control - Fuel System Air Tubes -
Introduction of non-vented burner to EEC pressure (Pb)
sense line tube assemblies.
