Subject: Transmittal of Revision 2 To Service Bulletin Number  
V25000-ENG-73-0169.

# International Aero Engines SERVICE BULLETIN

ENGINE - FUEL AND CONTROL - TO PROVIDE A NEW A5SCN15/T ELECTRONIC ENGINE  
CONTROL (EEC)

V2500-ENG-73-0169

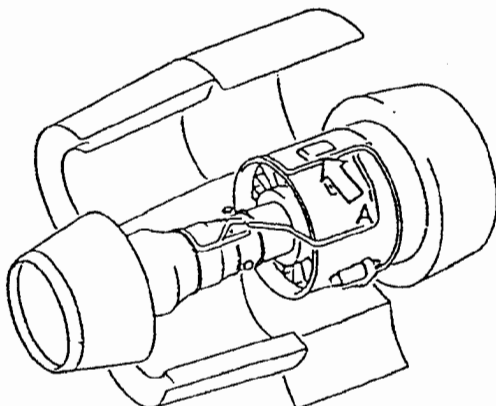
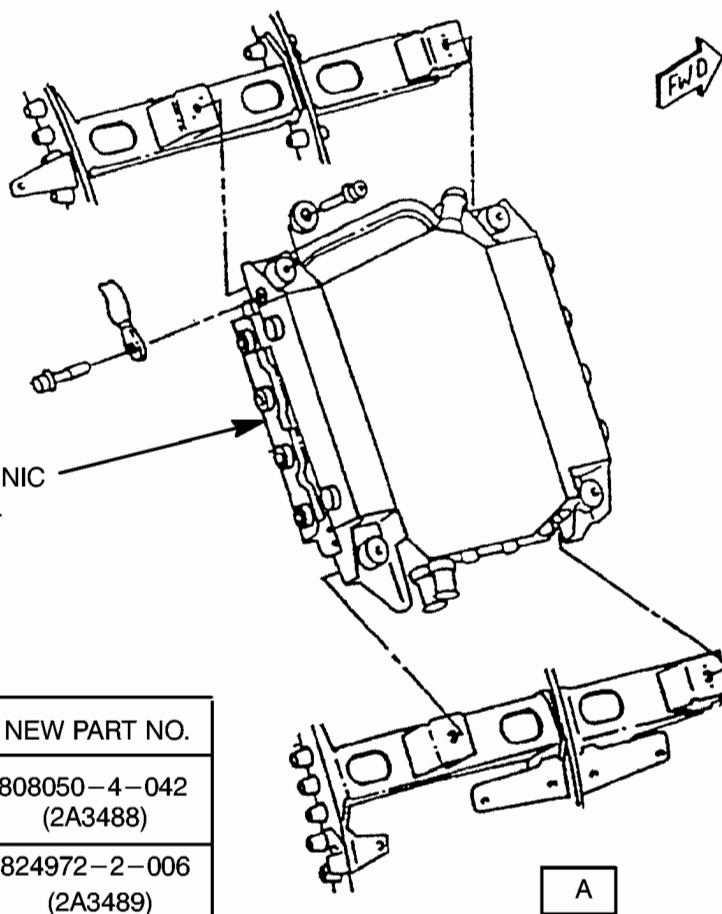
\* REPLACE ELECTRONIC  
ENGINE CONTROL

* EEC	OLD PART NO.	NEW PART NO.
150-20	808050-4-040 (2A3473)	808050-4-042 (2A3488)
150-40	824972-2-004 (2A3471)	824972-2-006 (2A3489)

- (1) Remove the Old P/N (See Table 4 Figure 1 Sheet 10) Electronic Engine Control by the procedure given in Reference (4), Chapter/Section 73-22-34, Removal Installation. Refer to Figure 2.
