V2500-A5/D5 SERIES PROPULSION SYSTEMS SERVICE BULLETIN

V2500-ENG-73-0171

ENGINE FUEL AND CONTROL – FUEL METERING UNIT – INTRODUCTION OF A REVISED TRW FUEL
METERING UNIT WITH SUPPLEMENTARY SOV TORQUE MOTOR CAP CLAMPING

SERVICE BULLETIN NUMBER FMU 550-73-8189

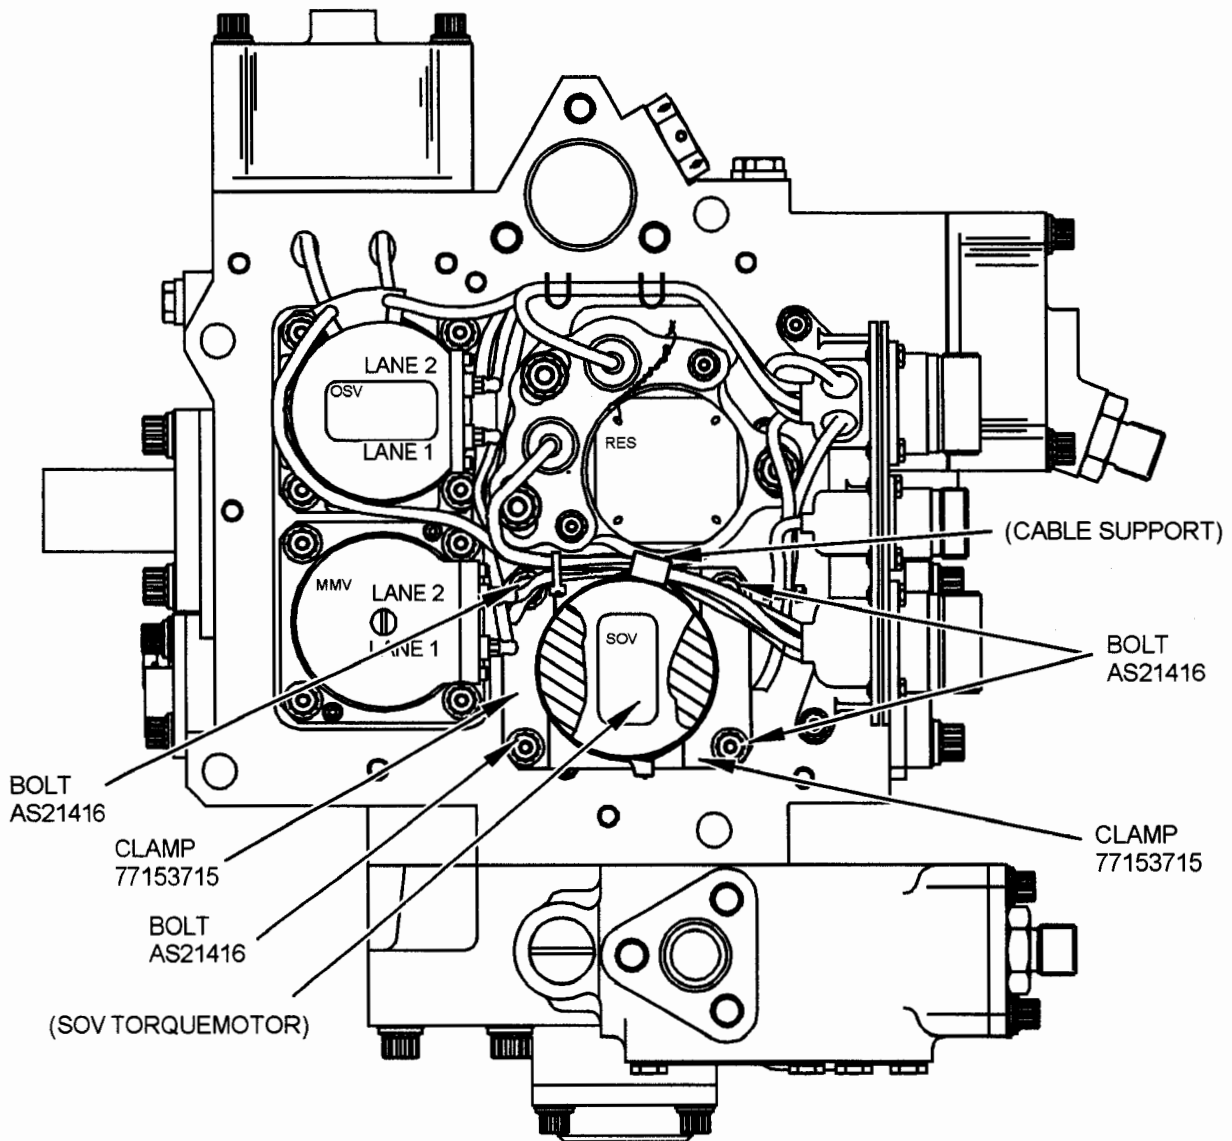
After Modification
Figure 3

- (1) This modification introduces a pair of C-shaped clamps to reinforce the flange of the Moog Shut-Off Valve (SOV) torque motor and, in the event of a torque motor cap failure by over-pressurisation, to prevent liberation of the cross-drilling plugs.

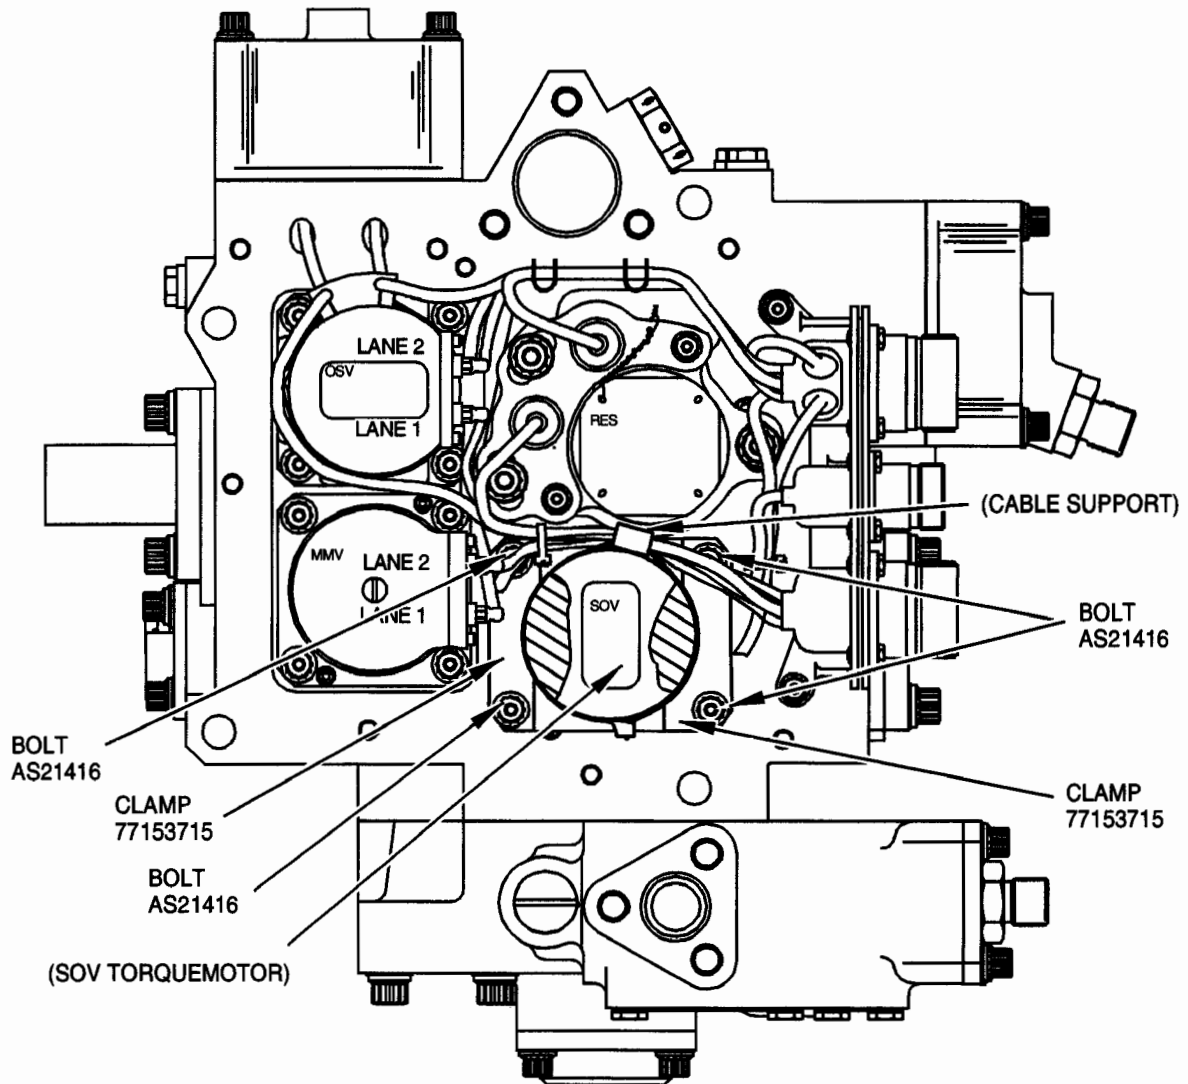
- (1) This modification introduces a pair of C-shaped clamps to reinforce the flange of the Moog Shut-Off Valve (SOV) torque motor and, in the event of a torque motor cap failure by over-pressurisation, to prevent liberation of the cross-drilling plugs.

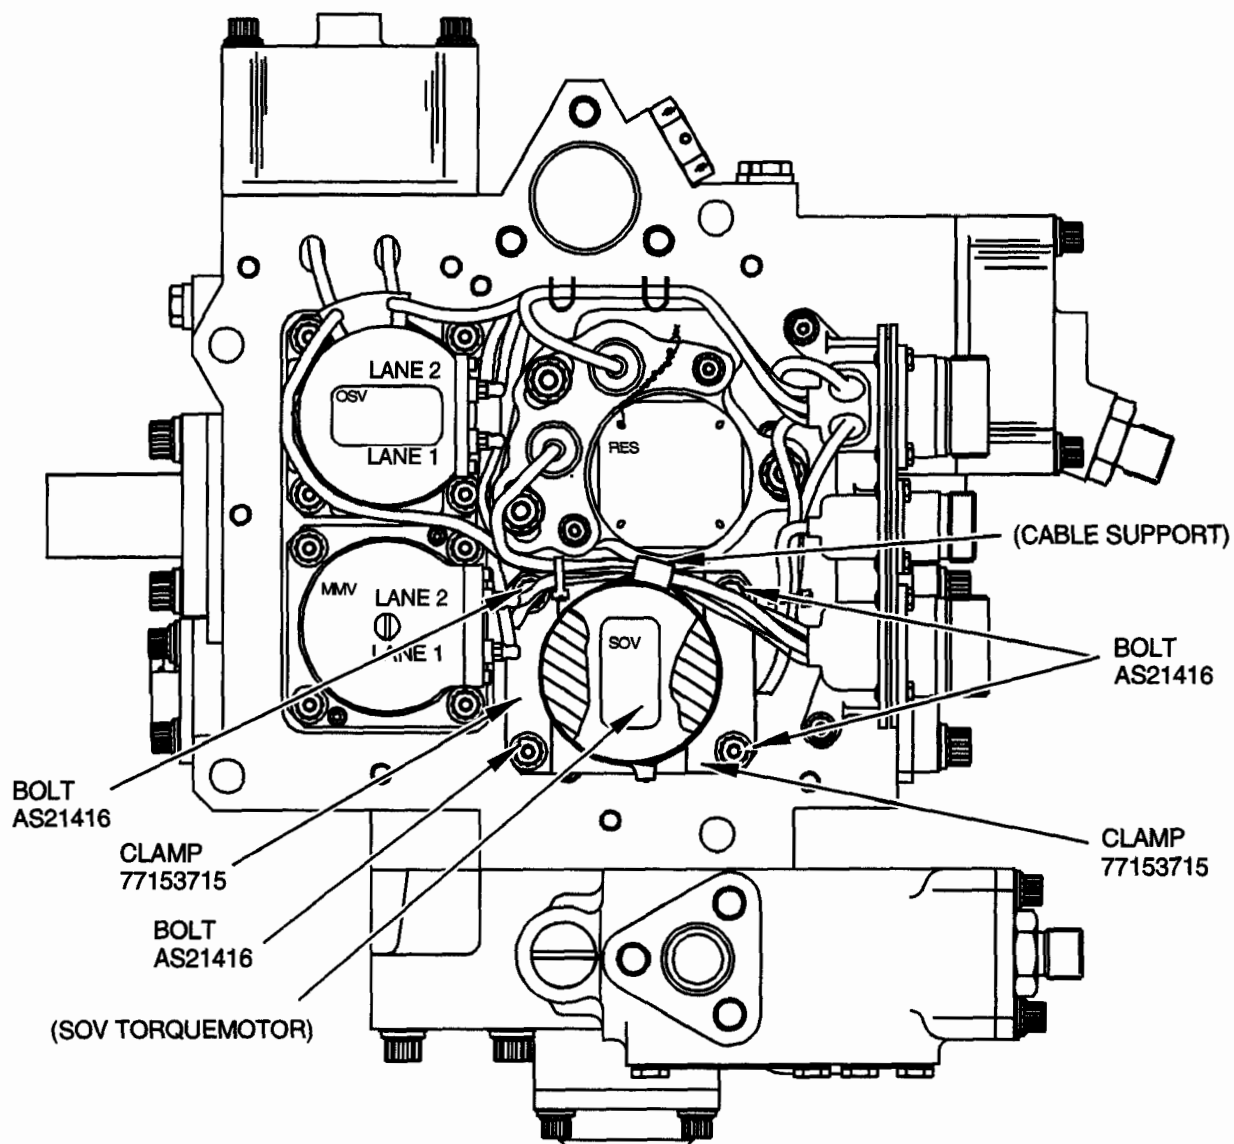
- (1) This modification introduces a pair of C-shaped clamps to reinforce the flange of the Moog Shut-Off Valve (SOV) torque motor and, in the event of a torque motor cap failure by over-pressurisation, to prevent liberation of the cross-drilling plugs.
