V2500-D5 SERIES PROPULSION SYSTEMS SERVICE BULLETIN

This document transmits the Initial Issue of Service Bulletin EV2500-73-0174

ENGINE FUEL AND CONTROL – FUEL FLOWMETER – INTRODUCTION OF A REVISED FUEL FLOW
TRANSMITTER SUPPORT BRACKET

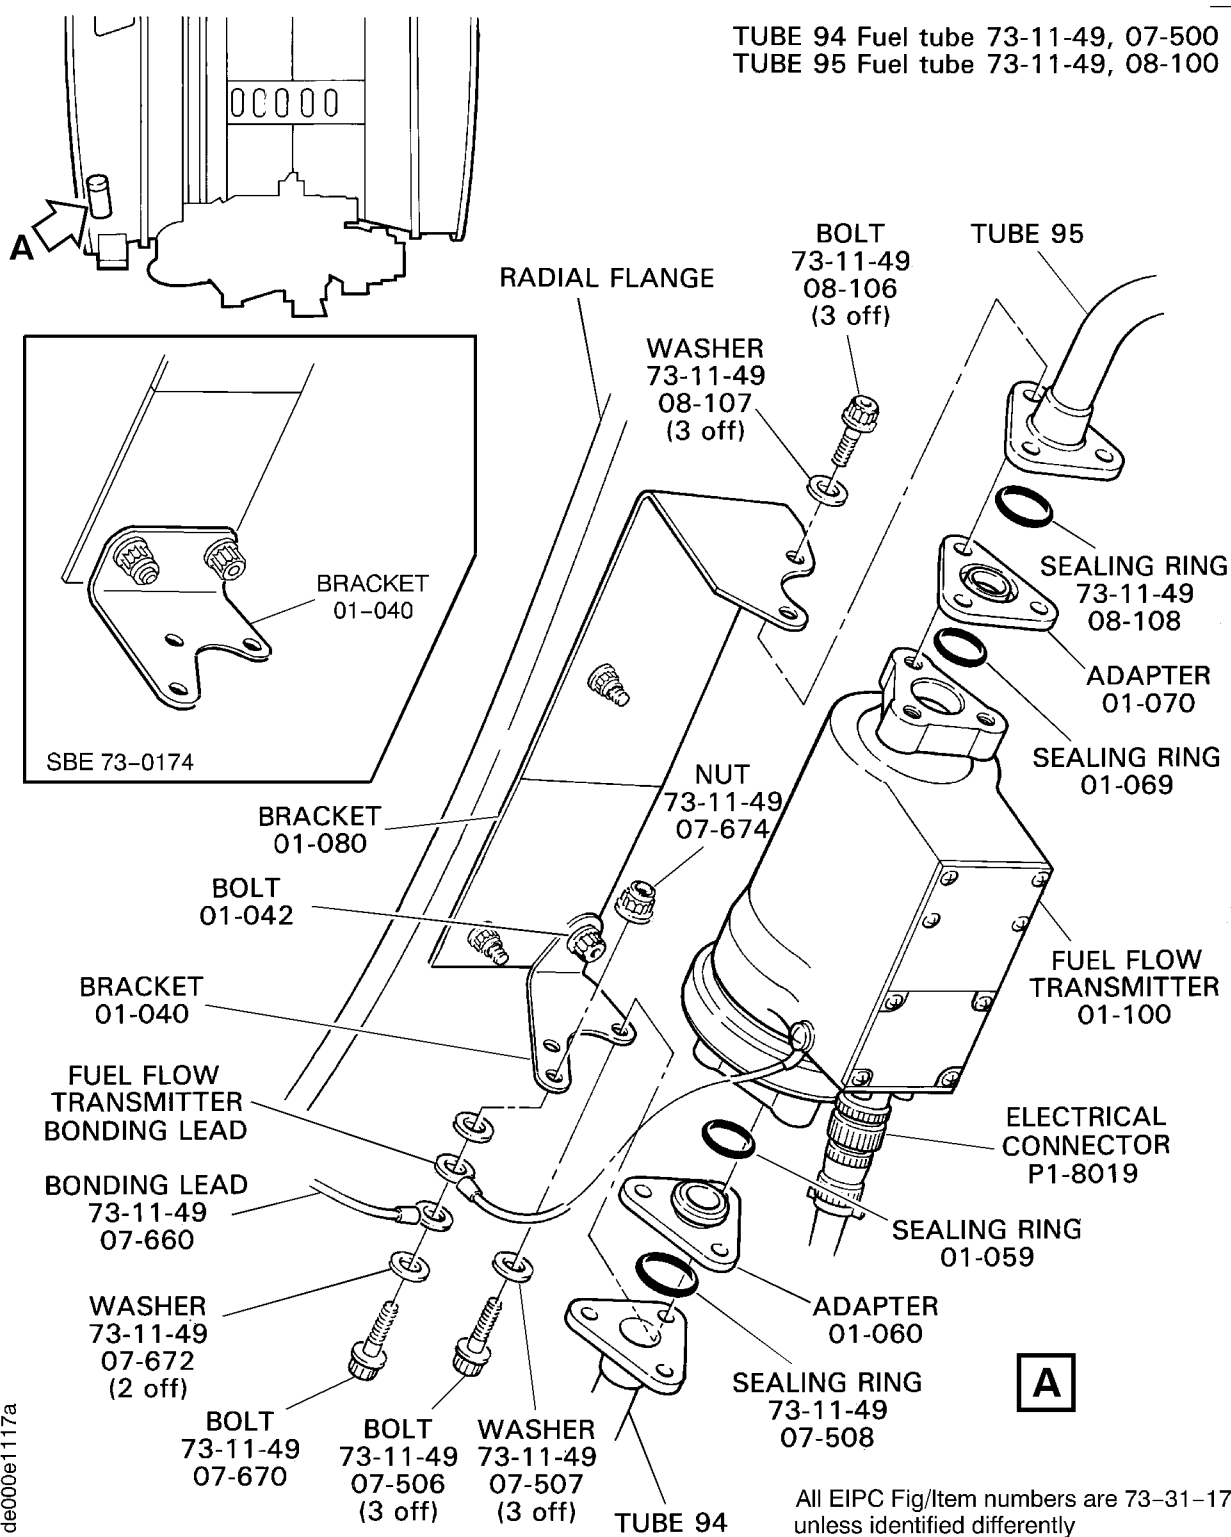
Install the fuel flow transmitter bracket
Fig 1

Cracking of the fuel flow transmitter bracket assembly and support bracket at the common attaching location may occur.

The problem has been attributed to fatigue, resulting from a single fixing point combined with a cantilever effect, which induces bending stresses in both brackets.

- (1) Attach the bracket (73-31-17, 01-040) to its location on the bracket (73-31-17, 01-080) with the bolt and washer (73-31-17, 01-042 and 01-044). Refer to the detail in Fig 1.
- (2) Attach the bracket assembly (73-31-17, 01-080) at the holes 16 and 17 (Refer to Fig 2) with the two bolts (73-31-17, 01-082), and the four washers (73-31-17, 01-084) and the two nuts (73-31-17, 01-086). Refer to the detail in Fig 1. Make sure the bolt inserted at hole 17 passes through the second hole in bracket (73-31-17, 01-040).

Torque the bolts installed in step (1) to 36 to 45 lbfin (4 to 5 Nm)
