V2500-A5/D5 PROPULSION SYSTEMS SERVICE BULLETIN

This document transmits the Initial Issue of Service Bulletin EV2500-73-0176

### ENGINE - FUEL AND CONTROL - TRW LUCAS AEROSPACE FUEL METERING UNIT (FMU) - REWORK INSTRUCTION FOR MACHINING THE MAIN METERING VALVE PLUNGER INSTALLED IN THE FMU 530, 540 AND 550 UNITS

#### NON-MOD SERVICE BULLETIN NUMBER FMU 530-73-103

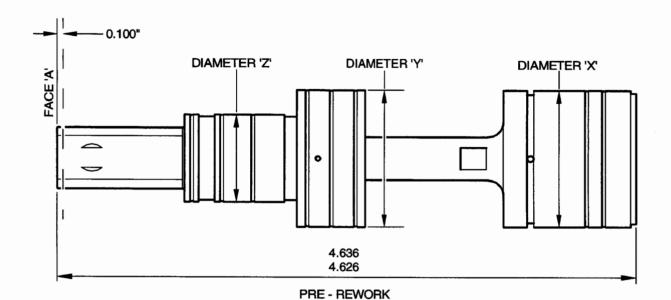
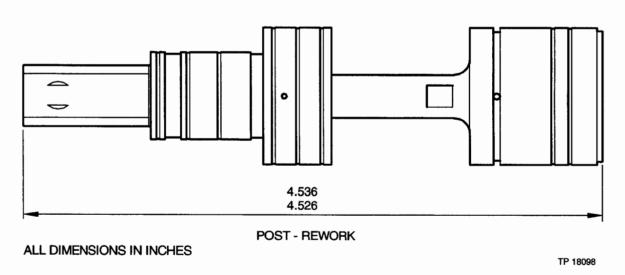
Main Metering Valve Plunger Re-work Detail Figure 1

The Main Metering Valve (MMV) Plunger is 0.100 in. (2,54 mm) longer in overall length than the drawing nominal dimension. The increase in length is the result of a machining process omission during original manufacture.

CAUTION: IT IS ESSENTIAL THAT THE PROCESS USED TO SET UP THE PLUNGER FOR GRINDING DOES NOT RESULT IN DISTORTION OF THE PLUNGER OR DAMAGE TO THE MATED SURFACES REF. 'X', 'Y' AND 'Z' FIG 1.

- (3) Position the plunger at 90 degrees to the traverse of the grinding wheel.
- (4) Surface grind the end face, adjacent to the rack location, ref. Face 'A' Fig 1, and reduce the overall dimension to the drawing limits of between 4.536 in. to 4.526 in. (115,214 mm to 114,960 mm).

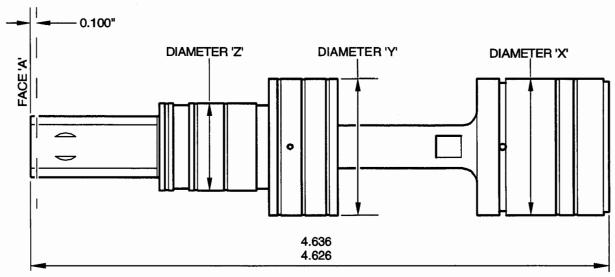
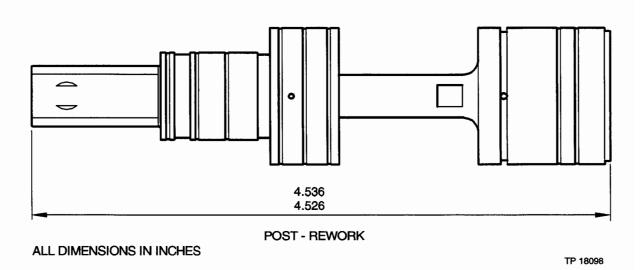
Main Metering Valve Plunger Re-work Detail Figure 1

The Main Metering Valve (MMV) Plunger is 0.100 in. (2,54 mm) longer in overall length than the drawing nominal dimension. The increase in length is the result of a machining process omission during original manufacture.

CAUTION: IT IS ESSENTIAL THAT THE PROCESS USED TO SET UP THE PLUNGER FOR GRINDING DOES NOT RESULT IN DISTORTION OF THE PLUNGER OR DAMAGE TO THE MATED SURFACES REF. 'X', 'Y' AND 'Z' FIG 1.

- (3) Position the plunger at 90 degrees to the traverse of the grinding wheel.
- (4) Surface grind the end face, adjacent to the rack location, ref. Face 'A' Fig 1, and reduce the overall dimension to the drawing limits of between 4.536 in. to 4.526 in. (115,214 mm to 114,960 mm).

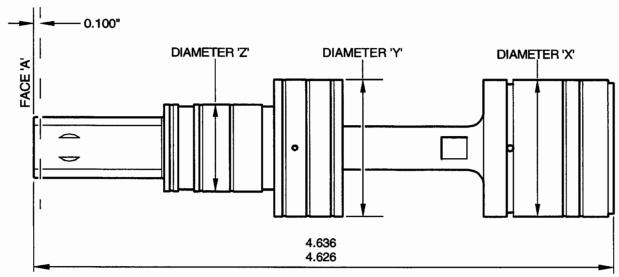
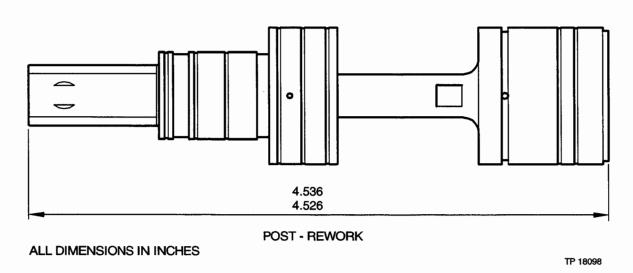
Main Metering Valve Plunger Re-work Detail Figure 1

The Main Metering Valve (MMV) Plunger is 0.100 in. (2,54 mm) longer in overall length than the drawing nominal dimension. The increase in length is the result of a machining process omission during original manufacture.

CAUTION: IT IS ESSENTIAL THAT THE PROCESS USED TO SET UP THE PLUNGER FOR GRINDING DOES NOT RESULT IN DISTORTION OF THE PLUNGER OR DAMAGE TO THE MATED SURFACES REF. 'X', 'Y' AND 'Z' FIG 1.

- (3) Position the plunger at 90 degrees to the traverse of the grinding wheel.
- (4) Surface grind the end face, adjacent to the rack location, ref. Face 'A' Fig 1, and reduce the overall dimension to the drawing limits of between 4.536 in. to 4.526 in. (115,214 mm to 114,960 mm).
