DATE ~~R~~ Apr.25/02**V2500-A5 PROPULSION SYSTEMS NON-MODIFICATION SERVICE BULLETIN**

V2500-ENG-73-0177

ENGINE - FUEL AND CONTROL - LP AND HP FUEL PUMP - INSPECTION OF TEIJIN SEIKI HOUSINGS
FOR HP INLET FLANGE CRACKS - NON-MODIFICATION SERVICE BULLETIN

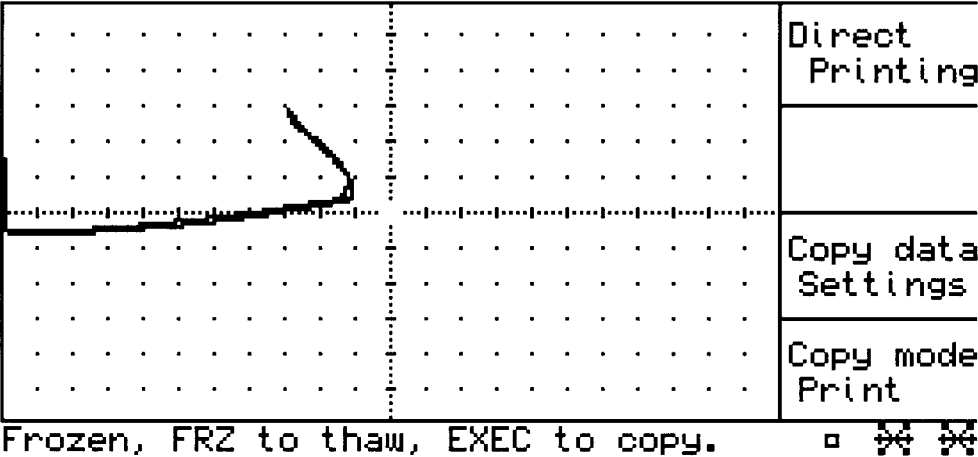
Appendix 1, Fig.1

- (5) To set lift off, lift the probe on and off the test block and adjust the phase angle ensuring that the spot/trace moves horizontally right to left (see Appendix 1, Fig.1).
- (6) Move the probe over the 0,5 mm slot at 90 degrees to the slot and adjust the Channel 1 gain to ensure the spot/trace moves upward 3 mainscale divisions in the vertical plane at approximately 45 degrees (see Appendix 1, Fig.1).
- (7) The instrument is now calibrated.

Calibration trace obtained from test block showing horizontal lift off and indication from 0,50 mm. slot

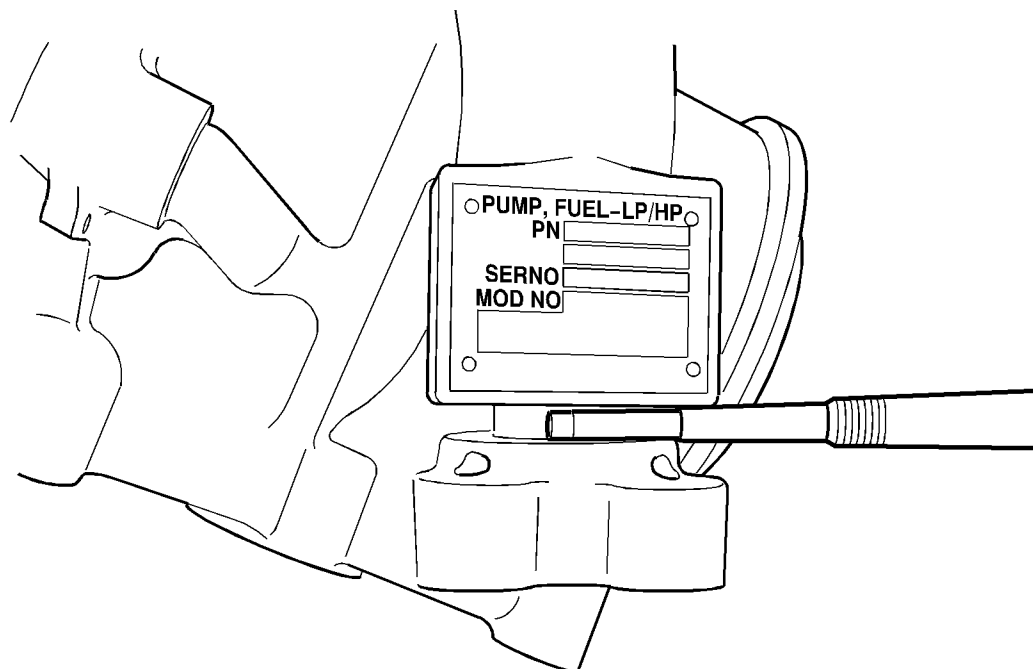
- (1) Position the probe on the fuel pump HP inlet boss radius, clear of the inspection area and balance the instrument.
- (2) Carry out a scan of the radius using a zig-zag pattern ensuring the lower 180 degrees of the circumference of the boss radius is inspected (see Appendix 1, Fig.2).

View of pump showing eddy current probe positioned in radius
Appendix 1, Fig.2

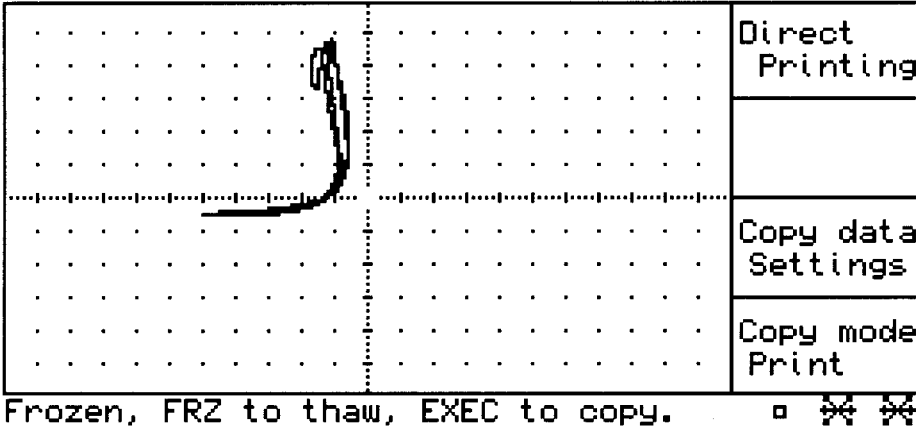
Appendix 1, Fig.3

- (1) Any rapid spot/trace movement in the vertical or near vertical direction is to be considered a crack indication (see Appendix 1, Fig.3).
- (2) An uncracked radius will display a lift off trace similar to Appendix 1, Fig.4.
- (3) Cracked pumps should be returned to the vendor for replacement of the housing, clearly stating NMSB 73-0177 on the paperwork.

Trace obtained from actual crack in radius

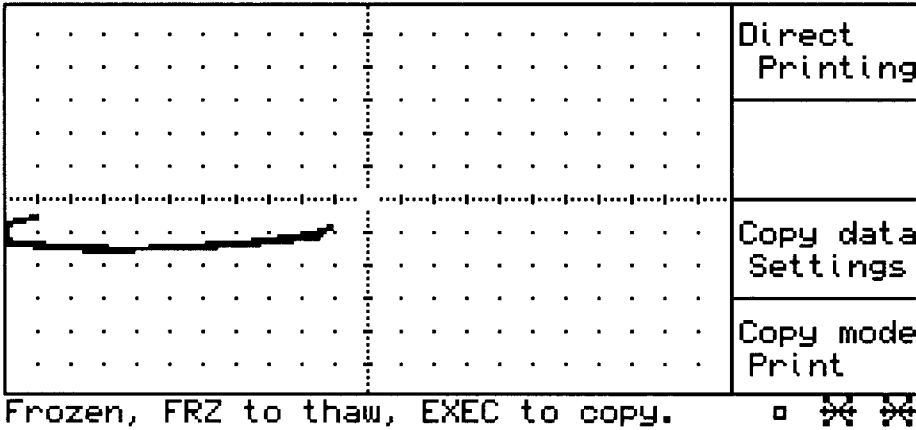
Trace obtained from uncracked radius
Appendix 1, Fig.4
