V2500-A1 SERIES PROPULSION SYSTEM SERVICE BULLETIN

This document transmits the Initial Issue of Service Bulletin EV2500-73-0181

ENGINE FUEL AND CONTROL – FUEL METERING UNIT – INTRODUCTION OF A REVISED MAIN
METERING VALVE (MMV) END COVER

ENGINE - FUEL AND CONTROL - FUEL METERING UNIT, TYPE FMU 500
INTRODUCTION OF A METERING VALVE END COVER (77154080)
WITH AN INCREASED FLANGE FILLET RADIUS

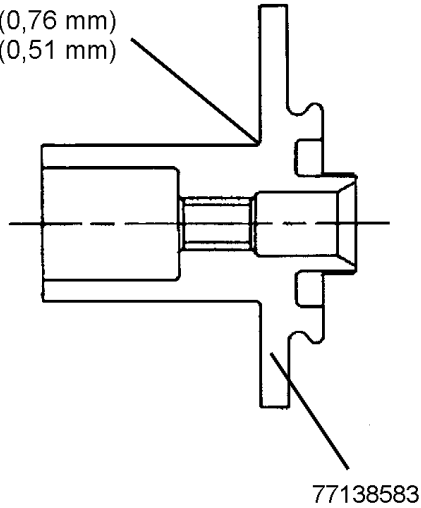
Before Mod CP8200

There have been four occurrences of cracks in the metering valve end cover (77138581) flange.

The flange fillet radius on the metering valve end cover (77138581) has been increased from the limits 0.020 to 0.030 in. (0,51 to 0,76 mm) to the limits 0.195 to 0.215 in. (4,95 to 5,46 mm), Ref Fig 1.

Fillet Radius

0.030 in (0,76 mm)
0.020 in (0,51 mm)

This Service Bulletin gives the accomplishment instructions for the maintenance facility to replace the installed metering valve end cover assembly (77138583) with the new metering valve end cover assembly (77154080).

- (1) Replace the metering valve end cover assembly (77138583), Ref Fig 1.
- (2) When the metering valve end cover assembly (77138583) is replaced you must
 - record the unit type, serial number and reason for removal on a label and attach the label to the rejected metering valve end cover assembly (77138583)
 - send the rejected cover to Goodrich at the address that follows:

- (1) Remove the metering valve end cover assembly (77138583), Ref Component Maintenance Manual 73-22-52 DISASSEMBLY, Page Block 301.
- (2) Install the post mod CP8200 metering valve end cover assembly (77154080), Ref Component Maintenance Manual 73-22-52 ASSEMBLY, Page Block 701 and Fig 1.
- (3) Test the unit, Ref Component Maintenance Manual 73-22-52 TEST AND FAULT ISOLATION, Page Block 101.

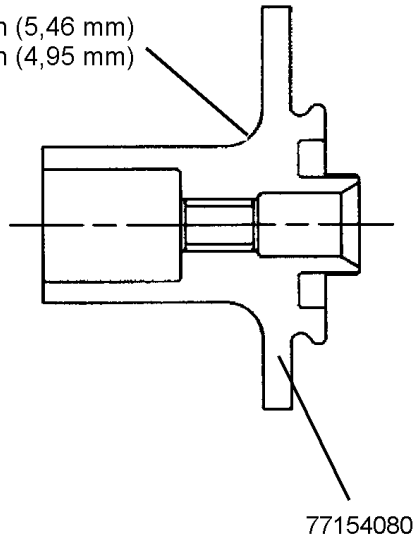
After Mod CP8200

Stress analysis has shown that an increase in the flange fillet radius on the metering valve end cover will increase the flange strength sufficiently to prevent cracks.

Fillet Radius

0.215 in (5,46 mm)
0.195 in (4,95 mm)
