V2500-A5 SERIES PROPULSION SYSTEM SERVICE BULLETIN

V2500-ENG-73-0185
Transmittal - Page 1 of 2

ENGINE – FUEL AND CONTROL – EEC150-40 PRESSURE BURNER SENSOR PORT SCREEN DELETION

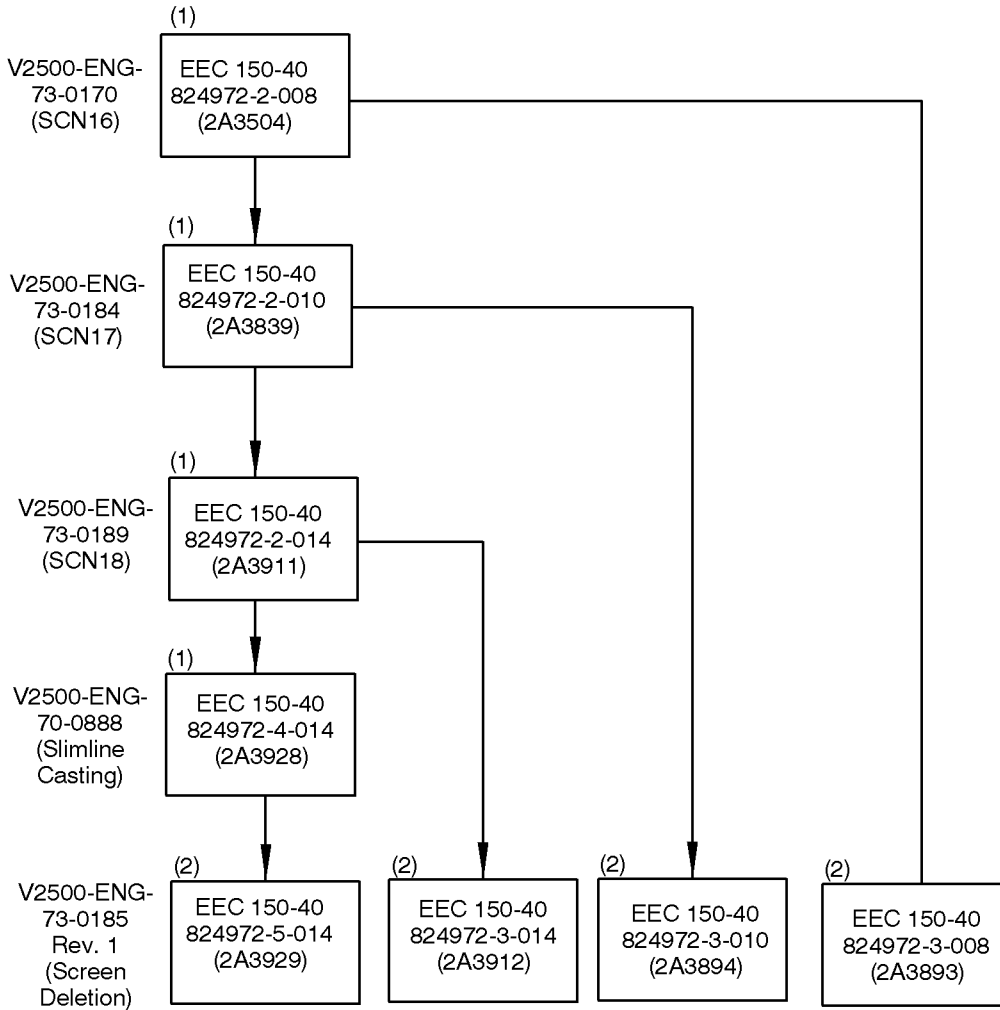
FAMILY TREE - ELECTRONIC ENGINE CONTROL (EEC) REF. CATALOG SEQUENCE NO. 73-22-34,
FIG. 01 ITEM 280

(1) WITH Pb SCREEN
(2) Pb SCREEN DELETED
