V2500-A1/A5. SERIES PROPULSION SYSTEMS SERVICE BULLETIN

V2500-ENG-73-0186

ENGINE – FUEL AND CONTROL – EEC150-1/EEC150-20 PRESSURE BURNER SENSOR PORT SCREEN
DELETION

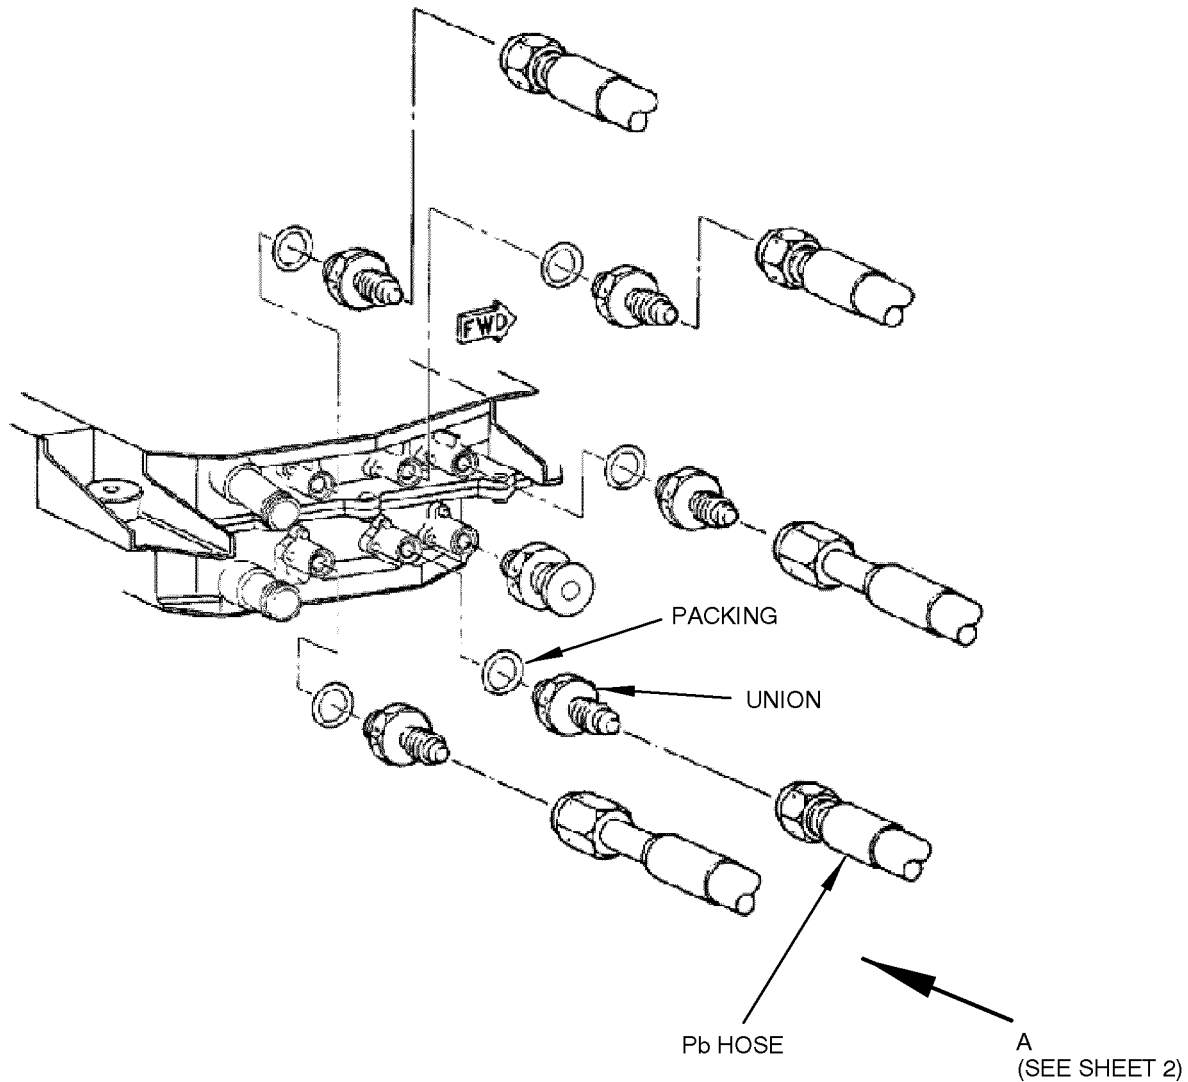
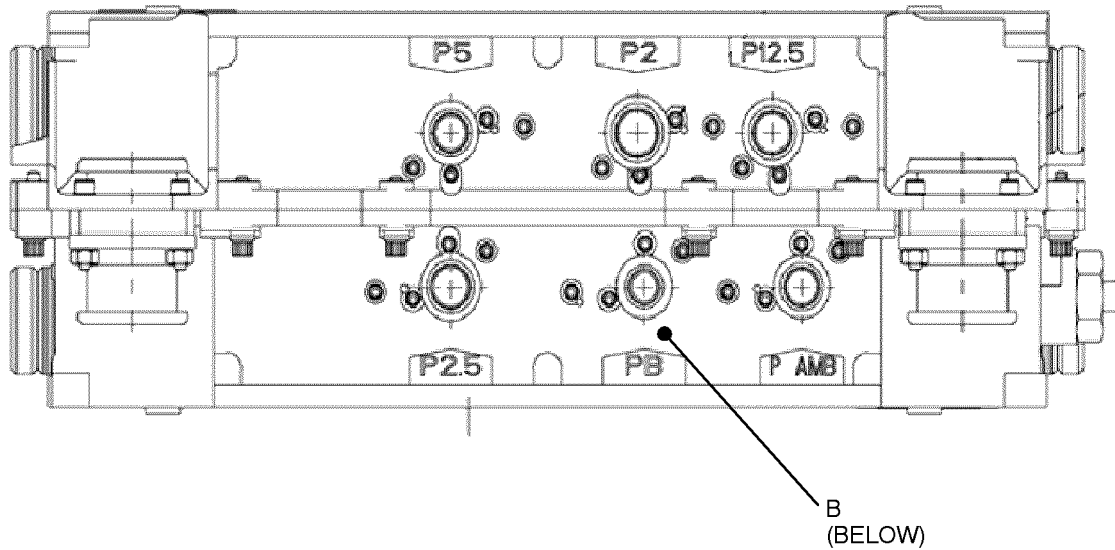
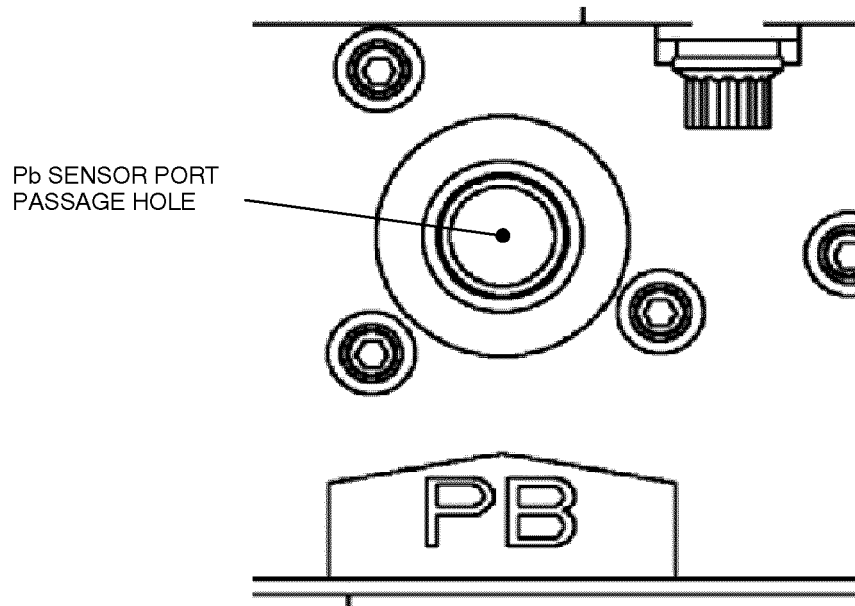
LOCATION AND REMOVAL OF THE PRESSURE BURNER SENSOR PORT
SCREEN BY AN OPERATOR
FIGURE 2, SHEET 1

- (1) Problem: The filter screen in the Pb port has a tendency to become contaminated with aluminum hydroxide which is present in the burner as a result of oxidation of aluminum from the compressor lining. Once contaminated, the screen attracts and holds moisture which frequently leads to freezing at cruise. The frozen Pb signal is detected by the EEC Pb Synthesis, which allows safe operation for the remainder of the flight. However, a non-dispatchable 'Sensor Fault' is annunciated to the cockpit.

- (2) Background: The 40 micron screen traps aluminum hydroxide contamination which leads to the in-flight Pb freezing events. Although the Pb sensor is directly heated, the screen is located in the Pb port and does not receive any heat generated by the sensor heater. The 40 micron mesh presents a relatively colder surface which encourages condensation on a surface that effectively traps and collects aluminum hydroxide. The contaminated filter screen collects water in the Pb line and freezes due to the cold temperatures observed during cruise.

- (3) Objective: Remove the 40 micron screen from the Pb port of the EEC150-1 and EEC150-20 vibrating cylinder. Screen removal will prevent localized condensation which precipitates aluminum hydroxide contamination and subsequent freezing at cruise.

R Make sure that no visible damage was sustained during the screen removal
R operation by comparing the condition of the Pb sensor port face to the
R baseline condition identified previously in these Accomplishment
R Instructions. There must be no damage to the Pb sensor port face that has
R exposed any EEC housing "base metal". Exposed "base metal" will be visible
R as a "shiny" surface when compared to the "dull" surrounding anodized
R finish surface.

R (18) Look inside the Pb sensor port. Ensure Pb sensor port internal threads are
R not damaged. Ensure there is no FOD in the Pb sensor port that was
R generated during the screen removal operation by comparing the condition
R inside the Pb sensor port to the baseline condition identified previously
R in these Accomplishment Instructions. Additionally, ensure there are no
R remaining pieces of screen in the Pb sensor port. A vacuum may be used to
R remove any remaining pieces of screen or debris.

R Do not return the EEC to service if visible damage to the Pb sensor port
R face has been sustained or if there is material in the Pb sensor port that
R cannot be removed.
