V2500-ENG-73-0190
Transmittal - Page 1 of 2

ENGINE – FUEL AND CONTROL – TO PROVIDE A NEW ELECTRONIC ENGINE CONTROL (EEC) WITH D5
SCN14/0 SOFTWARE

Boeing MD-90

V2525-D5, V2528-D5

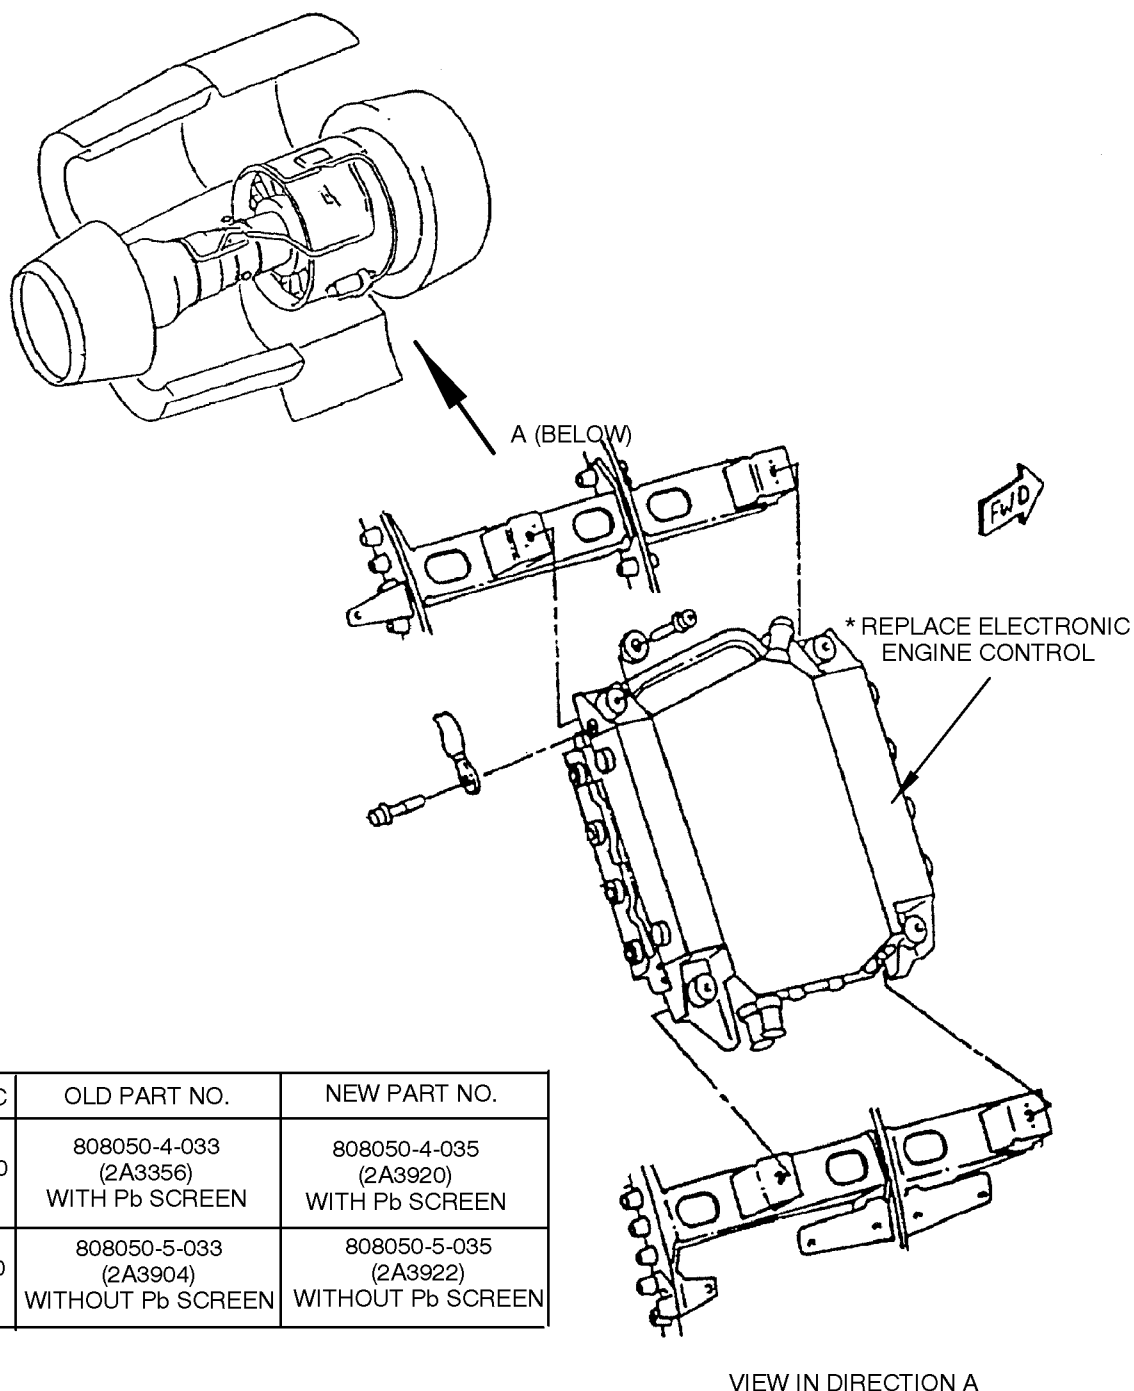
* EEC	OLD PART NO.	NEW PART NO.
150-20	808050-4-033 (2A3356) WITH Pb SCREEN	808050-4-035 (2A3920) WITH Pb SCREEN
150-20	808050-5-033 (2A3904) WITHOUT Pb SCREEN	808050-5-035 (2A3922) WITHOUT Pb SCREEN

Program the EEC with SCN14/0 software or replace the EEC with a new EEC that has SCN14/0 software.
