**V2500-D5 SERIES PROPULSION SYSTEM NON-MODIFICATION SERVICE BULLETIN**

**V2500-ENG-73-0196**  
**ENGINE – EXTERNALS – ACTUATOR PRESSURE FUEL SUPPLY AND**  
**ACTUATOR PRESSURE FUEL RETURN – CLIPPING POINT 7004**  
**INSPECTION**  
**NON-MODIFICATION SERVICE BULLETIN**

- (1) Aircraft
  - (a) Boeing MD-90
- (2) Engine
  - (a) V2525-D5
  - (b) V2528-D5

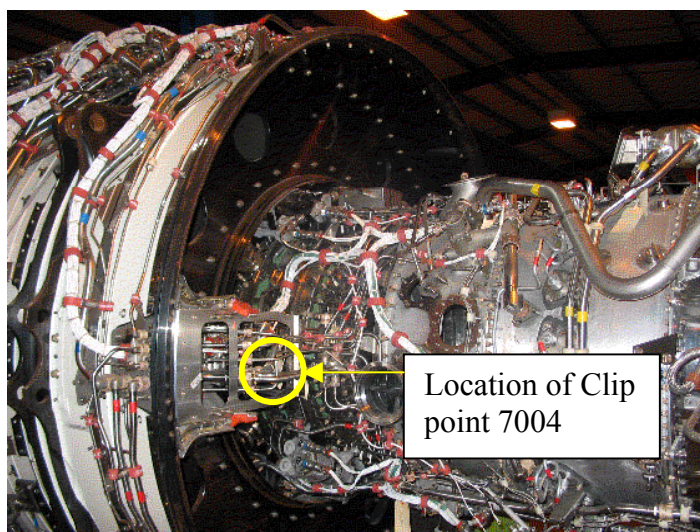
(1) Visually inspect the clip at clip point 7004, P/N AS62408. Refer to figure 1 for the location of the clip point, and figure 2 to identify individual parts. These figures are taken from a mock-up engine and are for reference only.

Figure 1. Location of clip point 7004.

| a. Clip rubber is worn or damaged | Replace the clip. |
| b. Clip is fractured, missing or loose | Replace the clip immediately.<br>Replace the Booster Stage Bleed Valve fuel return tube P/N 6A5132 within 50 cycles. |

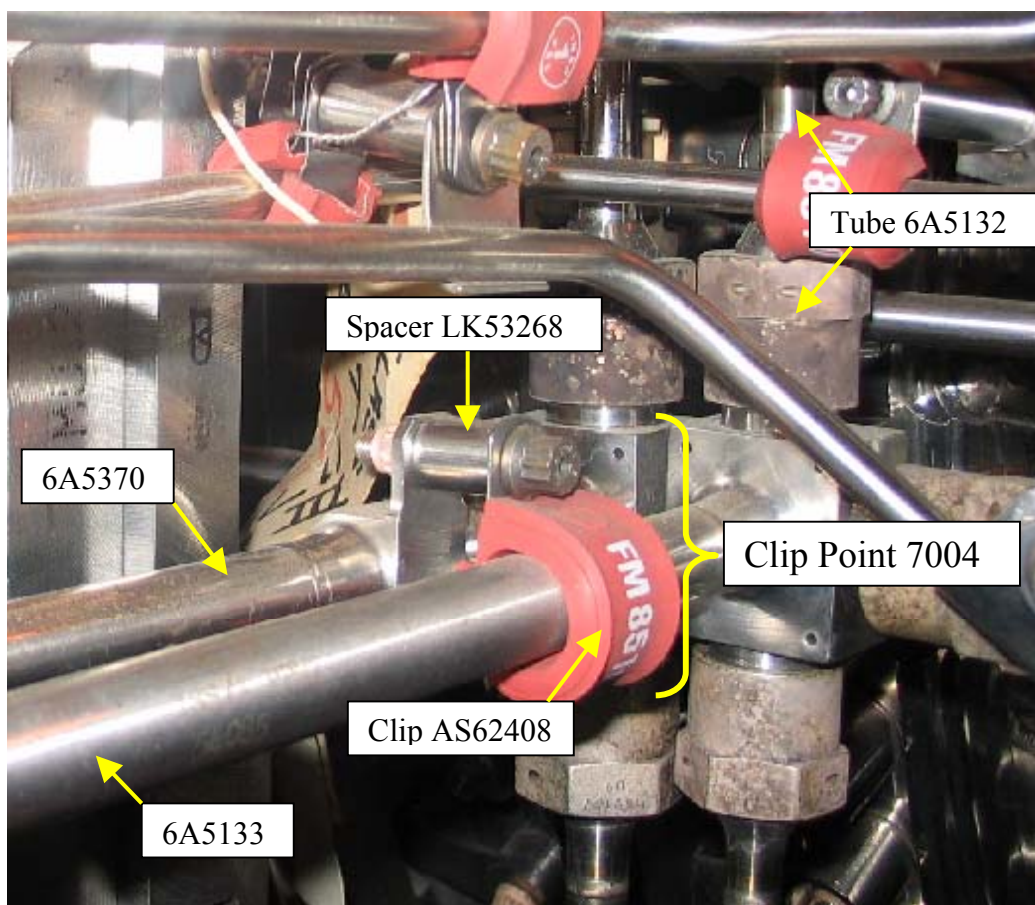
(2) Check the part number of the clip point spacer.

Figure 2. Identification of parts

| a. Correct spacer part number is installed (LK53268) * | No action required |
| b. Incorrect part number is installed | Replace the clip immediately.<br>Replace the spacer with p/n LK53268 within 50 cycles. If the spacer is not replaced immediately, the clip must be replaced again when the correct spacer is installed.<br>Replace tube p/n 6A5133 and p/n 6A5370 within 450 hours. |

\*The correct spacer (LK53268) is 12.5mm (0.492") in length.
