V2500-A1/A5 SERIES PROPULSION SYSTEM SERVICE BULLETIN

This document transmits the Initial Issue of Service Bulletin V2500-ENG-73-0202.

ENGINE – FUEL AND CONTROL – P4.9 TUBE ASSEMBLIES, PRESSURE CONTROL AND BOX AND CABLE,  
TC – REPLACE THE P4.9 TUBE ASSEMBLIES TO PREVENT FRACTURES AND REPOSITION THE EXHAUST  
GAS TEMPERATURE (EGT) CABLE TO PREVENT CHAFING

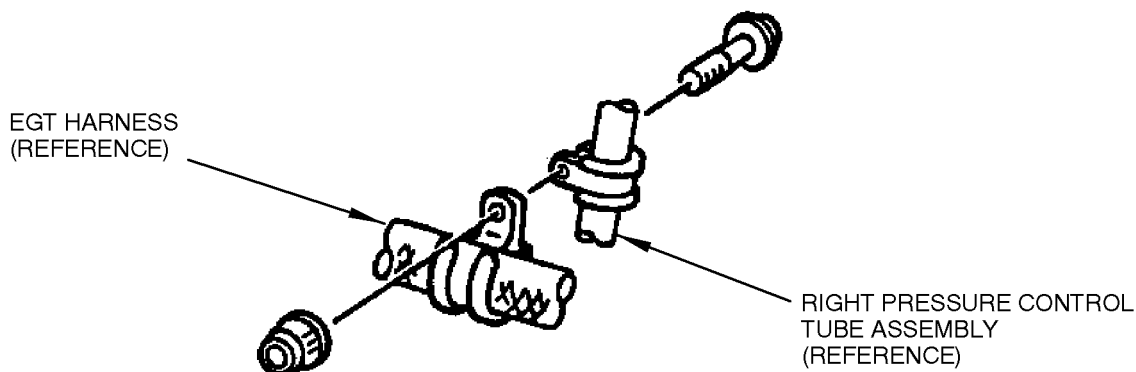
VIEW B  
PRE-SB 73-0202  
EGT HARNESS CLAMPING AND ROUTING

- (a) Clearance between the EGT harness and the nacelle heat shield is minimal. This is a result of engine thermal expansion which decreases clearance between the engine and nacelle components. This could create a harness chafing condition which may degrade the harness overbraid.
- (b) Analysis of the P4.9 left and right pressure control tube assemblies indicates that engine thermal expansion causes stress levels which may exceed allowable limits. Radial expansion of the engine may also result in a close clearance condition between the P4.9 sense line and the nacelle thermal blanket.

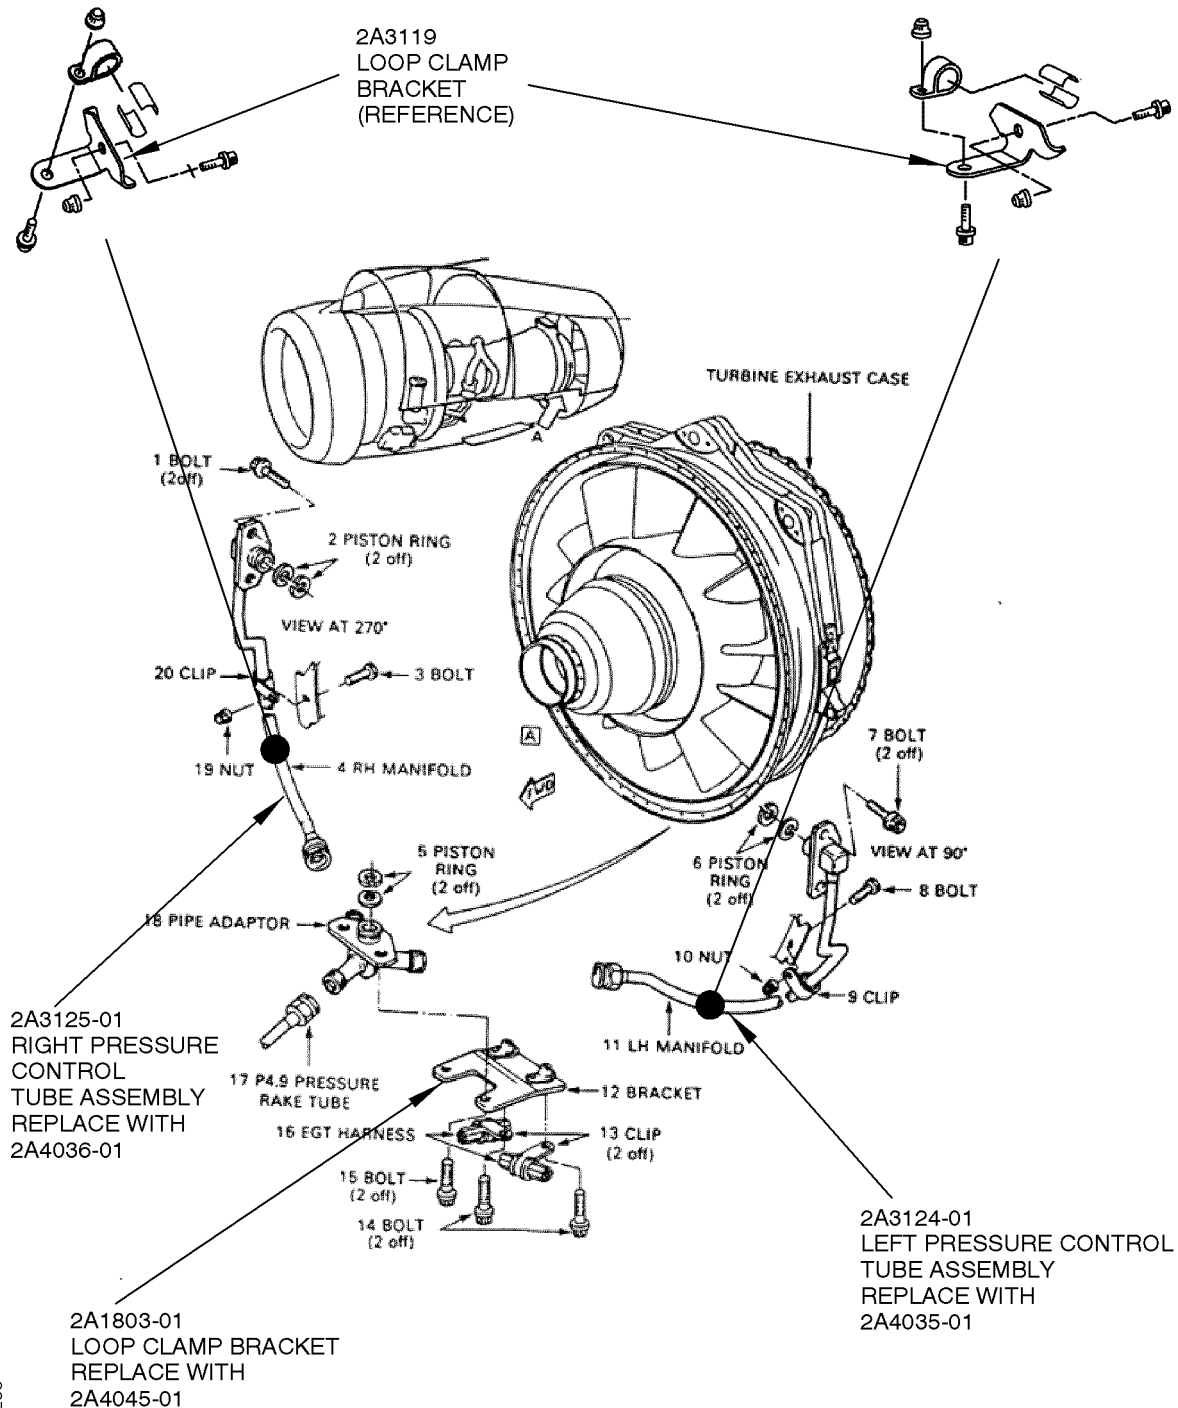
REPLACEMENT OF P4.9 BRACKET AND TUBE ASSEMBLIES  
FIGURE 4

- (a) Insufficient EGT harness clearance with the nacelle is caused by engine thermal conditions.
- (b) The failure mode was determined to be low cycle fatigue caused by differential thermal growth between the turbine exhaust case and P4.9 sense line. At times, a lack of clearance between the pressure control tube assembly and the nacelle could cause insufficient clearance, which contributes to stress.

- (a) Replace the Left Pressure Control Tube Assembly, P/N 2A3124-01 with P/N 2A4035-01.
  - (b) Replace the Right Pressure Control Tube Assembly, P/N 2A3125-01 with P/N 2A4036-01.

- (c) Replace Loop Clamp Bracket, P/N 2A1803-01 with P/N 2A4045-01. During installation, tighten the fasteners that attach the bracket to 85.9 - 105.9 lbfin (9,604 - 11,863 Nm).
