V2500-A5 SERIES PROPULSION SYSTEM SERVICE BULLETIN

This document transmits the Initial Issue of Service Bulletin V2500-ENG-73-0203

V2500-ENG-73-0203

ENGINE – FUEL AND CONTROL – PROVIDE A NEW ELECTRONIC ENGINE CONTROL (EEC) WITH A5
SCN20/Y SOFTWARE

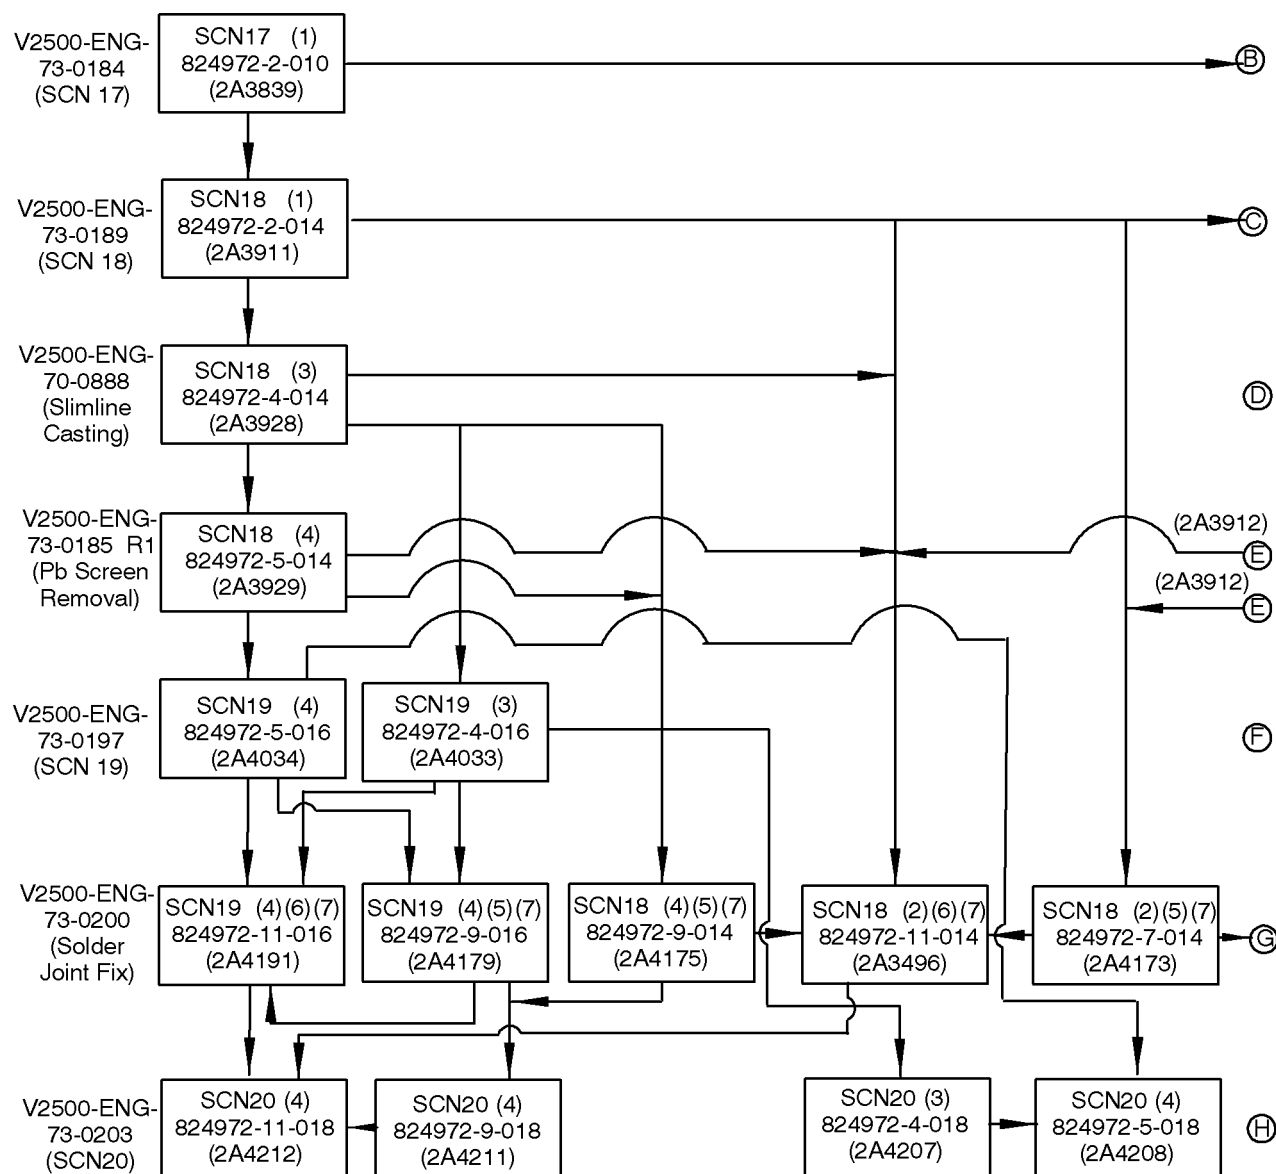
FAMILY TREE - ELECTRONIC ENGINE CONTROL (EEC) REF. CATALOG SEQUENCE NO. 73-22-34.
 FIG. 01 ITEM 280 - FOR V2500-A5 DELIVERED ENGINES
 CHART A (SHEET 1 OF 4)

- (1) With Pb Screen
 (2) No Pb Screen
 (3) With Pb Screen & Slimline Case
 (4) No Pb Screen & Slimline Case
 (5) The new part can be obtained by modification of the old part as specified in the Accomplishment Instructions.
 (6) The new part is a replacement part only, and cannot be obtained by modification of the old part.
 (7) With Reference 7, Service Bulletin No. V2500-ENG-73-0185 incorporated.
