ENGINE — FUEL AND CONTROL — INTRODUCTION OF 33K BUMP RATING, MODIFICATION OF THE DATA ENTRY PLUG AND NEW ENGINE IDENTIFICATION PLATE

Turbojet Engine Service Bulletin No. V2500-ENG-73-0209 Revision No. 2 dated September 16, 2013.

V2500 Series 73-0209

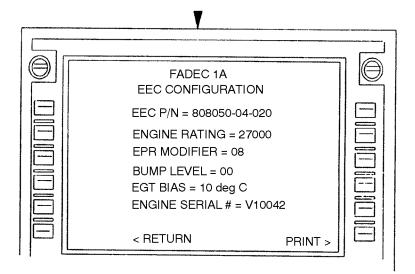
MCDU INTERROGATION OF EEC CONFIGURATION Figure 6

NOTE: If this does not agree, the Data Entry Plug must be corrected or replaced; until then the aircraft can not be dispatched.

- (b) Torque the Nuts between 36 45 lbfin. (4.0 5.0 Nm.).
- Check the data entry plug wiring by interrogating the MCDU and comparing the output EEC CONFIGURATION information output to the Data Plate information, when the EEC

and DEP are installed on the aircraft. Use the procedure specified in Reference 10, AMM Chapter/Section 73-22-35, Installation and Figure 6.
