## V2500-A1/A5 SERIES PROPULSION SYSTEM NON-MODIFICATION SERVICE BULLETIN

# V2500-ENG-73-0211

NON-MODIFICATION SERVICE BULLETIN – ENGINE FUEL AND CONTROL – INSPECTION OF FUEL  
NOZZLE AND SUPPORT ASSEMBLIES

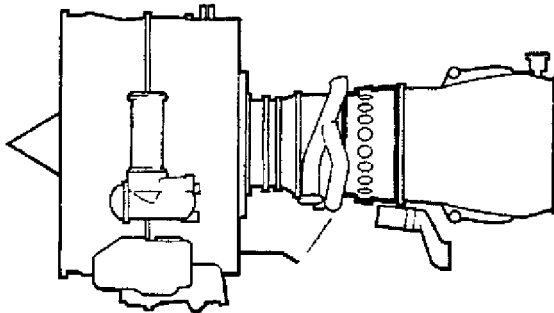
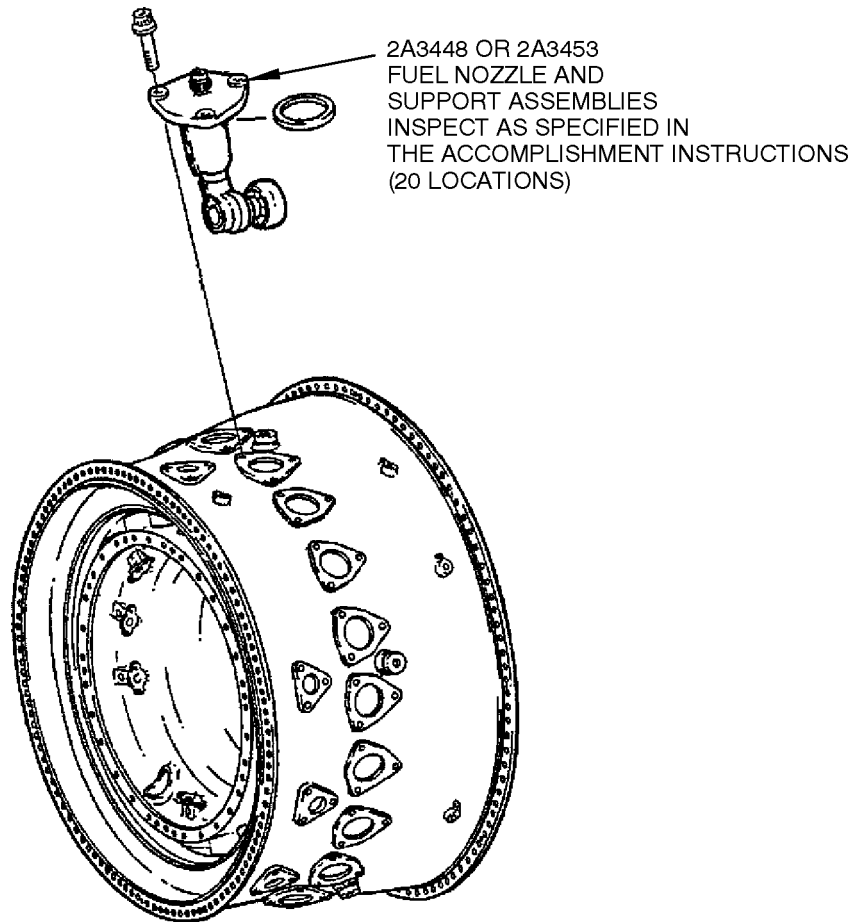
LOCATION OF THE FUEL NOZZLE AND SUPPORT ASSEMBLY 73-13-41  
FIGURE 1

During manufacture of fuel nozzle and support assemblies, a number of inlet fittings were installed that were manufactured from a non-conforming material. The non-conforming fuel nozzle and support assemblies have a potential of external fuel leak either at the conical sealing surface or through the attaching braze point.

- (1) Do an inspection of the 20 Fuel Nozzle And Support Assemblies, PN 2A3448 or PN 2A3453 by the procedure that follows. See Figure 1 for the location of the part.
  - (a) Open the fan cowl doors as specified in Reference 2, Aircraft Maintenance Manual, Chapter/Section 71-13-00.
  - (b) Open the thrust reverser halves as specified in Reference 2, Aircraft Maintenance Manual, Chapter/Section 78-32-00.
  - (c) Deactivate the thrust reverser hydraulic control unit as specified in Reference 2, Aircraft Maintenance Manual, Chapter 78-30-00.
  - (d) Make a suitable magnet to do the inspection of the fuel nozzle fitting. Use rare earth magnet. See Figure 2.

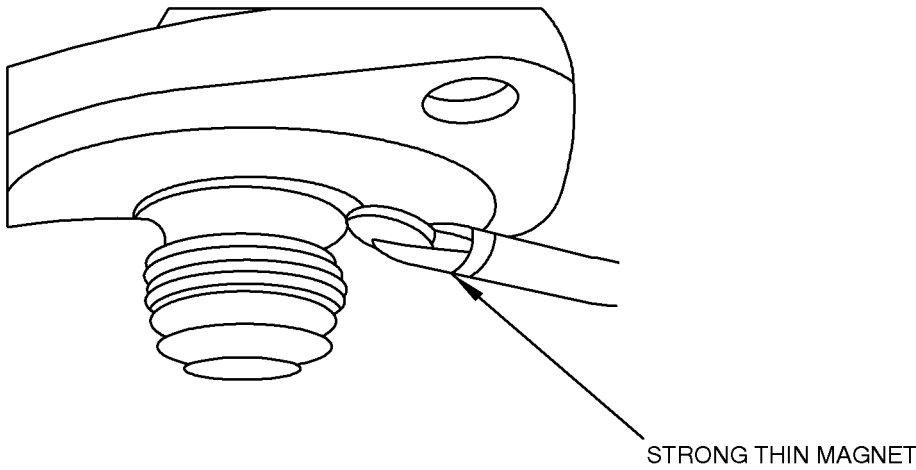
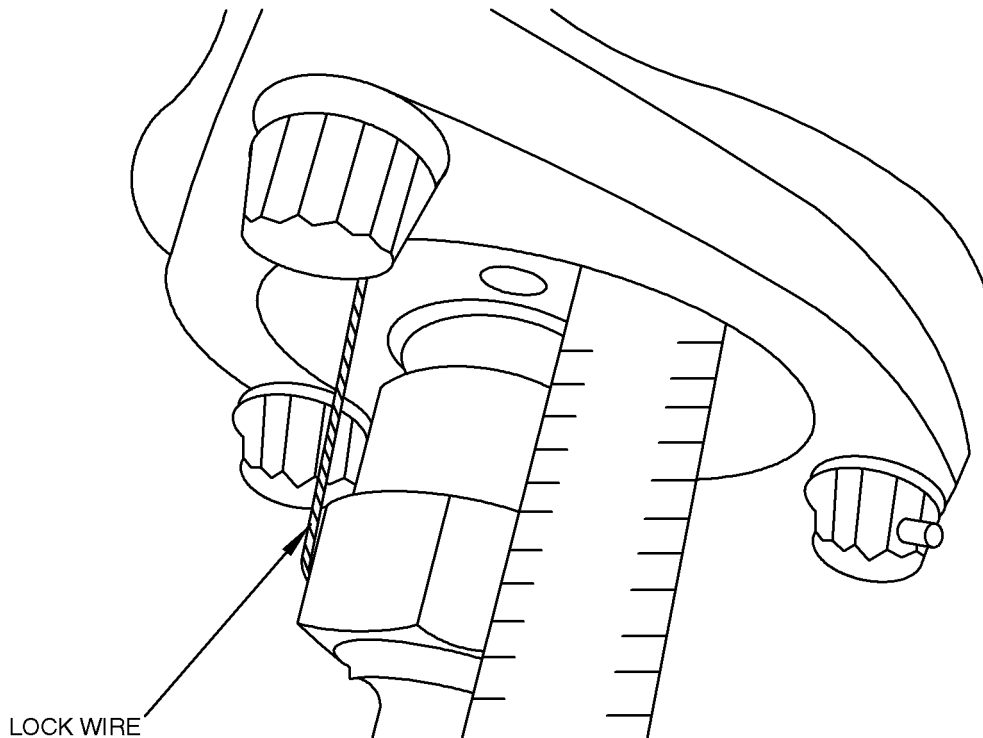
CORRECT PLACEMENT OF MAGNET FOR INSPECTION  
FIGURE 3

- (ii) If there is a strong magnetic bond, the part is not acceptable and is made of non-conforming material (suspect part).
- (f) Replace the suspect fuel nozzle and support assembly as soon as possible, but not later than 600 hours (next scheduled "A" check).

- (e) Place the magnet against the surface to check for magnetism on each fuel nozzle fitting. See Figure 3 for the correct placement of the magnet.
  - (i) If there is no magnetic bond, the part is acceptable.
