V2500-A5/D5 SERIES PROPULSION SYSTEMS SERVICE BULLETIN

V2500-ENG-73-0215

ENGINE – FUEL METERING UNIT (FMU) – TURBINE OVER SPEED VALVE – INTRODUCTION OF A
MODIFIED ELECTRO-HYDRAULIC SERVO VALVE COMPARTMENT HEAT SHIELD

ENGINE FUEL AND CONTROL - FUEL METERING UNIT (FMU) - Incorporation of Electrical Cover

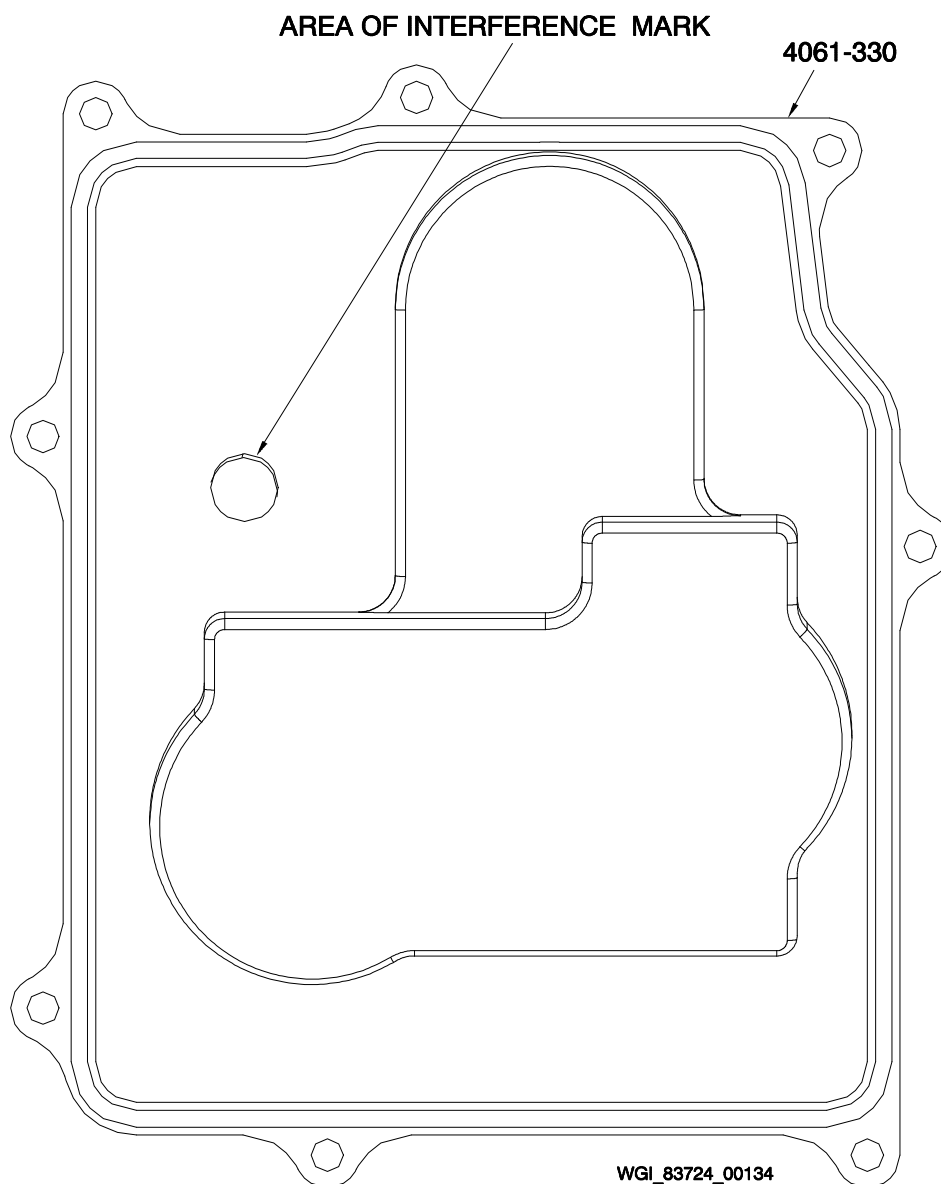
Cover Interference Marks
(Sheet 1 of 1)

Cause: Interference between the overspeed valve switch activation rod and the electrical cover (4061-330) results in cracking and separation of the switch rod head from the body. The separation of the head on the switch rod prevents switch activation which results in an EEC fault. Except for the switch indication, no other overspeed functions are affected.

- (1) Remove electrical cover P/N 4061-330, as specified in CMM 73-28-06, to gain access to the overspeed valve switch activation rod P/N 3100-1025.
 - (2) Check cover for marks associated with rod and cover interference similar to figure below (see Figure below).
- If interference exists, continue to step 3.
 - If interference does not exist, continue to step 8.

Improvement: A new electrical cover (3550-1563) has been released and includes a new raised feature above the switch activation rod to alleviate all interference potential.

- (3) Remove the overspeed valve switch activation rod P/N 3100-1025 and discard.
- (4) Disassemble the FMU to gain access to the overspeed valve dry drain seals P/N 1391-332 (quantity 2) and P/N 182658 (quantity 2).

- (5) Remove and discard the overspeed valve dry drain seals P/N 1391-332 (quantity 2) and P/N 182658 (quantity 2).
- (6) Install replacement overspeed valve dry drain seals P/N 1391-332 (quantity 2) and P/N 182658 (quantity 2).
- (7) Install replacement overspeed valve switch activation rod P/N 3100-1025.
- (8) Install replacement cover packing P/N 1355-794 and new electrical cover P/N 3550-1563.
- (9) Discard old cover P/N 4061-330 and cover packing P/N 1355-796.
- (10) Finish assemble the FMU.
- (11) Test the FMU as specified in TESTING AND FAULT ISOLATION.
- (12) Mark the Service Bulletin dataplate 73-0215.
