V2500-A1/A5 SERIES PROPULSION SYSTEM NON-MODIFICATION SERVICE BULLETIN

V2500-ENG-73-0218

NON-MODIFICATION SERVICE BULLETIN – ENGINE FUEL AND CONTROL – INSPECTION OF FUEL
MANIFOLD FOR CHAFING BY THE EXHAUST GAS THERMOCOUPLE (EGT) HARNESS

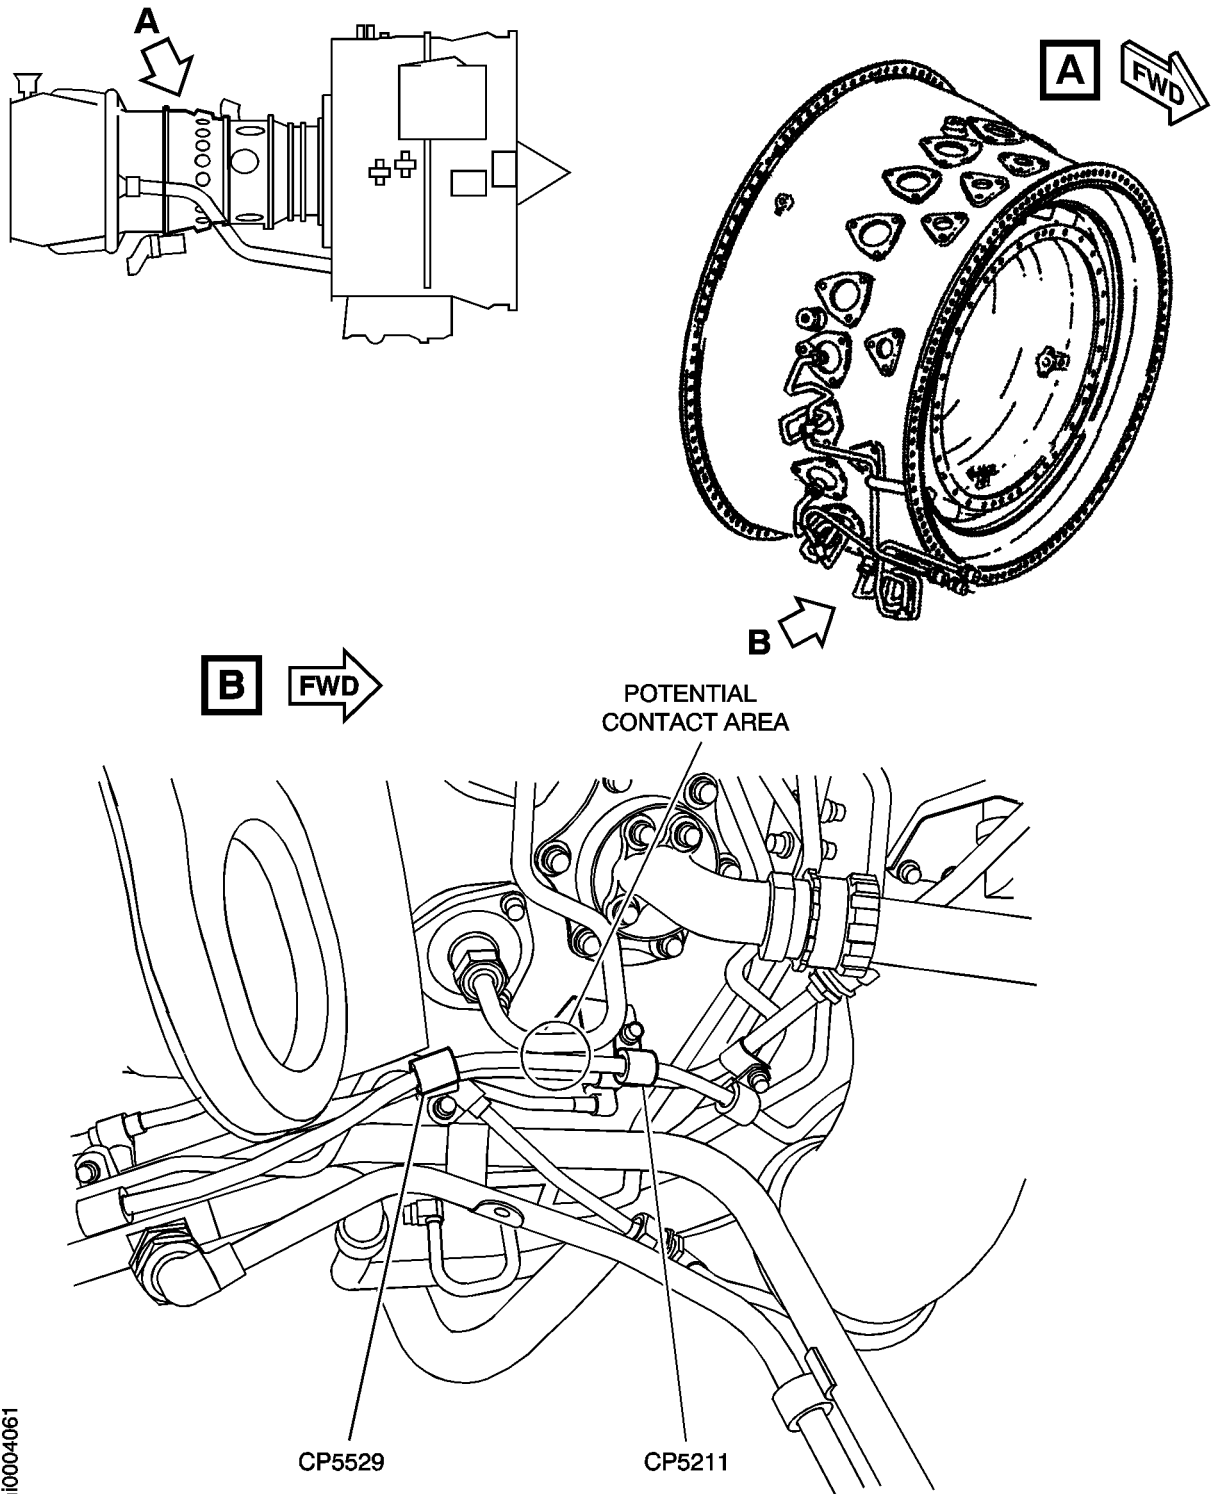
LOCATION OF THE FUEL MANIFOLD AND CLIP POSITIONS

The minimum clearance of 0.20 in. (5,0 mm) between the Exhaust Gas Thermocouple (EGT) harness and the fuel manifold may not be achieved because of excessive harness slack between two clamps on the EGT harness. The excessive slack may cause the EGT harness to chafe against the fuel manifold and cause a fuel leak.

- (i) A minimum clearance of 0.20 in. (5,00 mm) between the fuel manifold and EGT harness between clip positions CP5211 and CP5529 – Accept.

- (i) Not more than 0.0625 in. (1,588 mm) long, 0.010 in. (0,254 mm) wide, 0.003 in. (0,076 mm) deep, with chafed areas not less than 12.0 in. (304,80 mm) apart with no sharp edges – Accept.

Orientation of potentially chafed section of fuel manifold can lie either perpendicular or parallel to adjacent EGT harness.

- (ii) Less than (i) – adjust the harness and clips to make the minimum clearance 0.20 in. (5,0 mm).

- (ii) More than (i) – Replace in accordance with AMM Chapter 73-11-41.
