V2500-A5/D5 SERIES PROPULSION SYSTEM SERVICE BULLETIN

This document transmits the Revision 2 of Service Bulletin V2500-ENG-73-0220.

V2500-ENG-73-0220

ENGINE – FUEL AND CONTROL – PRESSURE BURNER SENSOR PORT SCREEN DELETION**1. Planning Information****A. Effectivity****(1) Airbus A319****Engine Models Applicable**

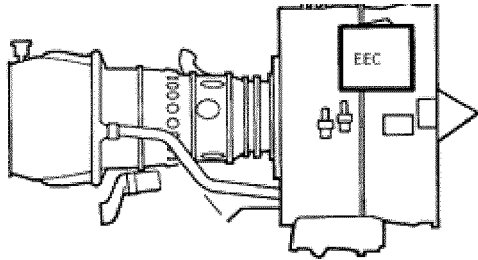
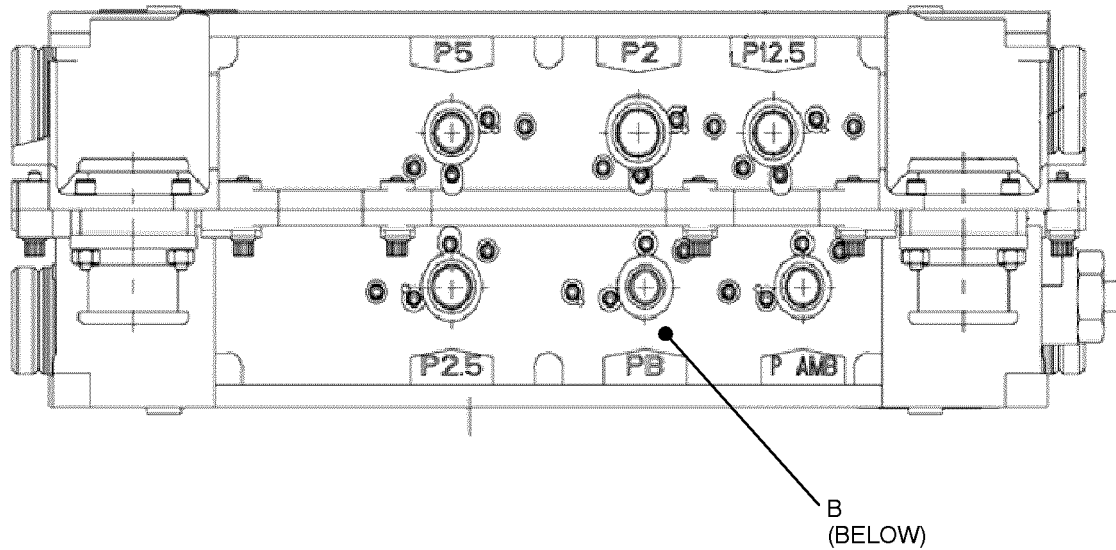
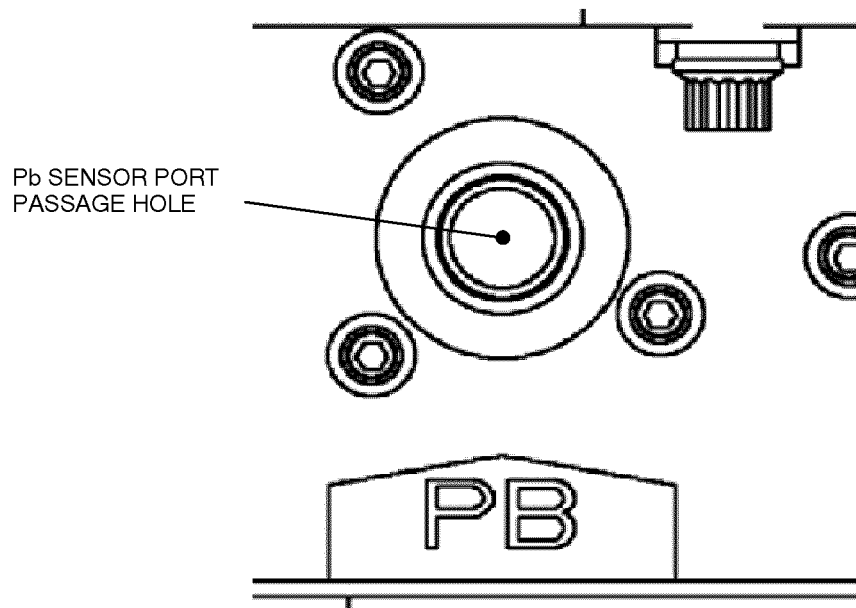
LOCATION AND REMOVAL OF THE PRESSURE BURNER SENSOR PORT
SCREEN BY AN OPERATOR
FIGURE 3, SHEET 1

- (1) Problem: The filter screen in the Pb port has a tendency to become contaminated with aluminum hydroxide which is present in the burner as a result of oxidation of aluminum from the compressor lining. Once contaminated, the screen attracts and holds moisture which can potentially lead to freezing at cruise. The frozen Pb signal is detected by the Electronic Engine Control (EEC) Pb Synthesis, which allows safe operation for the remainder of the flight. However, a non-dispatchable "Sensor Fault" is annunciated to the cockpit.

- (2) Background: The 40 micron screen traps aluminum hydroxide contamination which leads to the in-flight Pb freezing events. Although the Pb sensor is directly heated, the screen is located in the Pb port and does not receive any heat generated by the sensor heater. The 40 micron mesh presents a relatively colder surface which encourages condensation on a surface that effectively traps and collects aluminum hydroxide. The contaminated filter screen collects water in the Pb line and potentially freezes due to the cold temperatures observed during cruise.

- (12) Visually examine the Pb sensor port to obtain a "baseline" for the condition of the EEC Pb sensor port outer sealing face surface and threaded internal surfaces.

Make sure that no visible damage was sustained during the screen removal operation by comparing the condition of the Pb sensor port face to the baseline condition identified previously in these Accomplishment Instructions. There must be no damage to the Pb sensor port face that has exposed any EEC housing "base metal". Exposed "base metal" will be visible as a "shiny" surface when compared to the "dull" surrounding anodized finish surface.

(18) Look inside the Pb sensor port. Ensure Pb sensor port internal threads are not damaged. Ensure there is no FOD in the Pb sensor port that was generated during the screen removal operation by comparing the condition inside the Pb sensor port to the baseline condition identified previously in these Accomplishment Instructions. Additionally, ensure there are no remaining pieces of screen in the Pb sensor port. A vacuum may be used to remove any remaining pieces of screen or debris.

Do not return the EEC to service if visible damage to the Pb sensor port face has been sustained or if there is material in the Pb sensor port that cannot be removed.
