V2500-A5 PROPULSION SYSTEMS SERVICE BULLETIN

V2500-ENG-73-0225

ENGINE – FUEL AND CONTROL – PLUG, DATA ENTRY – MODIFICATION TO PERMIT A MORE OPEN
VARIABLE STATOR VANE SCHEDULE

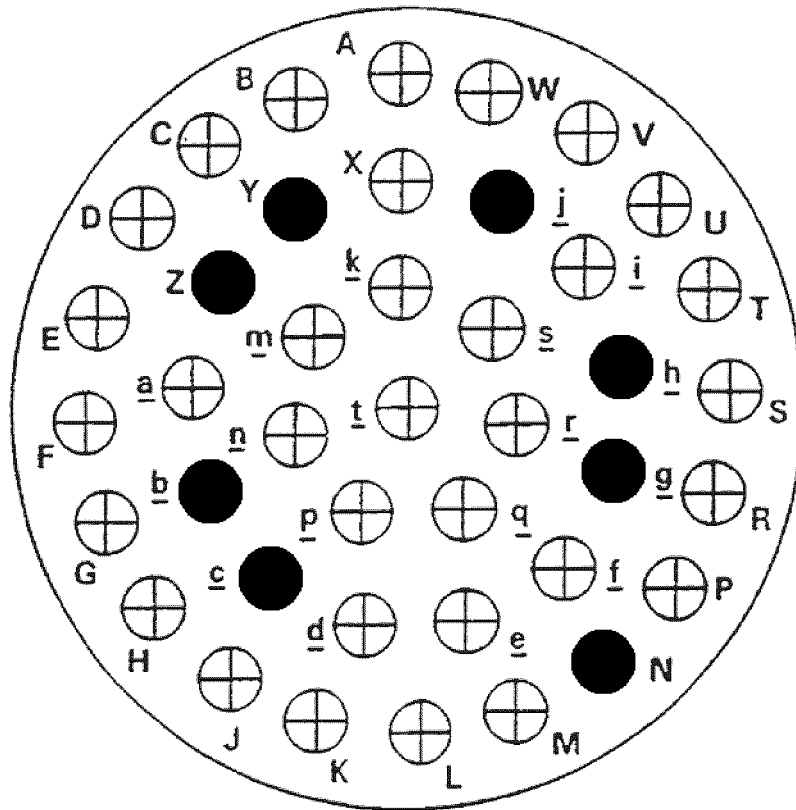
GROUND PIN LOCATIONS
Figure 1

CAUTION: WHILE RE-WIRING THE DATA ENTRY PLUG PER FIGURE B FOR NEW ENGINE VARIANT, DO NOT DISCONNECT THE GROUND PINS. SEE FIGURE 1 FOR GROUND PINS IN THE DATA ENTRY PLUG.

NOTE: The black dotted letters - Y, Z, b, c, j, h, g & N are ground pins

NOTE: While re-wiring the DEP for a new engine variant, make sure that the jumper pins are connected to its corresponding ground pins.

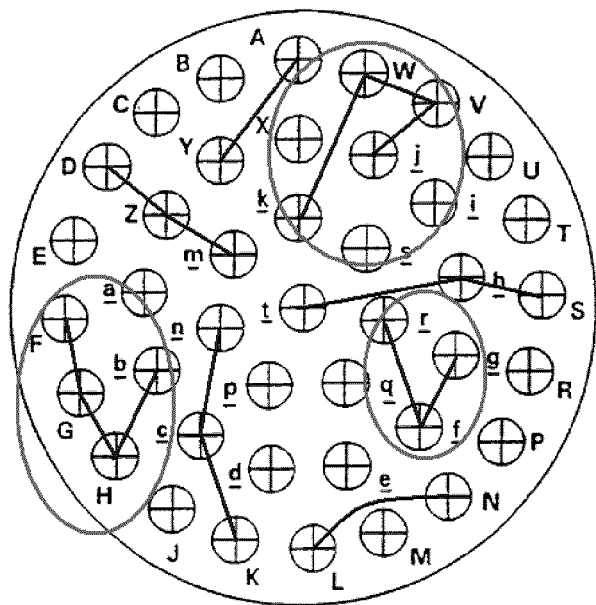
Incorrect Marking

NOTE: The above illustration (left side) shows the incorrect marking between ground pins b, g, and J, and non-ground pins. The right side shows correct marking.

- (iv) EPR modifier and Bias
 - (b) Mark the existing Data Entry Plug connections on the diagram in Figure A. After marking the existing Data Entry Plug wiring in Figure A, make sure all the connections originate from the ground pin to the non-ground pin. If not, re-arrange the marking to meet this requirement. See Figure 1 for an illustration of which pins are the ground pins. See Figure 2 for an example of correcting the marking of the Data Entry Plug diagram. The illustration shown in Figure 2 is only an example that utilizes 27K rating but the concept of correct marking applies to all engine ratings.
