V2500-A5 PROPULSION SYSTEMS SERVICE BULLETIN

V2500-ENG-73-0226
Transmittal - Page 1 of 1

ENGINE – FUEL AND CONTROL – CONTROL, ELECTRONIC ENGINE – REPLACEMENT OF THE CHANNEL A
INTERCONNECT CIRCUIT CARD ASSEMBLY

ENGINE FUEL AND CONTROL - EEC150-40 ELECTRONIC ENGINE CONTROL - CHANNEL TO CHANNEL CONNECTOR

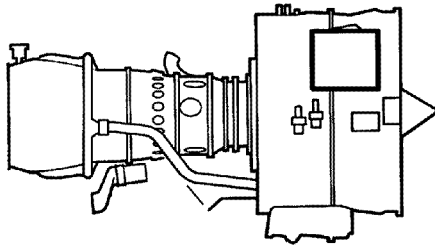
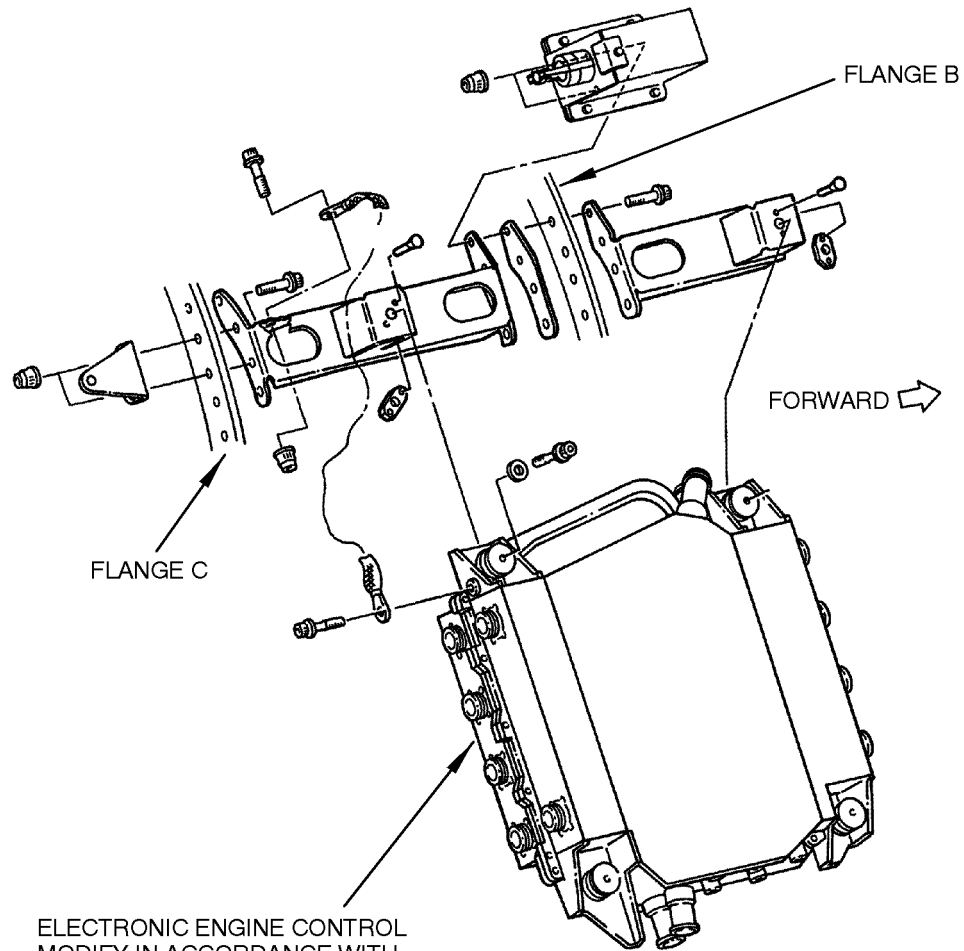
LOCATION OF THE ELECTRONIC ENGINE CONTROL
73-22-34
FIGURE 1

ELECTRONIC ENGINE CONTROL
MODIFY IN ACCORDANCE WITH
REFERENCE 1, HAMILTON SUNDSTRAND
SERVICE BULLETIN NO. EEC150-40-73-24

- (1) Modify your Electronic Engine Control (EEC) in accordance with Reference 1, Hamilton Sundstrand Service Bulletin No. EEC150-40-73-24. See Figure 1 for the location of the EEC.
- (2) Recording Instructions
 - (a) A record of accomplishment is required.
