V2500-A5 PROPULSION SYSTEMS NON-MODIFICATION SERVICE BULLETIN

V2500-ENG-73-0228

NON-MODIFICATION SERVICE BULLETIN – ENGINE – VARIABLE STATOR VANE (VSV) ACTUATOR –
LOW PRESSURE (LP) RETURN LINE RE-ROUTE PIPEWORK – FUEL TUBE REPLACEMENT AND HARNESS
INSPECTION

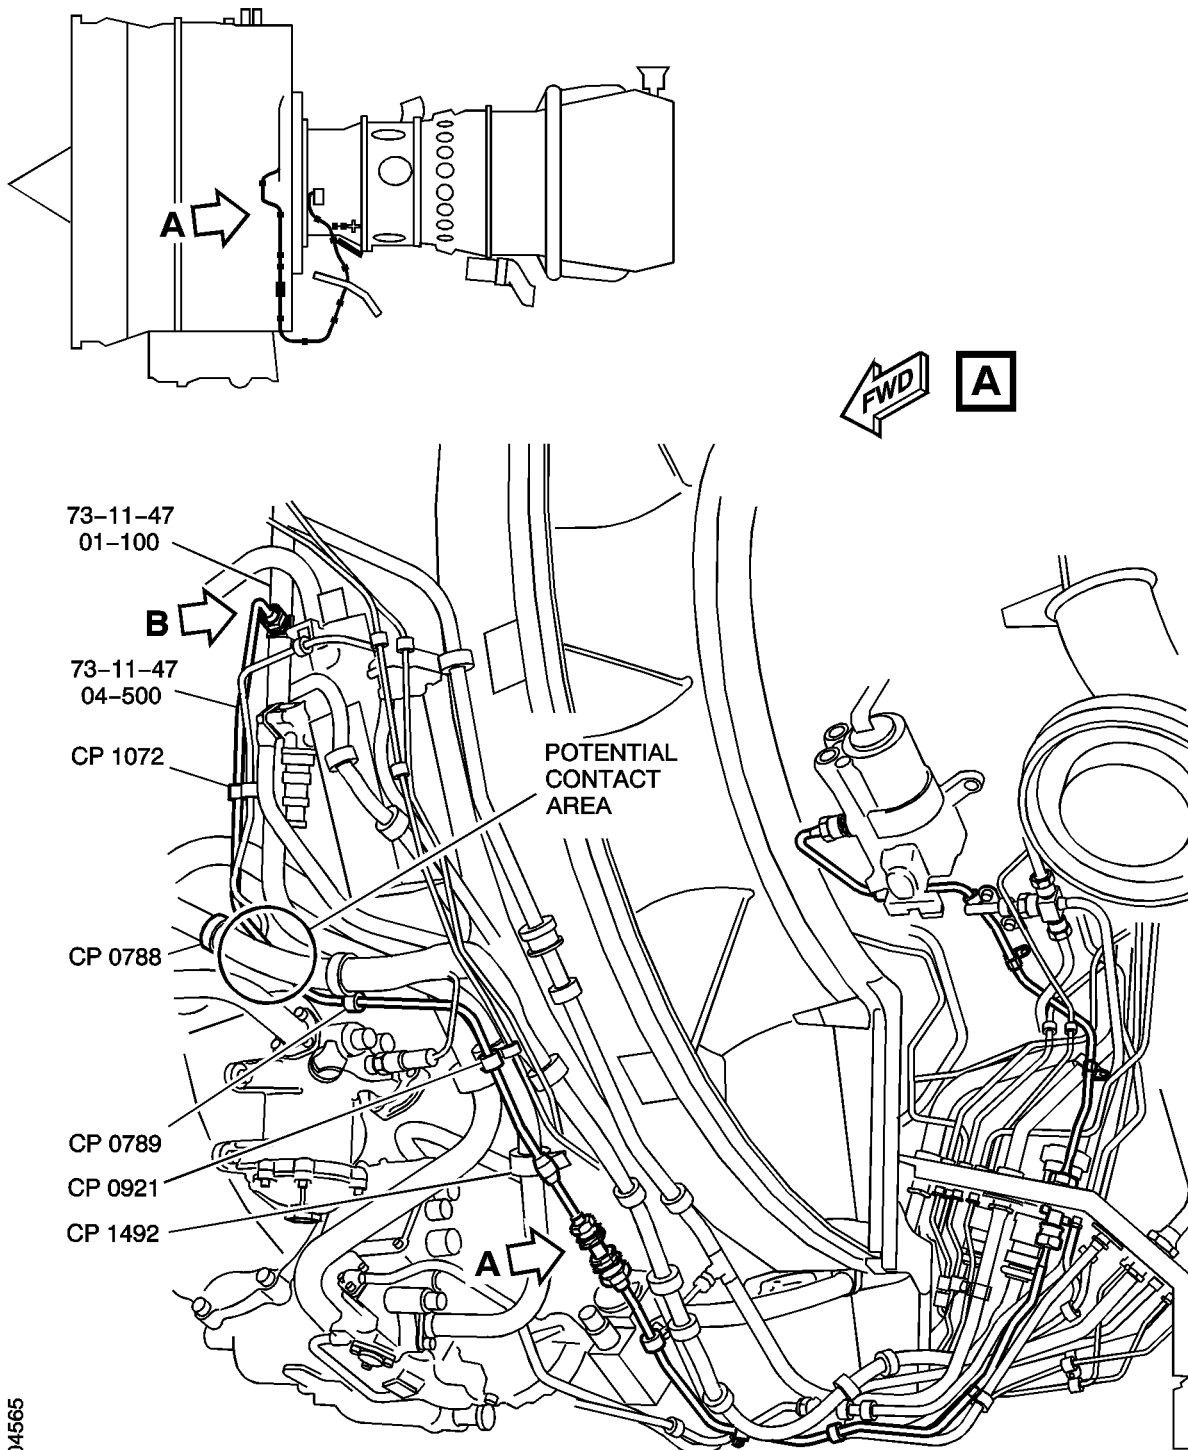
Figure 1 (Sheet 1 of 5)

- R (1) The Low Pressure Re-Route (LPRR) modification (Service Bulletin – V2500-ENG-73-0219) provides enhanced VSVA force margin to overcome track check messages experienced by some operators. A Controlled Service Use (CSU), during which the LPRR system benefit was proven to address the track check issue, was successfully completed and fully released into service in March 2011. A recent engine inspection revealed traces of fuel on an LPRR tube assembly (P/N 6B1353). Further inspections and investigations have confirmed a total of three such instances where a leakage has been identified through a small pinhole in the wall of the subject tube, which is positioned downstream of the Pressure Raising Valve (PRV).
- (2) Recent engine inspections have shown two instances of chafing to the harness cables next to the LPRR tube (P/N 6B1353).

(a) Remove the tube assembly (73-11-47, 04-500) from the engine (Refer to Figure 1)

- (4) Install a new tube assembly (73-11-47, 04-500) (Refer to Figure 1)
