V2500-A1/A5/D5 SERIES PROPULSION SYSTEM NON-MODIFICATION SERVICE BULLETIN

NON-MODIFICATION SERVICE BULLETIN – ENGINE FUEL AND CONTROL – INSPECTION OF THE
VARIABLE STATOR VANE ACTUATOR (VSVA) AND THE HIGH PRESSURE (HP) SERVO FUEL TUBE FOR
CHAFING

V2500-ENG-73-0229

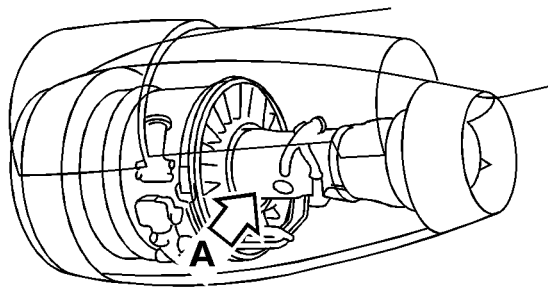
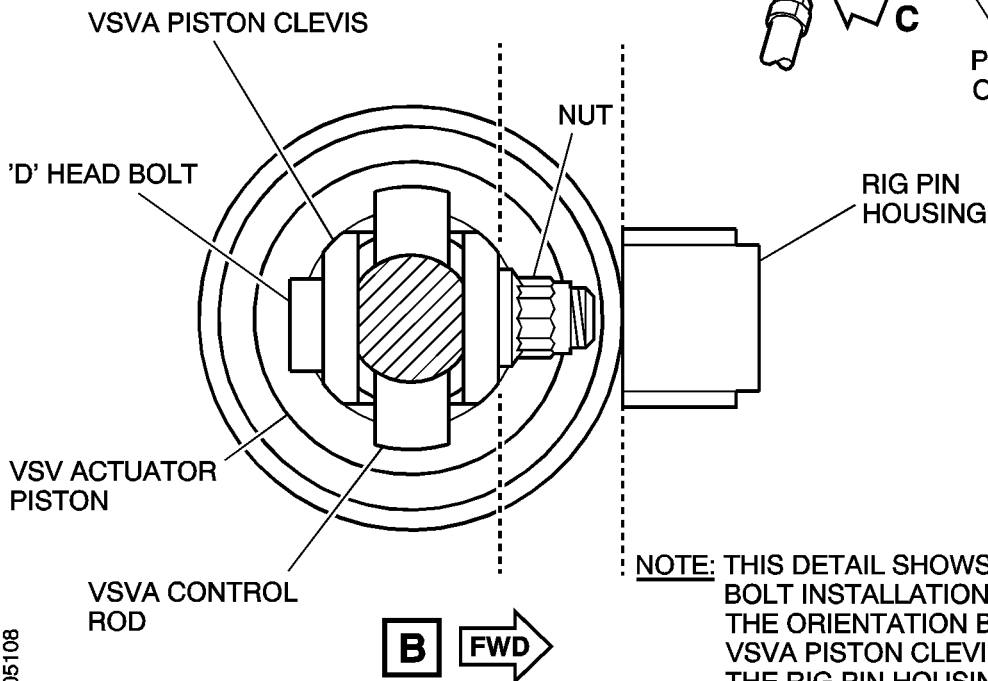
Variable Stator Vane Actuator (VSVA)
Figure 1 (Sheet 1 of 2)

Chafing on the High Pressure (HP) servo fuel tube and the Variable Stator Vane Actuator (VSVA) rig pin housing can occur. This is due to a loosened lock nut on the VSVA control rod assembly causing a misaligned VSVA piston clevis.

Four Operators have reported chafing on the HP servo fuel tube. Further investigation has shown that it is possible that the VSVA control rod bolt can touch the HP servo fuel tube. This can be caused by a misaligned VSVA piston clevis. Chafing of the VSVA control rod bolt against the HP servo fuel tube can cause a fuel leak.

POTENTIAL AREA
OF CHAFING

NOTE: THIS DETAIL SHOWS THE CORRECT
BOLT INSTALLATION AND INDICATES
THE ORIENTATION BETWEEN THE
VSVA PISTON CLEVIS AND THE
THE RIG PIN HOUSING.

- (ii) Make sure that the VSVA piston clevis is aligned correctly (Refer to Figure 1, detail B).
 - (iii) If the VSVA piston clevis is found aligned correctly, do the steps that follow:

(ii) Make sure that the VSVA piston clevis is aligned correctly (Refer to Figure 1, detail B).

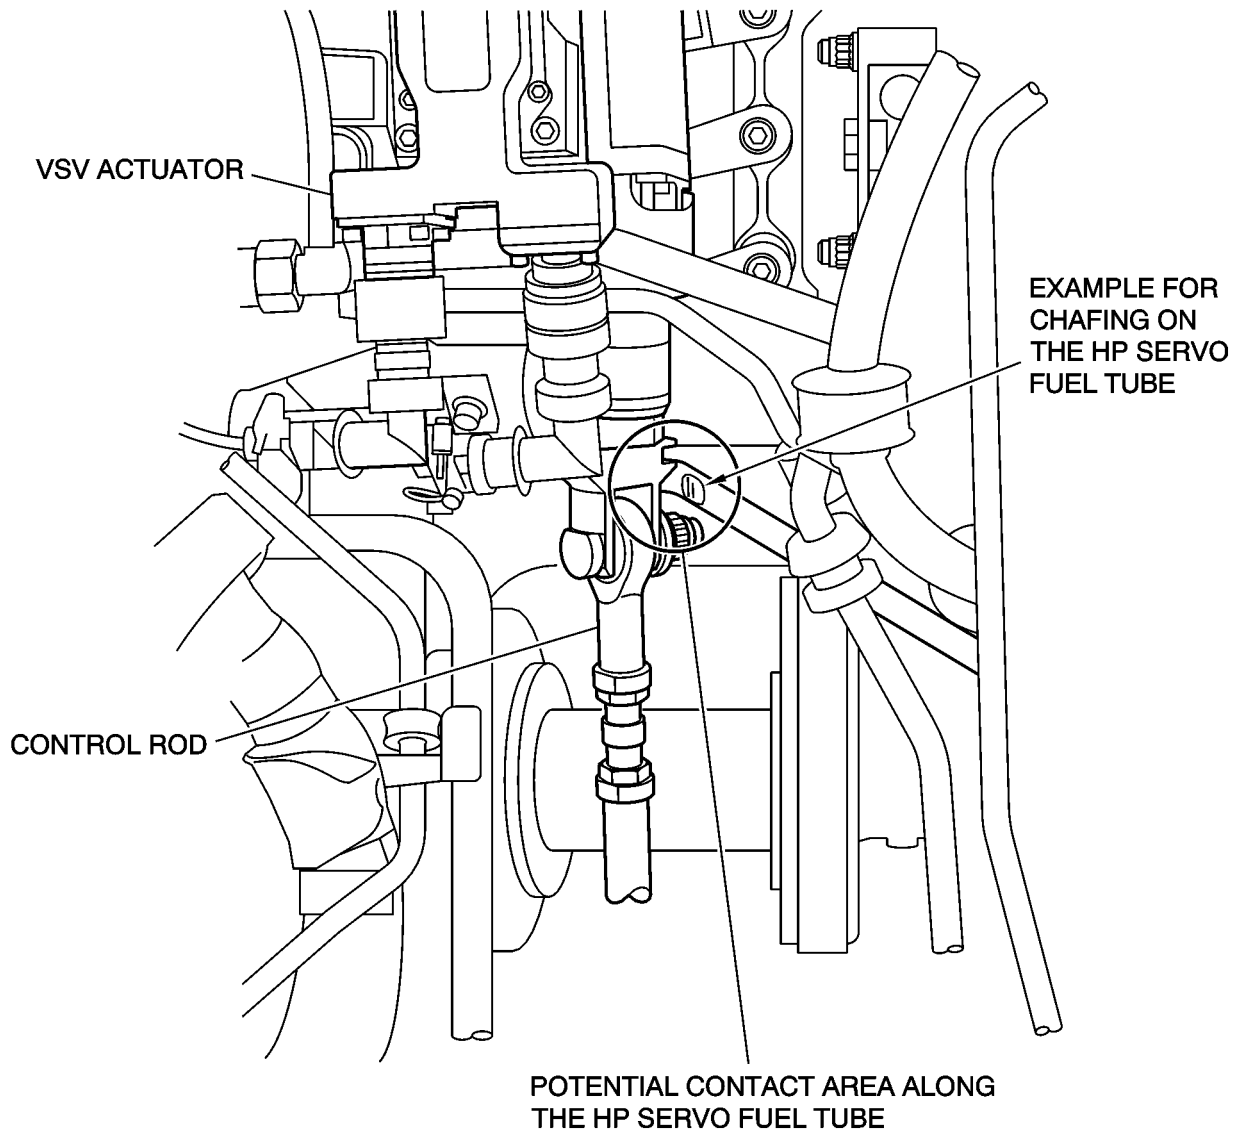
Variable Stator Vane Actuator (VSVA)
Figure 2

NOTE: THE VSVA CLEVIS AND CONTROL ROD END ARE SHOWN INCORRECTLY POSITIONED.

- (i) Inspect the HP servo fuel tube (73-11-49, 12-500) for chafing (Refer to Figure 2).

(2) If the HP servo fuel tube (73-11-49, 12-500) is found chafed, replace the HP servo fuel tube (73-11-49, 12-500).
