ENGINE - IGNITION - INTRODUCE IGNITER PLUG INSERTS WITH AN INCREASED WALL THICKNESS AND  
IMPROVED THREAD REQUIREMENTS - CATEGORY CODE 4 - MOD.ENG-74-0004

V2500-ENG-74-0004

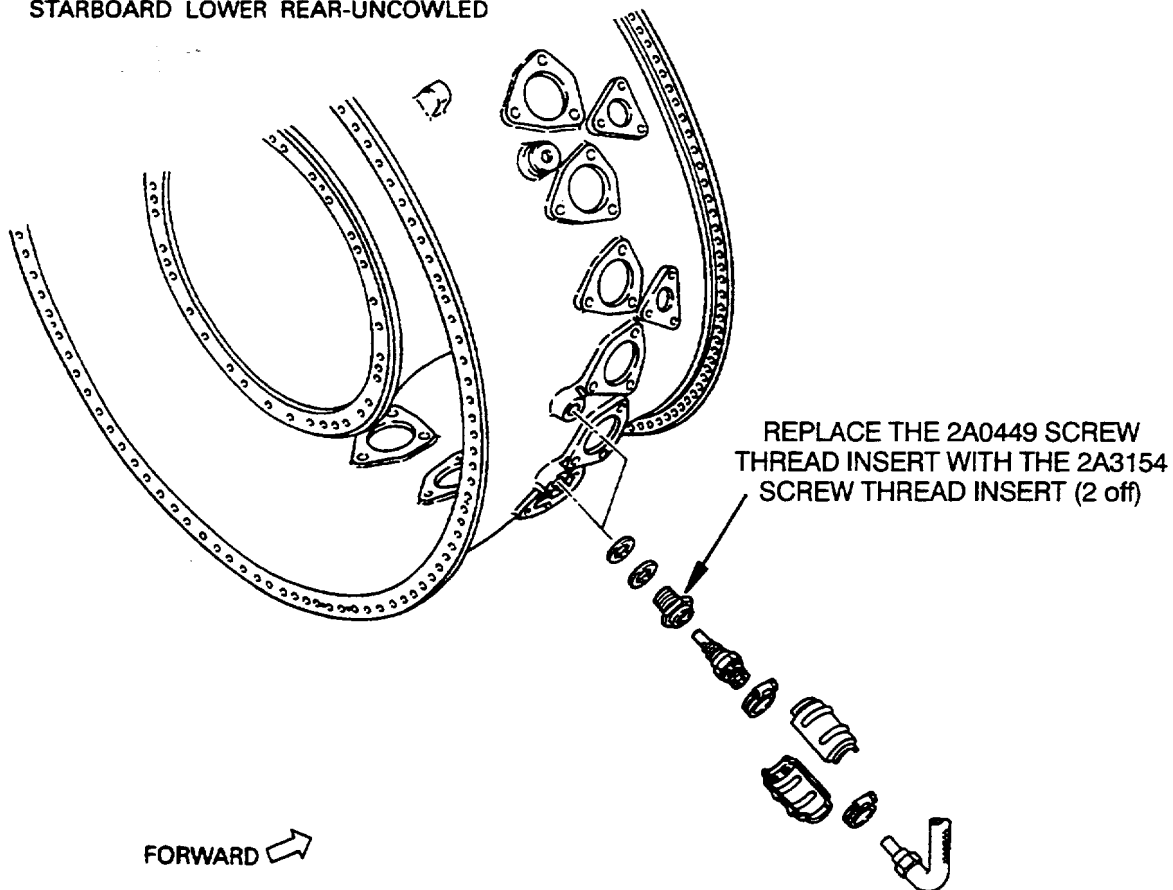
Modification of the Screw Thread Insert (V2500-A1 and V2528-D5)  
Fig.2

A thin wall condition is possible in some igniter plug inserts. This reduced thickness results in reduced part strength and can lead to complete fracture, particularly during igniter removal.

Replace the inserts with the potential thin wall condition with a new insert that has increased wall thickness, eliminating the potential for fracture.
