V2500-A5 SERIES PROPULSION SYSTEM NON-MODIFICATION SERVICE BULLETIN

This document transmits the Initial Issue of Non-Modification Service Bulletin V2500-ENG-74-0006.

NON-MODIFICATION SERVICE BULLETIN – IGNITION – INSTALLATION REQUIREMENTS FOR IGNITER
PLUGS OF SERVICE BULLETIN V2500-ENG-70-1003 STANDARD

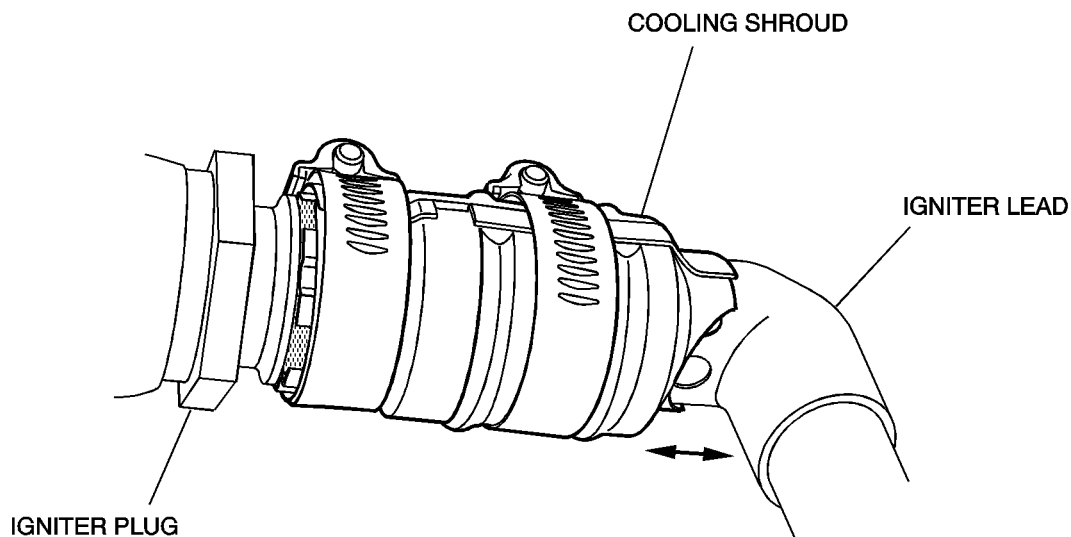
Service Bulletin V2500-ENG-70-1003 introduced a new ignition plug, P/N CH31964, and Service Bulletin V2500-ENG-70-1004 introduced a new ignition lead, P/N 512090-1. It has been found that if the new ignition lead, P/N 512090-1, is installed together with the new Champion ignition plug, P/N CH31964, and cooling shrouds, P/N 5U0065, a potential for misalignment of the cooling shrouds is given. Misalignment of the cooling shrouds will lead to incorrect installation causing a partial blocking of the cooling holes on the ignition lead. The unblocked cooling holes will vent cooling air into the core zone. This will reduce the cooling of the igniter plug.

To accommodate larger cooling air outlet holes and changes to the ferrule assembly, the new ignition lead has an increased height 90 degree elbow and fitting. With the increased height the current cooling shroud, P/N 5U0065, can be installed incorrectly when the engine is equipped with the new Champion igniter plug, P/N CH31964, together with the new ignition lead, P/N 512090-1.

INCORRECTLY INSTALLED COOLING SHROUD

CAUTION: INSTALL THE COOLING SHROUD AS CLOSE AS POSSIBLE TO THE INNER RADIUS OF THE IGNITION LEAD ELBOW. MAKE SURE THAT THE COOLING AIR EXIT HOLES ARE NOT BLOCKED AND FULLY COVERED BY THE HOLLOW PART OF THE COOLING SHROUD.

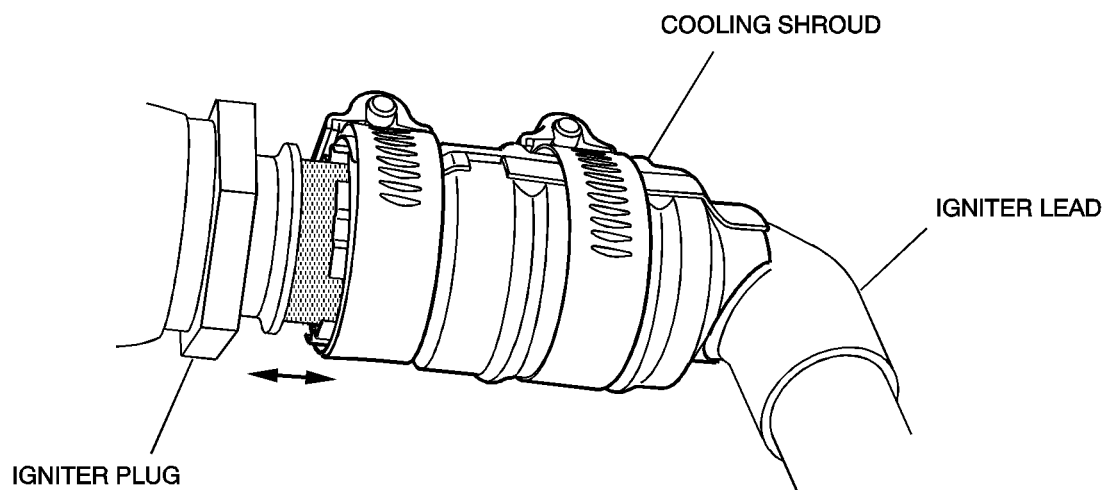
NOTE: Figure 1 shows the installation of the NGK igniter plug, the current shroud standard together with the new ignition lead of Service Bulletin V2500-ENG-70-1004.

CORRECTLY INSTALLED COOLING SHROUD

(a) If an igniter plug has to be replaced ensure the correct installation of the cooling shrouds (Refer to Figure 1 and the CAUTION below)
