## V2500-A1 SERIES PROPULSION SYSTEM SERVICE BULLETIN

V2500-ENG-75-0001

## AIR - INTRODUCE A REVISED LPT ACC SUPPORT ASSEMBLY CONFIGURATION

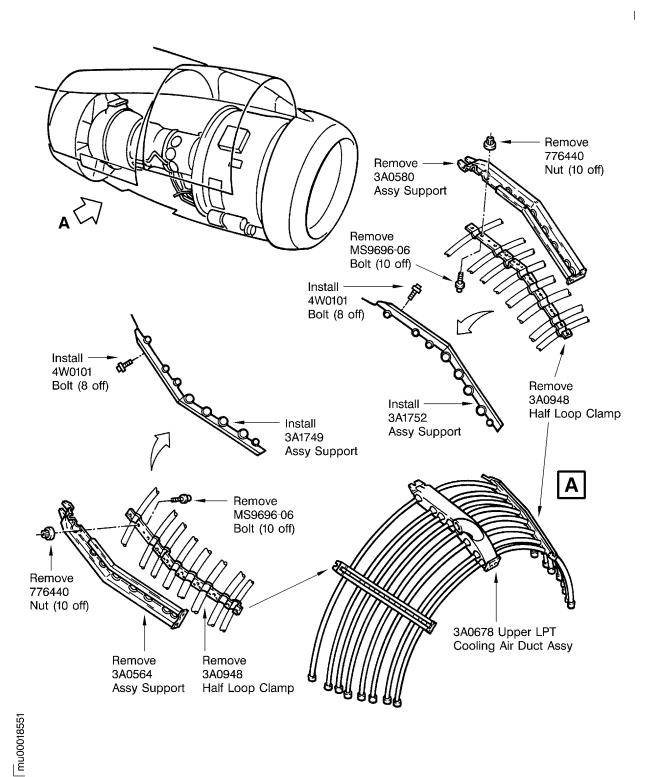
Removal and Installation of Support Assemblies Fig.2

The supports A/O and half loop clamps are preassembled with rivets at the front and rear ends.

Clip nuts are attached to the half loop clamps.

The supports have clip nuts at the front LP Turbine case attaching location.
