AIR - PROVIDE REVISED MATERIAL TUBE CLIP AT CLIPPING POINT LOCATION CP5776 - CATEGORY
CODE 4 - MOD.ENG-75-0004

V2500-ENG-75-0004

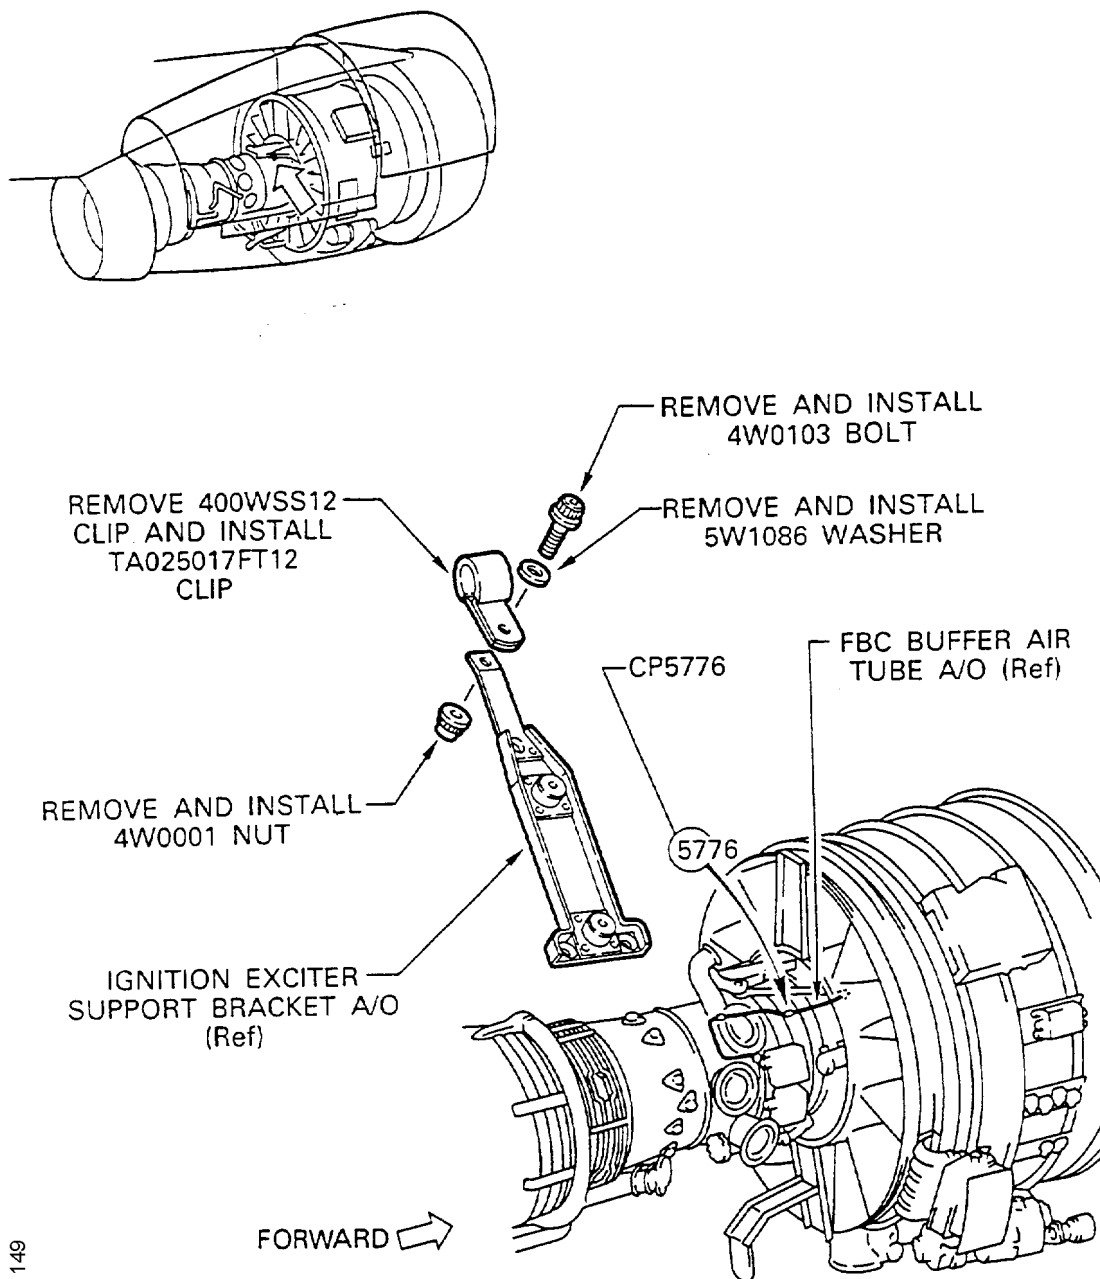
The existing rubber cushion clip attached to the Bearing Compartment Cooling and Sealing Tube at CP5776, could be affected by the high temperatures in the Core Engine Zone.

This could result in ineffective clipping for the Tube.

(a) The clip at CP5776 has been changed from the Adel clip to the TA-clip to increase the durability. (see Figure 1.)

Replacement of the clip at clipping point CP5776
Fig.1

- (1) Find clipping point CP5776 which safeties the FBC Buffer Air Tube A/O. (Refer to Figure 1.)
- (2) At CP5776, remove PN 4W0001, Nut, PN 4W0103, Bolt, PN 5W1086, Washer and PN 400WSS12, Clip from the FBC Buffer Air Tube A/O and the Ignition Exciter Support Bracket A/O. (Refer to Figure 1.)
- (3) At CP5776, Install new PN TA025017FT12, Clip, PN 5W1086, Washer, PN 4W0103, Bolt and PN 4W0001, Nut to the FBC Buffer Air Tube A/O and the Ignition Exciter Support Bracket A/O. (Refer to Figure 1.)
- (4) At CP5776, Torque the Nut to 36 – 40 lbfin (4,07 – 4,52 Nm). (Refer to The Aircraft Maintenance Manual, 70-23-11, Torque Tightening Technique.)
