AIR - INCORPORATION OF ACC VALVE BRACKETS AND STATOR ROD FEATURING CHROME PLATED
BEARING DETAILS - CATEGORY CODE 4 - MOD.ENG-75-0006

(1) AIRCRAFT: Airbus A320

(2) ENGINE: V2500-A1 Engines, Serial No.V0014 through V0085

V2500-ENG-75-0006

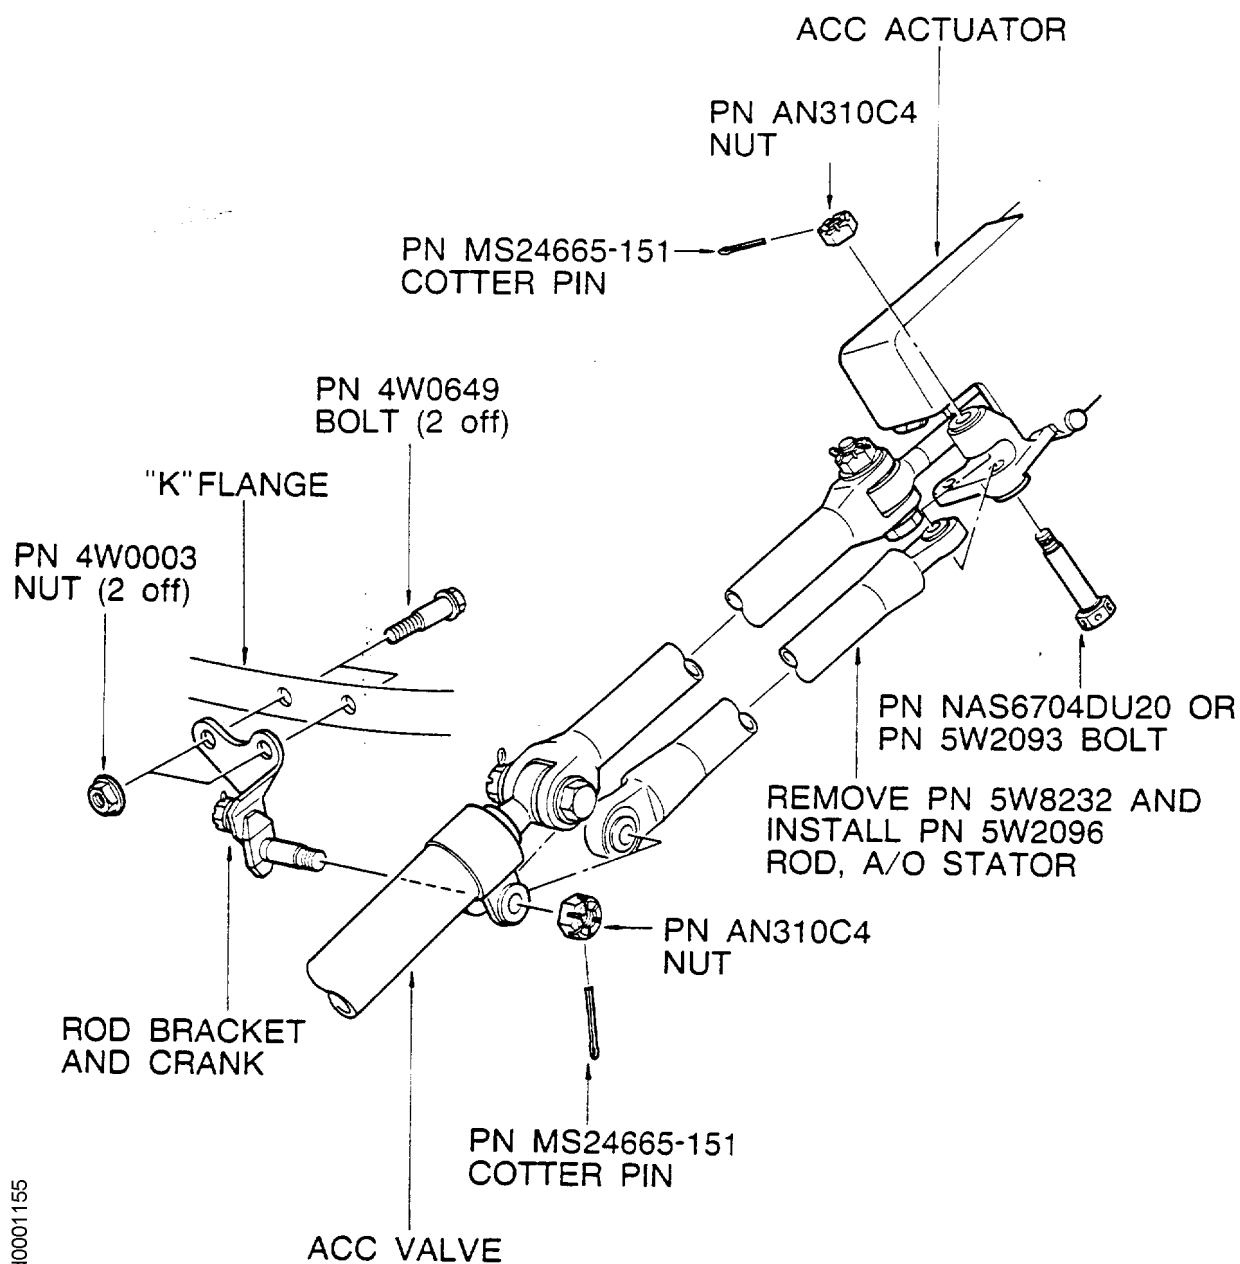
Replacement of the stator rod
Fig.1

Corrosion may occur on spherical bearing balls used in ACC valve brackets and stator rod.

- (1) Remove PN MS24665-151 Cotter pin from the bolt retaining PN 5W8232 stator rod to the ACC actuator and discard it.
- (2) Remove PN AN310C4 nut and PN NAS6704DU20 or PN 5W2093 bolt.
- (3) Remove PN MS24665-151 cotter pin from the crank retaining another end of the stator rod to the rod bracket and discard it.
- (4) Remove PN AN310C4 nut.
- (5) Remove two PN 4W0003 nuts and PN 4W0649 bolts which retain the rod bracket to the K flange.
- (6) Remove the rod bracket with crank from the ACC valve to remove PN 5W8232 stator rod.
- (7) Be in position PN 5W2096 stator rod and align holes of the rod end bearings, the ACC valve and ACC actuator.
- (8) Install PN NA6704DU20 or PN 5W2093 bolt and PN AN310C4 nut to the ACC actuator.
- (9) Install the rod bracket with crank to the K flange with two PN 4W0649 bolts and PN 4W0003 nuts.

- (10) Torque the PN 4W0003 nuts to 10 to 170 lbfin. (16,95 to 19,21 Nm).

- (11) Torque two PN AN310C4 nuts to 32.5 to 42.5 lbfin. (3,67 to 4,80 Nm) and align the slot of the nut and pin hole of the bolt or crank.
- (12) Safety the nuts with new PN MS24665-151 cotter pins.
- (13) Remove two PN 4W0003 nuts and PN 4W0471 bolt to release PN 5W1699 ACC valve bracket from the M flange.
