AIR - HPT/LPT ACC ACTUATOR ASSEMBLY - NEW LVDT COVER INTRODUCTION AND REWORK OF LVDT COVER AND ACTUATOR BODY BOSS - CATEGORY CODE 4 - MOD.ENG-75-0008

AIR - V2500 - HP/LP ACC ACTUATOR, PART NUMBER 5860017-109 & -111. MODIFICATION OF SPRING RETAINER SYSTEM, REWORK OF LVDT OVER, ACTUATOR BODY AND WASHER REPLACEMENT AND UPGRADE TO A -113 CONFIGURATION.

5860017-75-51

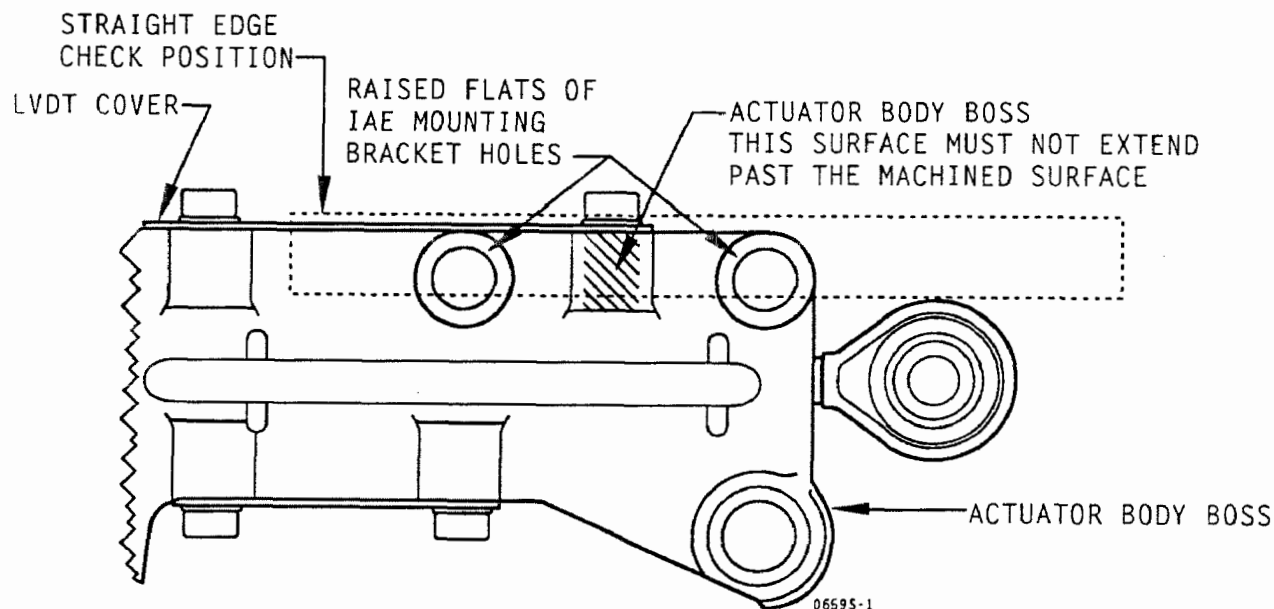
Straight Edge Check
Figure 1

<u>TASK</u>	<u>MAN HOURS</u>
Check the actuator body and LVDT cover for excess material as shown in Figure 1 in this service bulletin.	0.25
Remove the insulation blanket and LVDT cover from the actuator assembly.	0.25
Rework the actuator body and/or LVDT cover.	1.00
Reassemble the LVDT cover and insulation blanket on the actuator assembly.	0.50
Reidentify the actuator assembly.	<u>0.50</u>
TOTAL	2.50

(c) If no interference occurs between the straight edge and the actuator body boss or the LVDT cover, modify the actuator as follows:

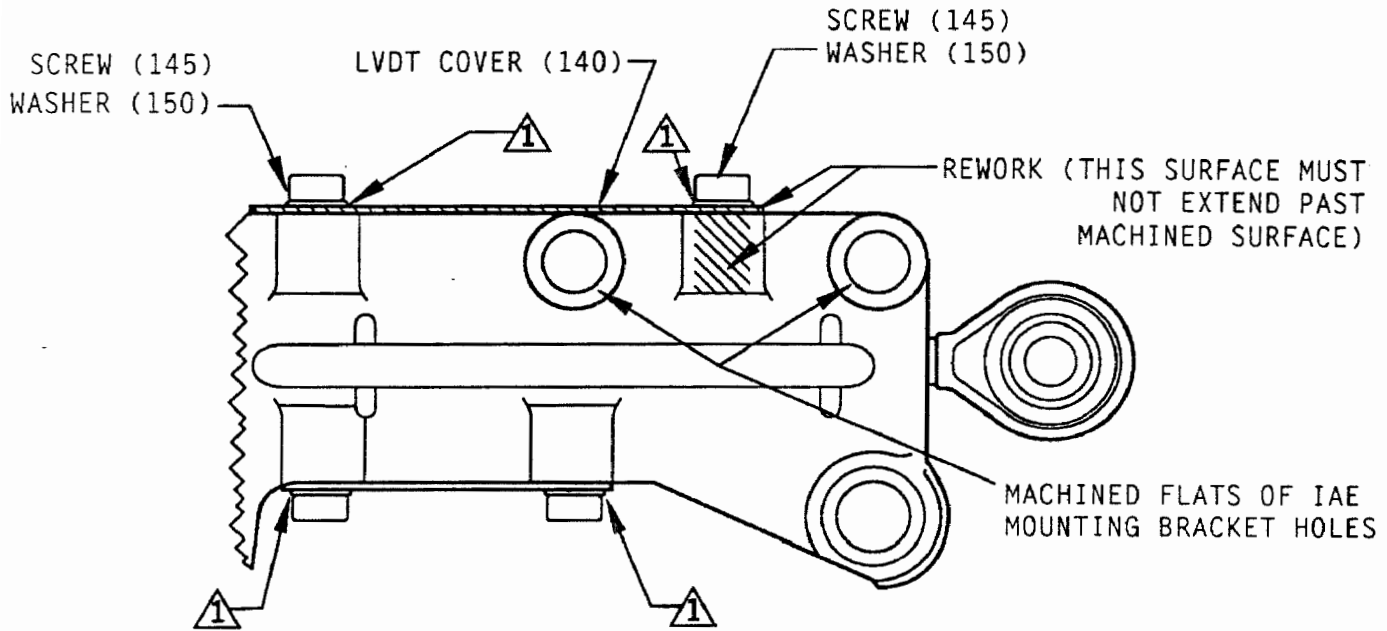
VIEW A

- ⚠ THE 5860017-111 ACTUATOR REQUIRES THE REPLACEMENT OF FOUR WASHERS (150) WITH FOUR NEW WASHERS P/N NAS620C6 (4 PLACES).

- 1) Refer to Figure 2, View A, in this service bulletin, and remove four screws (145) and four washers (150) from the noted locations on the LVDT cover.
- 2) Reinstall four screws (145) with four new washers, Part Number NAS620C6, in the noted locations on the LVDT cover.
- 3) Torque four screws (145) 10 to 11.5 lb.in. (1.13 to 1.30 N·m).
- 4) Proceed with Paragraph 2.D.(2)(c) and reidentify the actuator to indicate completion of this service bulletin.

- (1) Remove the insulation blanket (5) from the actuator assembly.
- (2) Remove five screws (145) and five washers (150) from the LVDT cover (140); then remove the LVDT cover.
- (3) Carefully rework to remove any excess material from the actuator body boss until interference with the straight edge layed flat across the actuator body machined raised flats is no longer present. (See View A.)
