AIR - HPT/LPT ACC SYSTEM - IMPROVED CONNECTION OF THE ACC ACTUATOR AND THE STATOR ROD
- CATEGORY CODE 4 - MOD.ENG-75-0009

V2500-ENG-75-0009

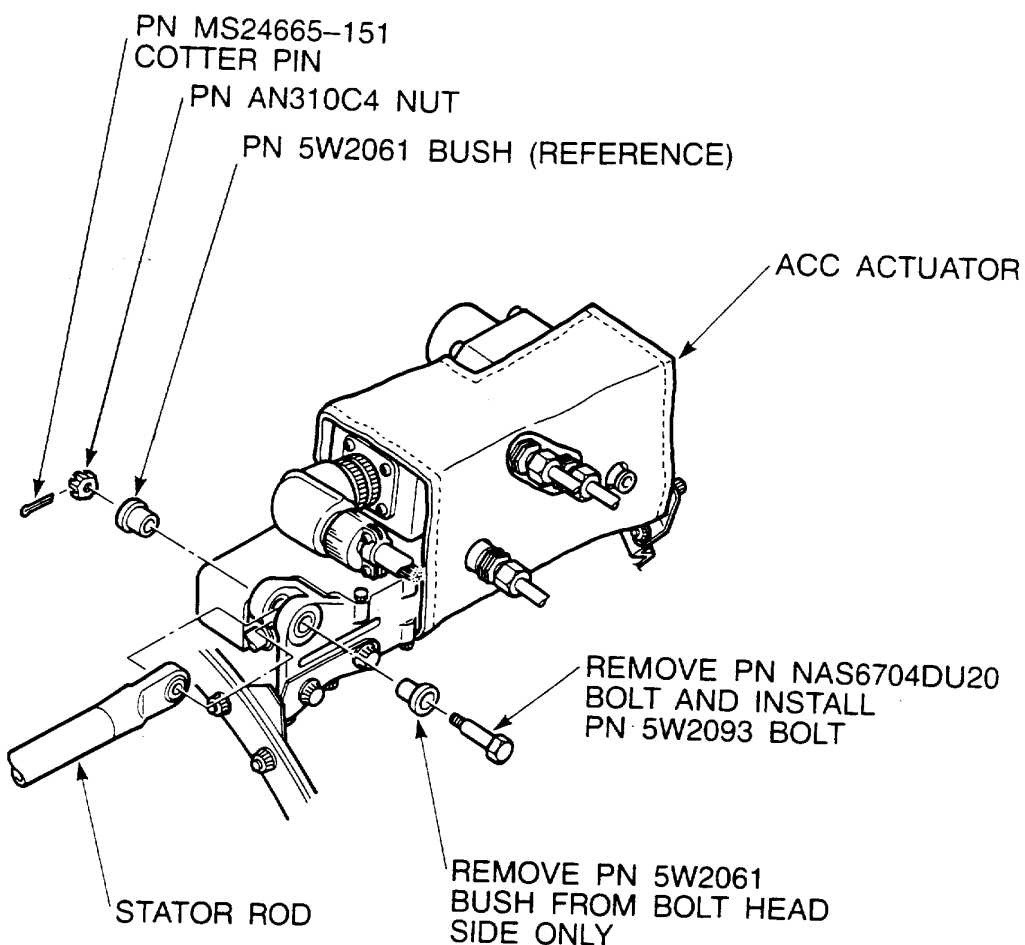
Replacement of bolt and removal of bush
Fig.1

Existing bushing tolerances may result in difficulty during installation of the ACC actuator clevis.

B. Replacement Instructions, refer to Figure 1.

- (1) Disconnect 5W8232 or 5W2096 Stator Rod from the ACC actuator.
 - (a) Remove MS24665-151 Cotter Pin, AN310C4 Nut and NAS6704DU20 Bolt.
- (2) Remove 5W2061 Bush from the ACC actuator.
 - (a) Draw the bush using the Puller, IAE1J13504.
- (3) Put the stator rod between the clevis of the ACC actuator.
- (4) Connect the stator rod.
 - (a) Align the holes of the stator rod and the clevis of ACC actuator. Install 5W2093 Bolt and AN310C4 nut.
 - (b) Torque the Nut to 32.5 to 42.5 lbfin (3,67 to 4,8 Nm).
 - (c) safety the nut with a new MS24665-151 Cotter Pin.
