SERVICE BULLETIN

AIR - ENGINE - DEDICATED ALTERNATOR - COOLING AIR SUPPLY - CATEGORY CODE 5 -
MOD.ENG-75-0010

V2500-ENG-75-0010

ENGINE DEDICATED ALTERNATOR-STATOR
UNIT. INTRODUCTION OF AIR COOLING
TO ALTERNATOR STATOR.

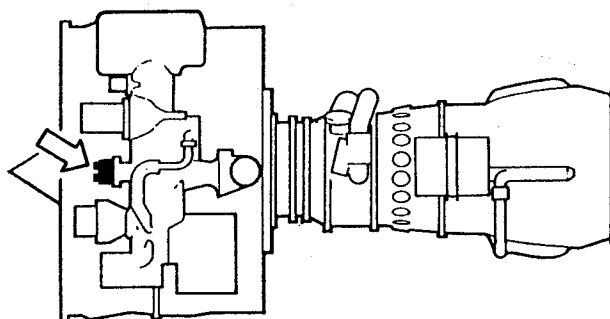
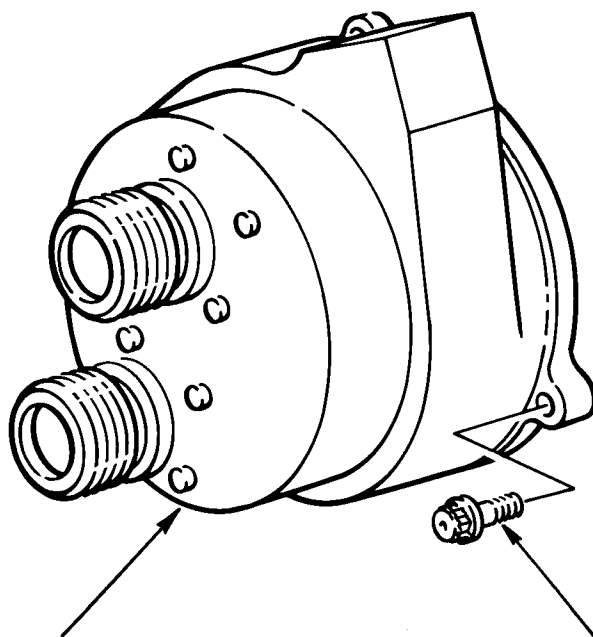
Location of dedicated alternator (stator)
Fig.1

REMOVE PMA1664 Mk2 AND
INSTALL PMA1664 Mk3

REMOVE 4P0153 BOLTS (3 off) AND
INSTALL AS32218 BOLTS (3 off)

- (1) Remove the engine dedicated alternator (E.D.A.) stator 1664 Mk2 as instructed in the Aircraft Maintenance Manual, TASK 73-22-38-000-010.
- (2) Disconnect the nut connecting tube 6A2135 to the fan exit pressure boss 5A9518, remove the bolts 4W0107 (3 off) securing the fan exit pressure boss to the fan case (refer to Figure 13) and remove the fan exit pressure boss.

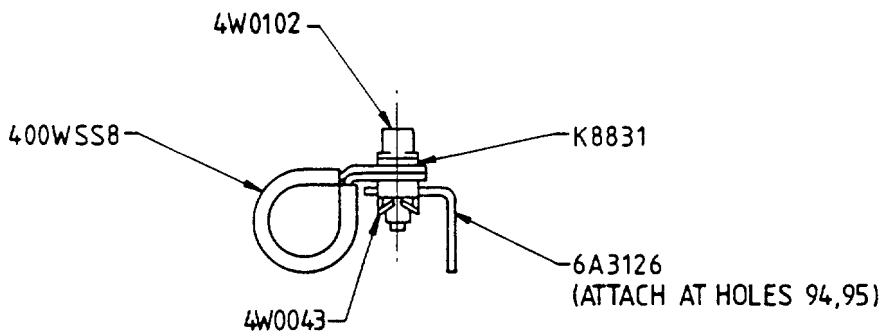
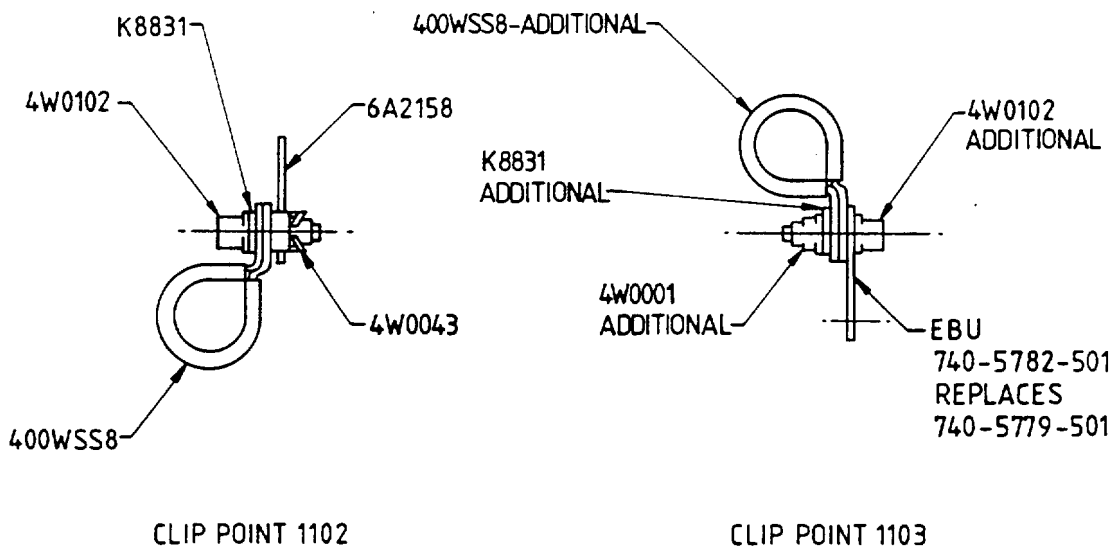
Clipping points - Before and after alteration
Fig.5

CLIP POINT 1101
AFTER ALTERATION

- (3) Install the tube 6A2155; support at CP1101 and CP1102 (refer to Figures 2, 4 and 5) and connect to tube 6A2164.
- (4) Install the tube 6A2157; support at CP1103, CP0853, CP0852 and CP0851 (refer to Figures 4, 5, 6 and 7) and connect to tube 6A2155.

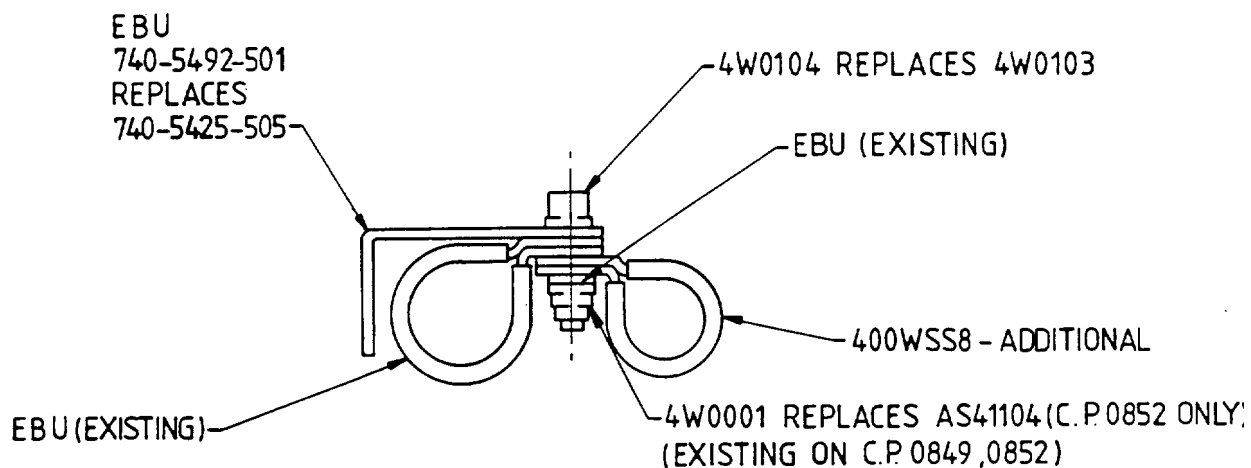
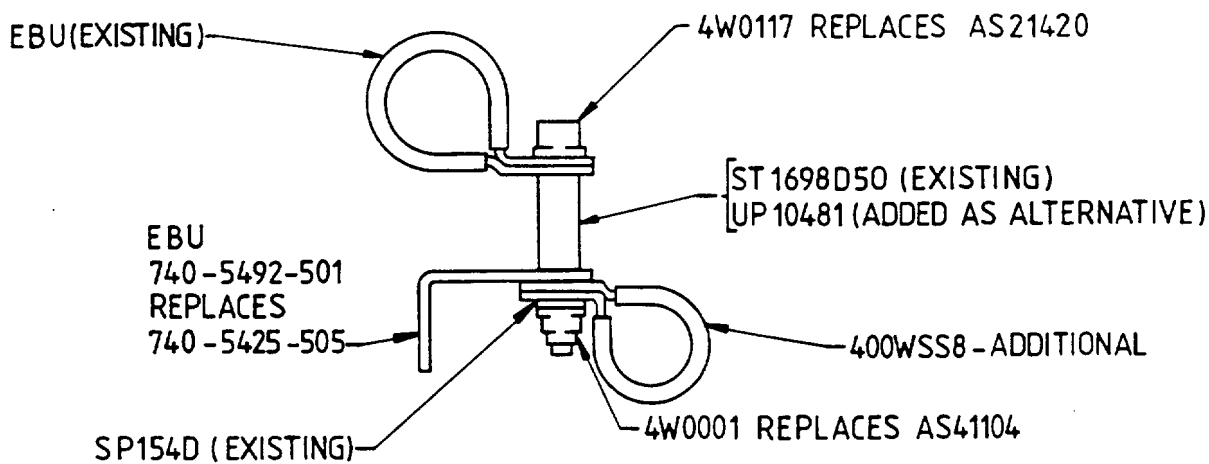
Clipping points - Before and after alteration
Fig.7

CLIP POINTS 0849 0851 & 0852
BEFORE AND AFTER ALTERATION

CLIP POINT 0853

- (5) Install the tube 6A2156; support at CP0849, CP0893, CP0847, CP0846, CP0845 and CP0779 (refer to Figures 7, 8, 9, 10 and 11) and connect to tube 6A2157.

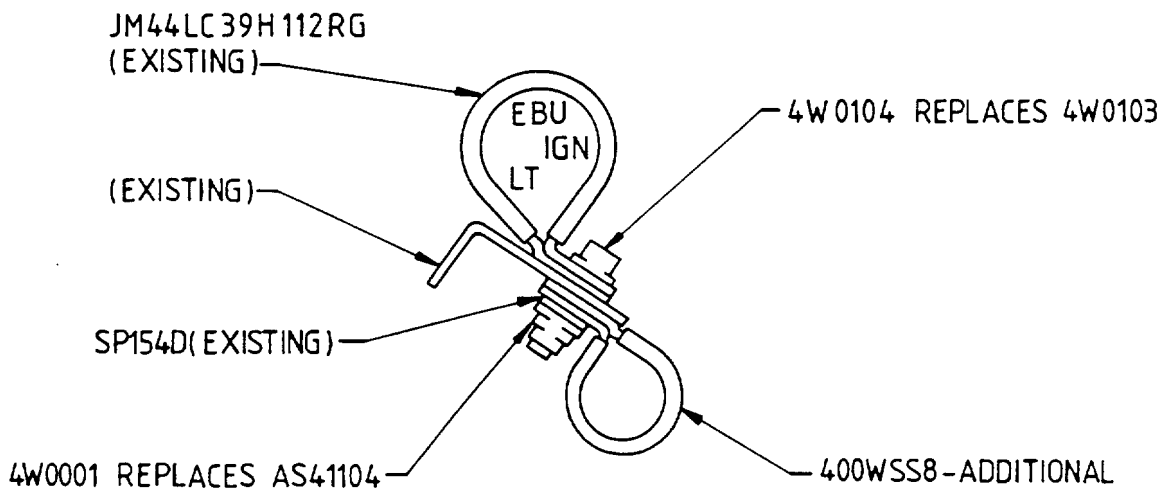
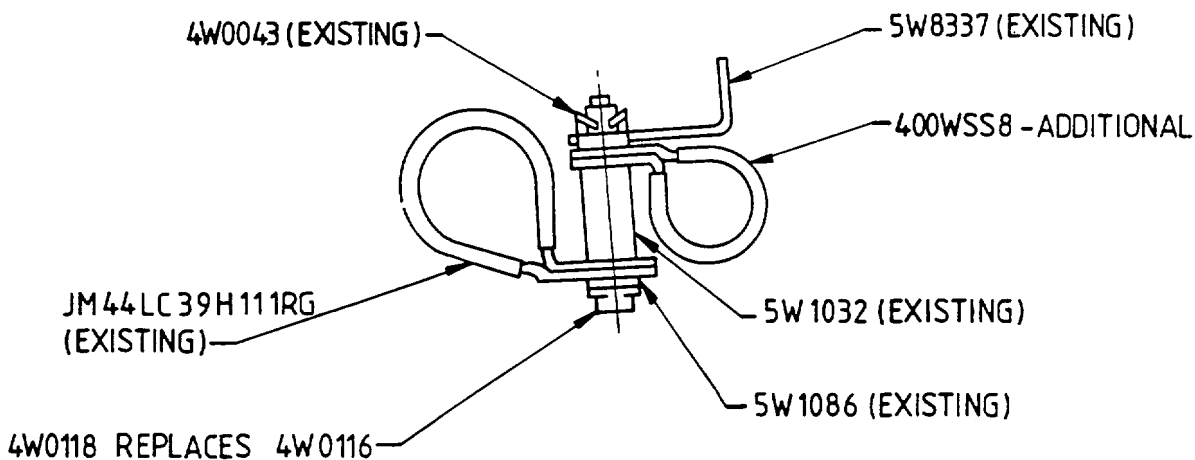
Clipping points - Before and after alteration
Fig.11

CLIP POINT 0845
BEFORE AND AFTER ALTERATION

CLIP POINT 0779

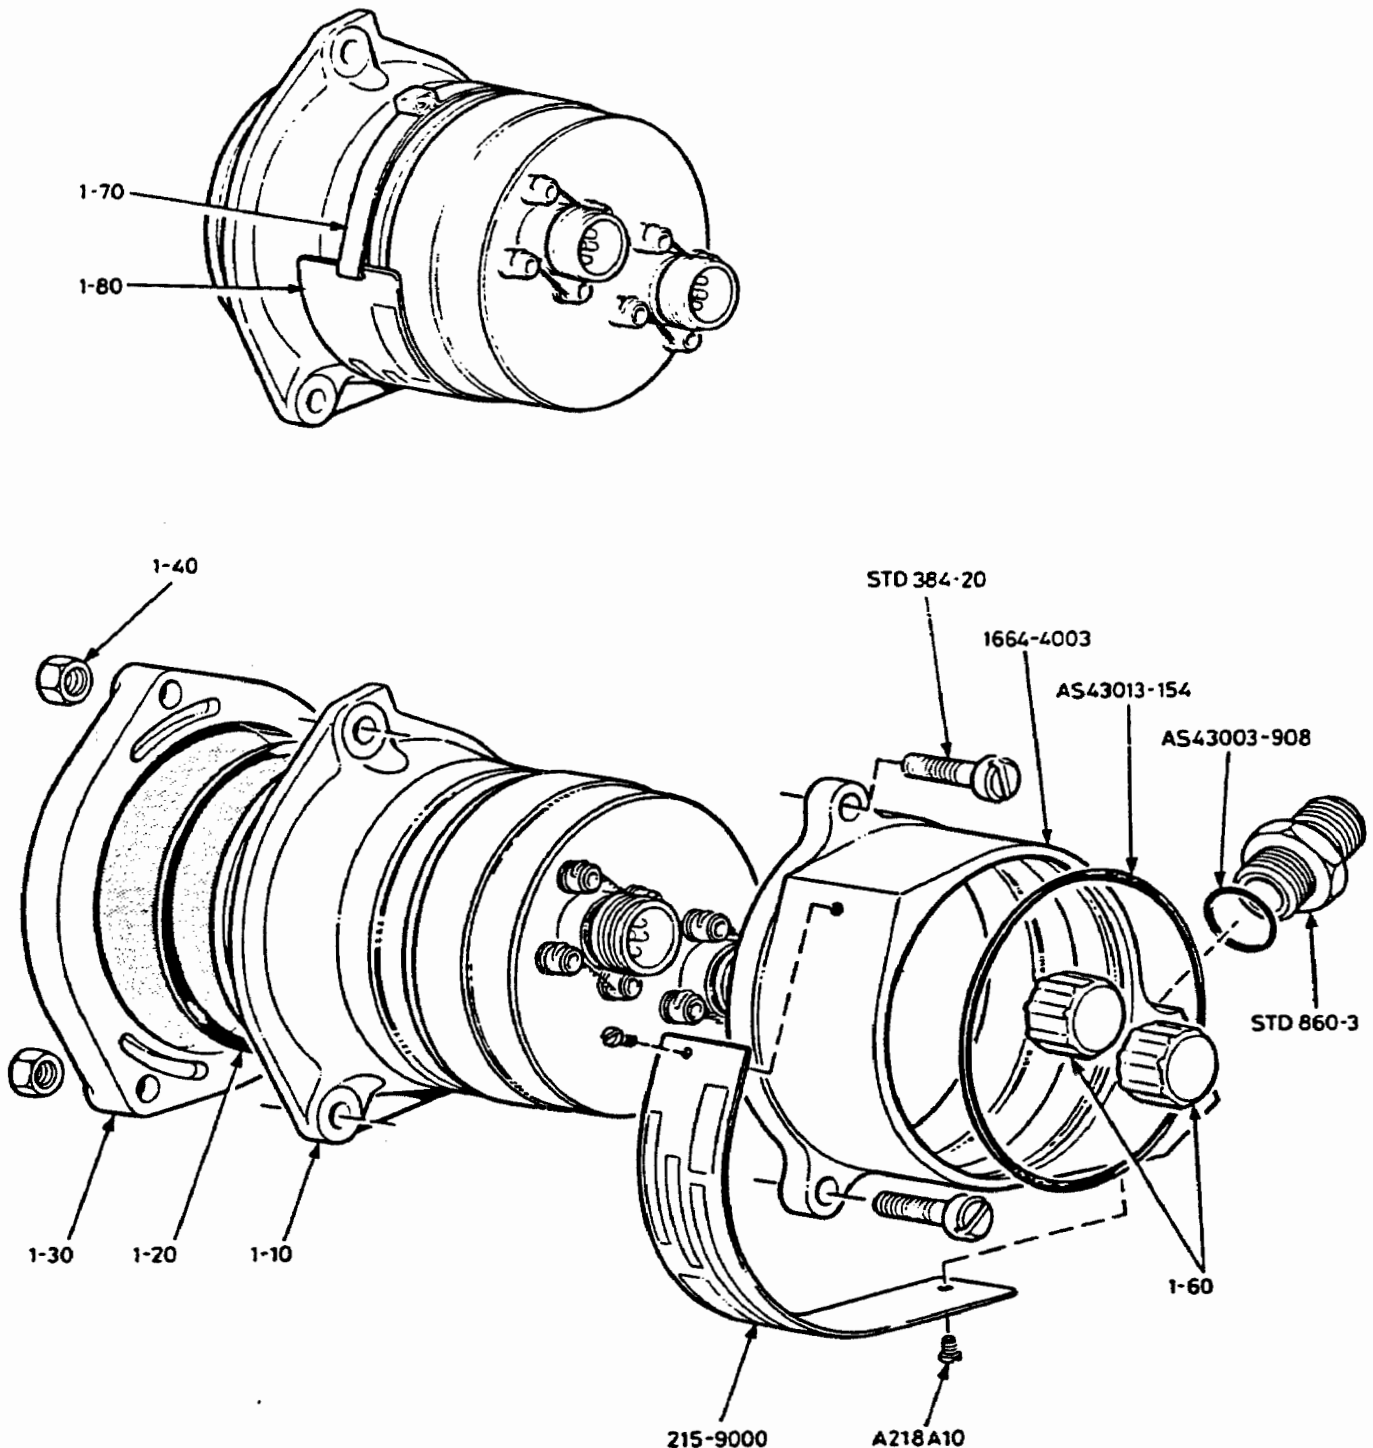
Assembly of the Cooling Shroud
Figure 1

The current standard of Alternator runs with a Stator Unit winding temperature of approximately 245°C. This temperature exceeds the continuous functional capability of the slot liner material which causes material shrinkage. This causes a slow and continuous increase in winding temperature which can result in an electrical failure.

- (1) Remove the Engine Dedicated Alternator (EDA), Stator Unit as instructed by IAE Service Bulletin V2500-ENG-75-0010.
- (2) Refer to 73-22-38 and Figure 1 of this Service Bulletin and release the bonding strip (1-70); remove the bonding strip (1-70) and the identification plate (1-80) from the stator unit.

- (3) Discard the bonding strip (1-70) but keep the identification plate (1-80) until the Service Bulletin accomplishment (Part 1), is complete.
- (4) Install the toroidal sealing ring (AS43003-908) onto the smaller threaded end of the stepped union (STD 860-3).

- (5) Assemble the stepped union (STD860-3) to the threaded bore in the shroud and inserts assembly (1664-4003). Hold the shroud and inserts assembly in a soft-jawed vice and torque tighten the stepped union to 40.5 to 49.5 Nm (360 to 440 lbf.in.). Remove the shroud and inserts assembly from the vice.

- (6) Install the toroidal sealing ring (AS43013-154) into the groove inside the shroud and inserts assembly.
- (7) Assemble the shroud and inserts assembly (1664-4003) over the body of the stator unit (1-10). Align the holes in the flange of the shroud and inserts assembly with the holes in the flange of the stator unit body.

- (8) If it has been removed, install the toroidal sealing ring (1-20) to the groove on the stator unit body. Fit the transport cover (1-30) to the stator unit body; assemble the three bolts (STD384-20) and the three nuts (1-40) to keep the components in place.

- (11) Where possible, fill in the stamped letters/numbers with black paint and wipe away the surplus.
- (12) Destroy the first identification plate.
- (13) Carefully bend the new identification plate to the shape of the shroud and inserts assembly, as shown in Figure 1.
- (15) Line up the holes in the identification plate with the holes in shroud and inserts assembly; install the two panhead screws (A218A10). Torque tighten the panhead screws to 0.72 to 0.88 Nm (6.3 to 7.7 lbf.in.).
- (16) Install the EDA, Stator Unit as instructed by IAE Service Bulletin V2500-ENG-75-0010.
- (17) A record of accomplishment is required.
