AIR - INTRODUCE A SUPPORT BRACKET FOR THE FBC BUFFER AIR TUBE ASSEMBLY - CATEGORY CODE  
6 - MOD.ENG-75-0011

V2500-ENG-75-0011

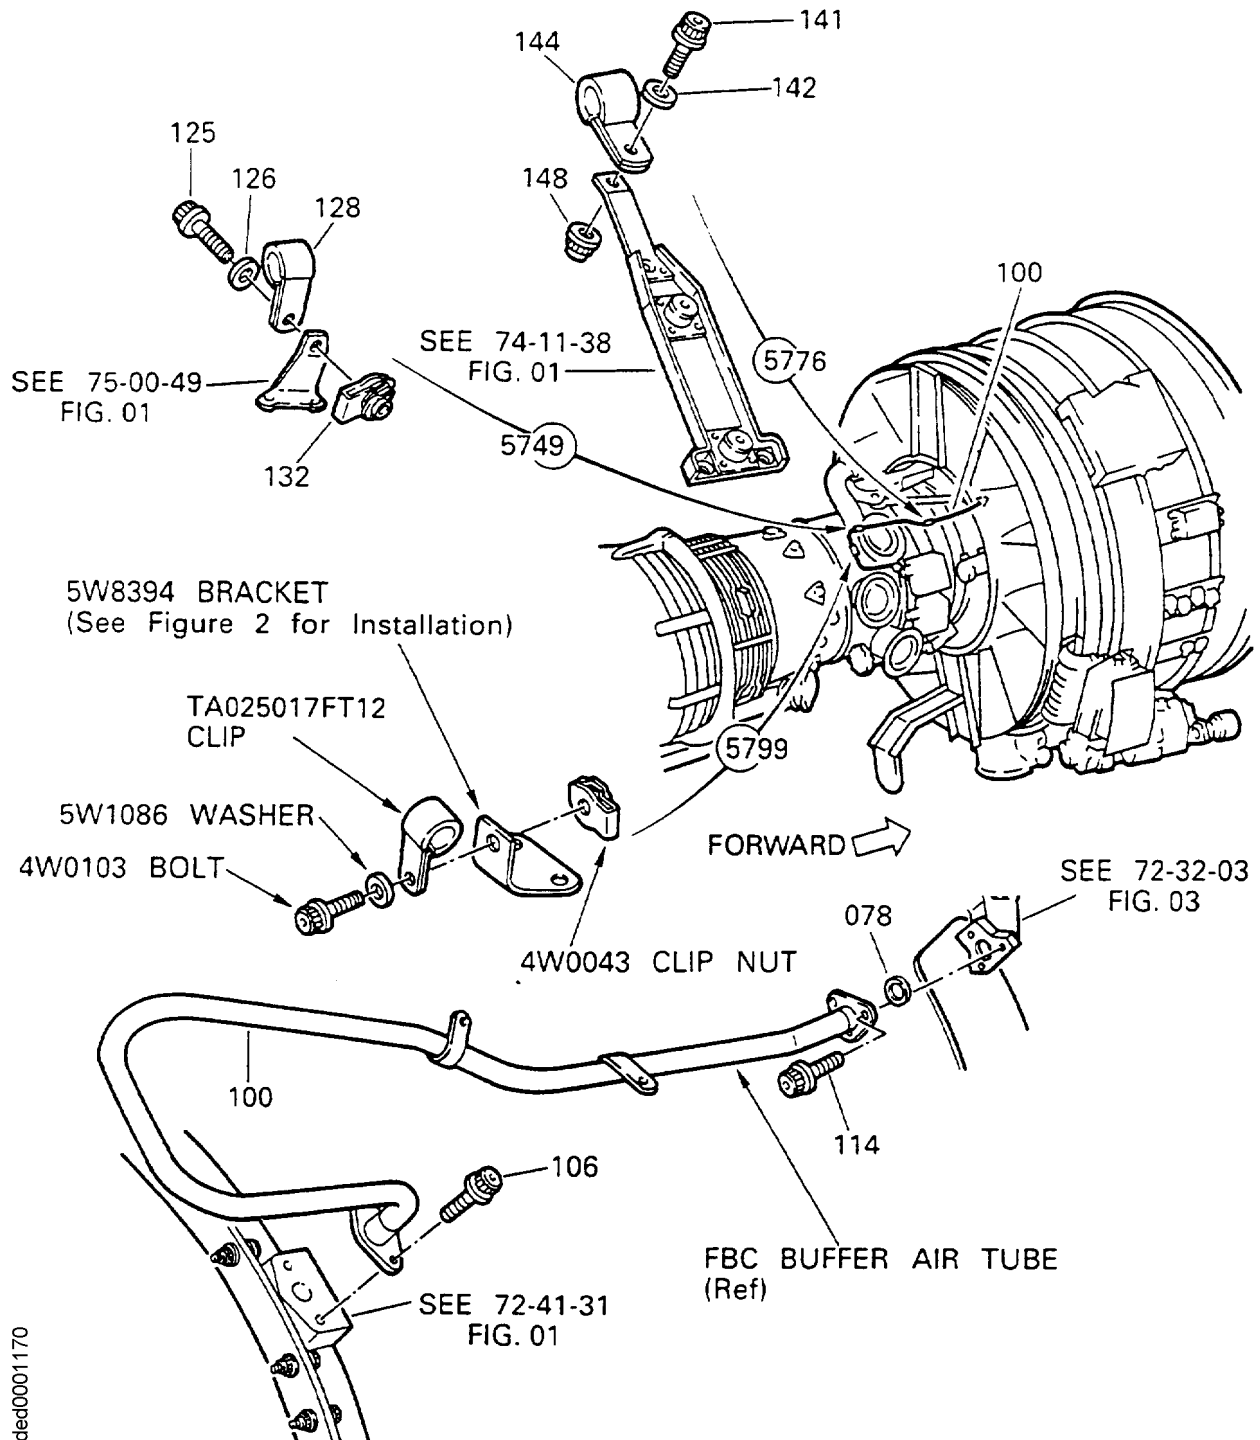
Location of the FBC buffer air tube and the additional bracket at CP5799  
Fig.1

Possible vibration of the Front Bearing Compartment (FBC) Buffer Air Tube may occur because of resonance of the Tube during engine operation.

This condition was observed on the development engine during the shake test at 189 Hz.

A shake test has shown that an additional support Bracket for the FBC Buffer Air Tube is necessary to eliminate the resonance on this tube.

- (a) An additional clipping Bracket which is mounted on the Air Off-take Duct lower flange is introduced to hold the FBC Buffer Air Tube at an additional clipping position CP5799. (See Figures 1 and 2).

- (1) Install the additional 5W8394, Bracket, on the Air Off-take Duct lower flange when installing the Air Off-take Ducts to the HP Compressor Case by the approved procedures in the Engine Manual, 72-00-40, Installation, TASK 72-00-40-420-005. (Refer to Figure 2, and 1.K.(2)).
- (2) At additional CP5799, install the additional 4W0103, Bolt, 5W1086, Washer, TA025017FT12, Clip, and 4W0043, Clip Nut, to the additional 5W8394, Bracket, and the FBC Buffer Air Tube, when installing the Tubes by the approved procedures in the Engine Manual, 72-00-40, Installation, TASK 72-00-40-420-006. Torque the Bolt to 36 - 45 lbfin. (4,00 - 5,00 Nm) at CP5799. (Refer to Figure 1, 1.K.(2), and 1.K.(3)).
