AIR - INCORPORATE A NON-RETURN VALVE INTO THE LPC BLEED-MASTER ACTUATOR LP RETURN LINE  
- CATEGORY CODE 4 - MOD.ENG-75-0019

**V2500-ENG-75-0019**

ENGINE COMPRESSOR CONTROL - LPC BLEED -  
MASTER ACTUATOR - INTRODUCTION OF  
RETURN PORT NON-RETURN VALVE

(IAE SB V2500-ENG-75-0019)  
(DFS MOD.D.TV.028)

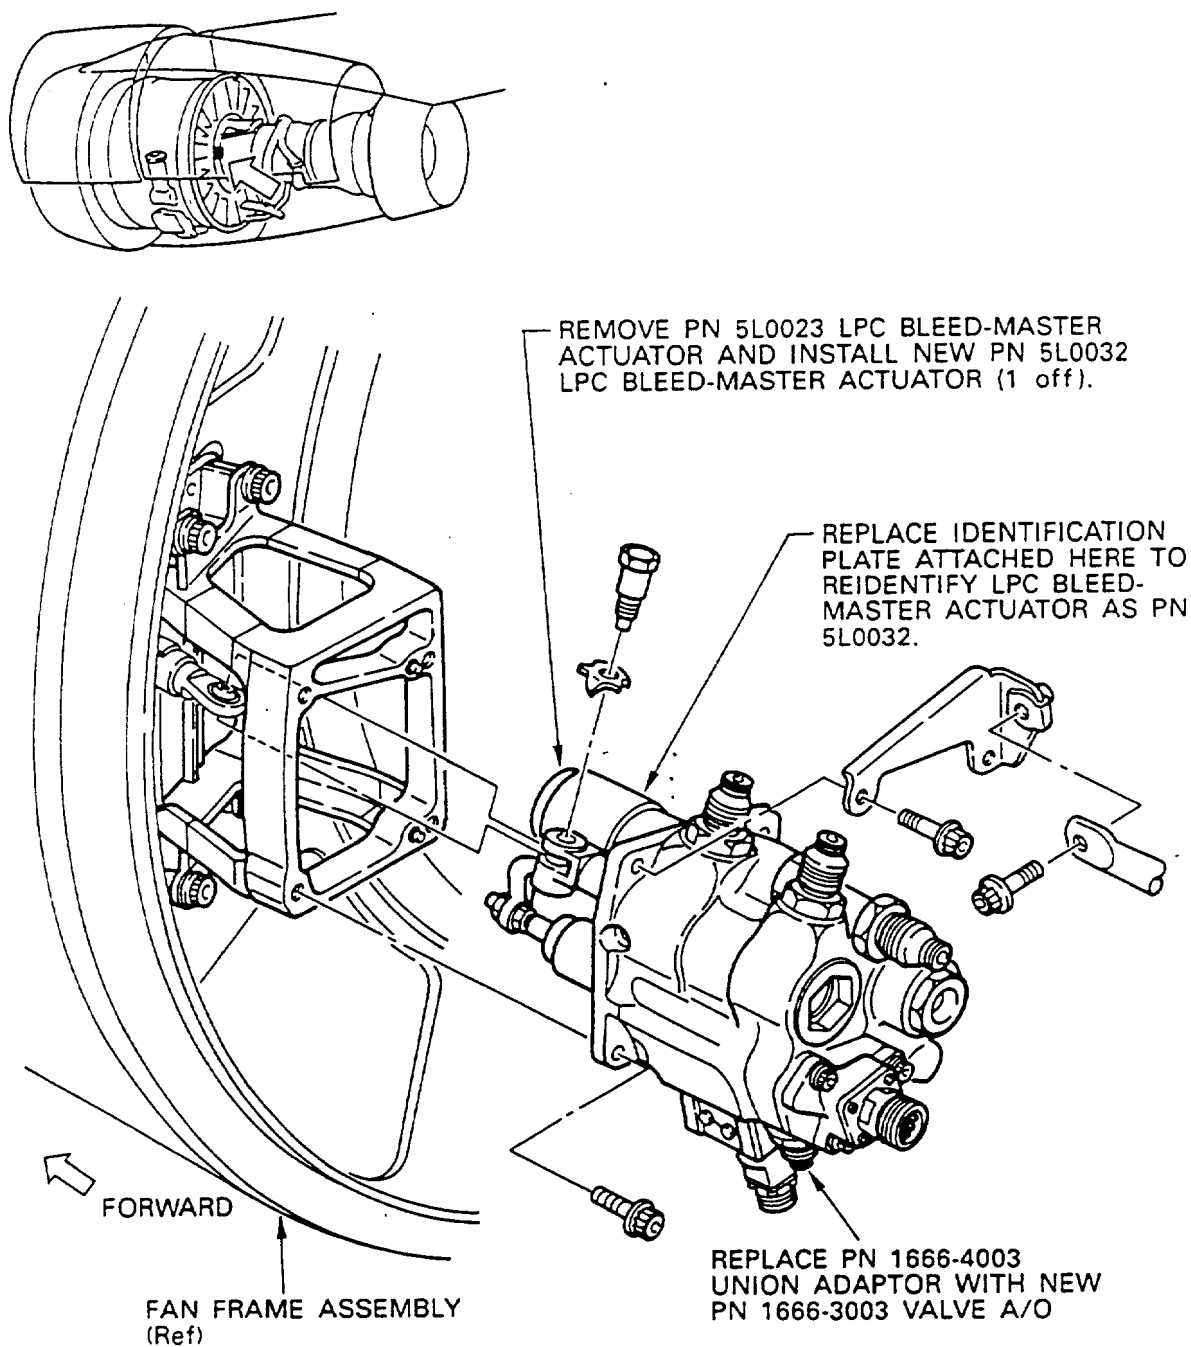
Location of the LPC Bleed-Master Actuator  
Fig.1

(a) A Union Adaptor which is fitted in the LP return port of the LPC Bleed-Master Actuator has been changed with a Non-return Valve A/O (See Figure 1).

(b) Existing Part Number of LPC Bleed-Master Actuator has been changed to a new Part Number (See Figure 1).
