SERVICE BULLETIN

<u>AIR - HP COMPRESSOR VARIABLE STATOR VANE ACTUATOR (VSVA) - INTRODUCTION OF RETURN PORT</u> NON RETURN VALVE - CATEGORY CODE 4 - MOD.ENG-75-0020

ENGINE COMPRESSOR CONTROL-VARIABLE STATOR VANE ACTUATOR. INTRODUCTION OF RETURN PORT, NON-RETURN VALVE

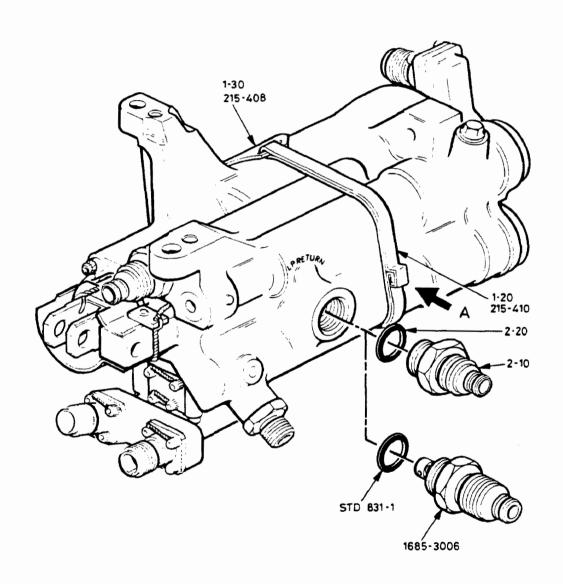
Assembly of the Non-return Valve Figure 1

It has been noted that a reversal of the LP return flow may take place during Fuel System priming resulting in possible contamination of the Variable Stator Vane Actuator (VSVA).

A. Install the Non-return Valve (Figure 1).

- (1) Unscrew and remove the union adaptor (2-10) from the connection marked 'L.P. RETURN'; remove the sealing ring (2-20).
- (2) Fit the new toroidal sealing ring STD831-1 (supplied with the Mod. kit), to the non-return valve assy. 1685-3006.

- (3) Assemble the non-return valve assy. 1685-3006 to the unit connection marked 'L.P. RETURN'; torque tighten the non-return valve assy. to 300 lbf.in. (34 Nm).
- (4) Release the strap (1-20) which secures the data plate (1-30), remove the strap and the data plate; keep the data plate but discard the strap.
- B. Re-identify the VSVA
 - (1) Obtain the new data plate 215-408 (supplied with the Mod.kit).
 - (2) Refer to the information on the first data plate (1-30) and mark the new data plate as follows (use 3/32 in. (2.5 mm) letter/number stamps with the data plate held on a flat surface):
