AIR - HP/LP TURBINE ACC SYSTEM - VALVE VANE REPLACEMENT AND ADDITION OF PLUG STORAGE
PLATE TO HPT/LPT ACC AIR VALVE - CATEGORY CODE 4 - MOD.ENG-75-0021

V2500-ENG-75-0021

AIR - V2500 - HPT/LPT ACC AIR VALVE ASSEMBLY, PART NUMBERS 5860016-107 THROUGH 5860016-113 and 5860016-117. UPGRADE TO 5860016-119/-120 AND 5860016-121/-122.

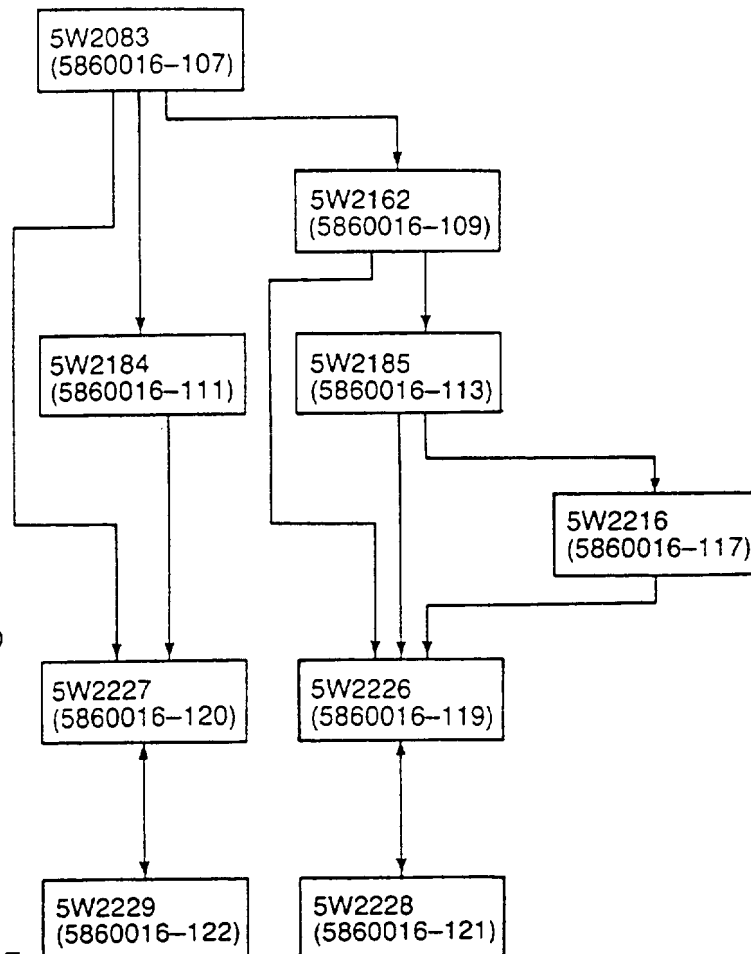
Family Tree - HPT/LPT ACC Air Valve Ref. Catalog Sequence No.75-24-51, Fig 01, Item 100
Fig.1

V2500-ENG-70-0050
RIB ADDED TO THE
CAMBOXV2500-ENG-75-0012
SEAL RINGS REMOVEDV2500-ENG-75-0018
CONTROLLED SERVICE
USE: 4-HOLES AND
SINGLE SEAL RING
ADDED: PLUGS REMOVEDV2500-ENG-75-0021
PART 1, 3
4-HOLES, SINGLE SEAL
RING AND PLUG
STORAGE PLATE ADDED:
PLUGS ON HPT VALVE
VANEV2500-ENG-75-0021
PART 2
PLUGS ON PLUG STORAGE
PLATE

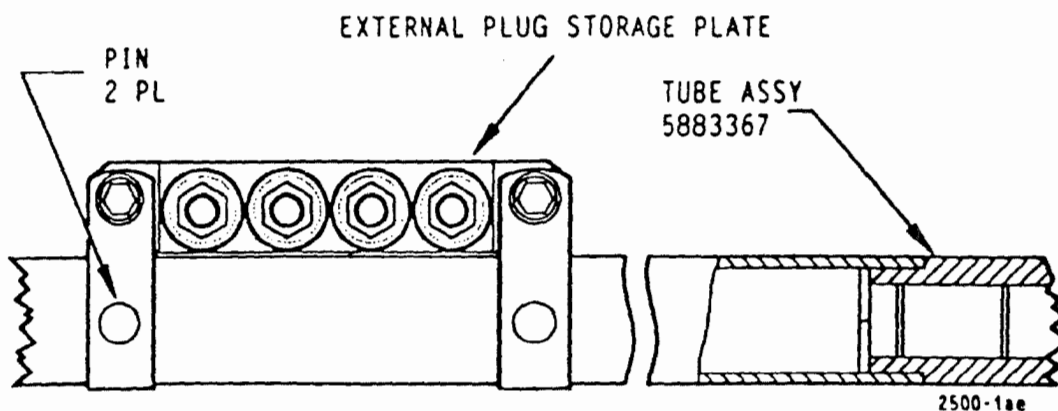
NOTE: The external plug storage plate is used to visually identify the specific location of the HPT vane plugs. Check and verify that either of the following is applicable:

1. If the vane plugs are contained in the external plug storage plate, it shall be concluded that they are no longer in the valve HPT vane.
2. If the vane plugs are not visibly contained in the external plug storage plate and the four holes are visibly empty, it shall be concluded that the HPT vane contains the four vane plugs.

(1) Use standard hand tools and remove each of four self locking nuts, Part Number NAS679C06, screws, Part Number MS16995-18, washers, Part Number 5903265-101, and bushings, Part Number 5903264-101, from the HPT vane.

(2) Install the four vane plugs in each of the four holes located in the external plug storage plate. Torque the four self locking nuts, Part Number NAS679C06 at 10.0 to 11.5 lb.in. (1.13 to 1.30 Nm).
