<u>AIR - LPC BLEED MASTER ACTUATOR - NEW FUEL DRAIN PASSAGE - CATEGORY CODE 6 - MOD.ENG-75-0023</u>

1666-75-002

ENGINE COMPRESSOR CONTROL - LPC BLEED
MASTER ACTUATOR - INTRODUCTION OF

(<u>IAE SB V2500-ENG-75-0023</u>) (DFS MOD D.TV.029)

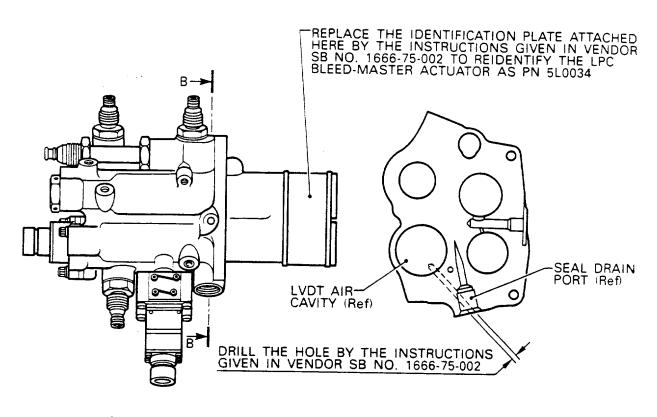
Modification of the LPC Bleed-Master Actuator Fig.2

Hydraulic locking of the Linear Variable Differential Transformer (LVDT) may occur if the LVDT air cavity in the LPC Bleed-Master Actuator body becomes full with fuel. This could cause the damage to the fork arm linkage and subsequent loss of LVDT feedback signal to the Electronic Engine Control (EEC).

There have been two instances of damage to the fork arm linkage in service. An investigation has revealed that the cause of damage has been due to the hydraulic locking of the LVDT resulting in fuel leaked into the LVDT air cavity through the LVDT sealing ring which was attributed to damage during initial assembly into unit. A simulation testing has also shown an evidence of this condition.

- (1) The changes introduced by this Service Bulletin are as follows: Refer to Figure 1 and 2.
 - (a) A drain passage between the LVDT air cavity and the unit seal drain port is introduced to prevent the hydraulic locking of the LVDT.

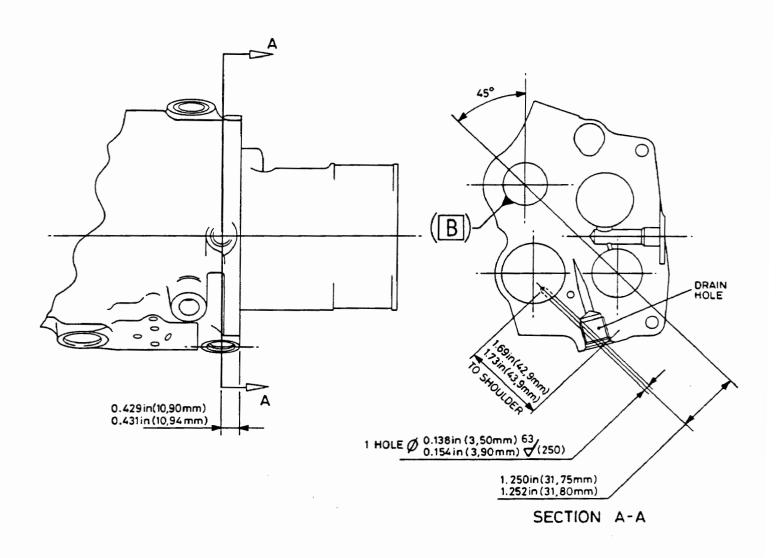
Body , insert and plugs assembly - re-work details
Figure 1

It has been established that hydraulic locking of the Linear Variable Differential Transformer (LVDT), can occur if the LVDT air cavity in the unit body becomes full with fuel.

The LVDT air cavity in the unit body is currently unvented. Leakage from the LVDT, LP seal can cause the air cavity to become full with fuel. This results in hydraulic locking of the LVDT, failure of the fork arm linkage and subsequent loss of LVDT feedback signal to the Electronic Engine Control (defined as a tracking failure). Two such incidents have occurred in service, both caused by the LVDT, LP seal sustaining damage during initial assembly into the unit; for this reason, both service failures have been infantile.

- (1) The Modification introduces a drain hole between the LVDT air cavity and the unit seal drain port, to prevent the LVDT air cavity becoming full with fuel.
- (2) The existing LPC Bleed Master Actuator can be reworked to a new configuration.

- (5) Machine a hole 0.138-0.154 in.(3,50-3,90 mm) dia. from the drain hole to the LVDT cavity as shown, (Refer to Figure 1).
 - (6) Remove the body from the jig boring machine and remove, by using hand tools, any burrs from the machined hole in the LVDT cavity.
