## SERVICE BULLETIN

ENGINE - AIR - REVISED HPT ACC MANIFOLD SUPPORT BRACKET - CATEGORY CODE 8 -  
MOD.ENG-75-0026

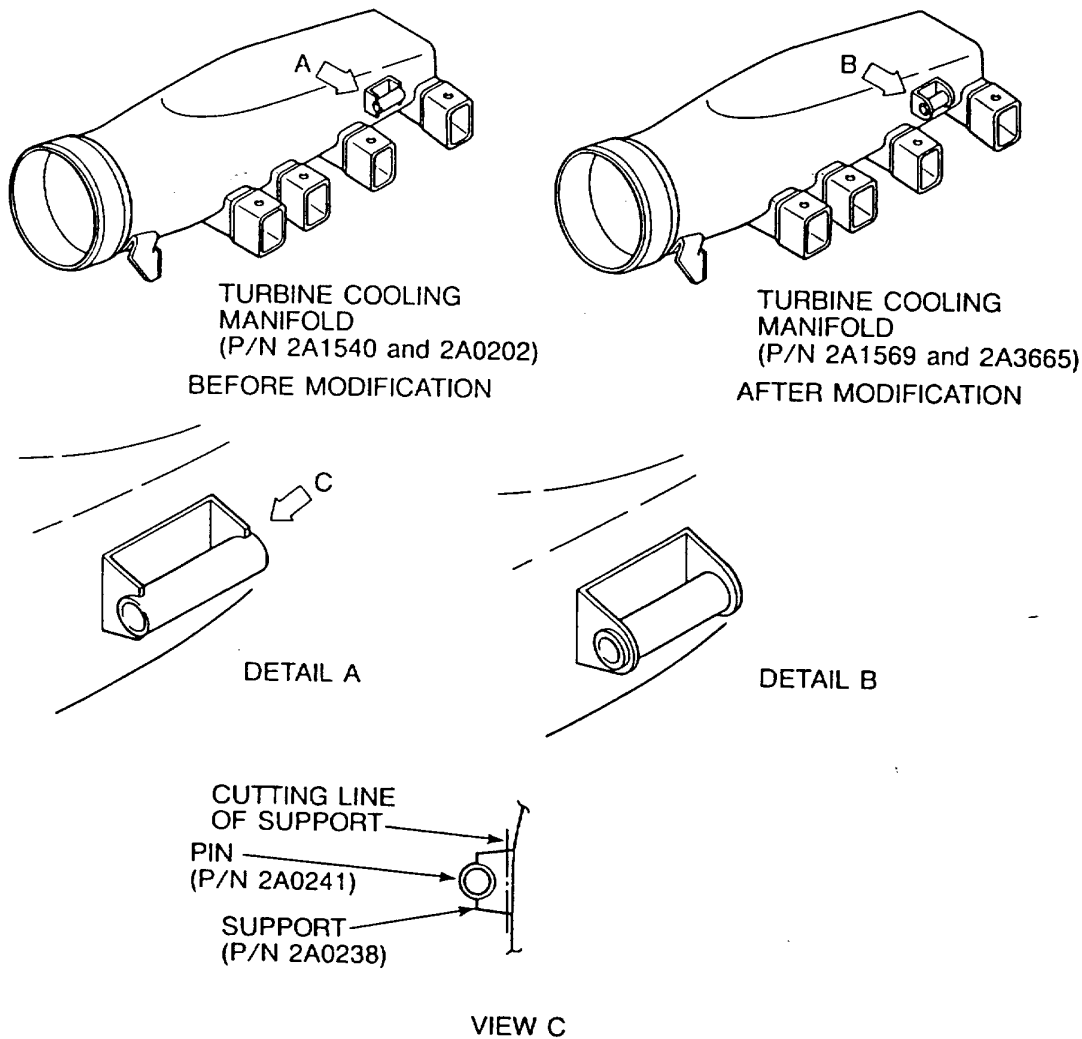
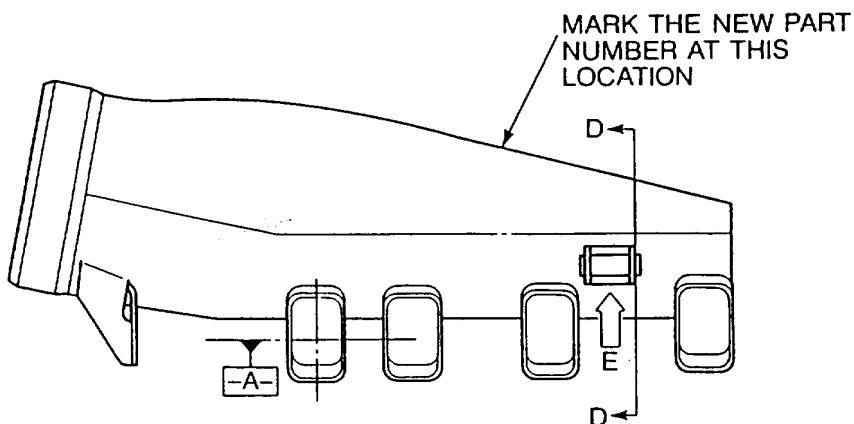
Sheets) Modification of 2A1450 and 2A0202 Turbine Cooling Manifold  
Fig.1 (Sheet 1 of 3

Cracking has occurred on the side support pin of some Turbine Cooling Manifolds.

Procedure	Supplementary Information
(a) Cut out the support at 2 points, each point is as close as the manifold	Refer to Figure 1 requirements Use a wire cutter

(b) Remove the residual support from the manifold body, keeping the original thickness of the manifold body	Use a hand held pneumatic grinder Refer to Figure 1 requirements

(d) Weld the Pin to the Support by tungsten inert gas (TIG) weld	Refer to Reference (2), 70-31-02 Argonarc Welding Repairs-01 and -08, and Figure 1 requirements. Use a tungsten inert gas (TIG) system. Use CoMat 03-204 welding filler wire.

(e) Weld the Support to the manifold by tungsten inert gas (TIG) weld	Refer to Reference (2), 70-31-02 Argonarc Welding Repairs-01 and -08, and Figure 1 requirements. Use a tungsten inert gas (TIG) system. Use CoMat 03-204 welding filler wire.

NOTE : MARK NEW PART NUMBER NEAR BY  
OLD PART NUMBER PER SPM TASK 70-09-00
