AIR - HPT/LPT ACC VALVE ACTUATOR - INSTALLATION OF PIN RETAINER ON SERVO VALVE -
CATEGORY CODE 3 - MOD.ENG-75-0027

AIR - V2500 - HP/LP ACC ACTUATOR, PART NUMBER 5860017-109, -111, -113 AND -114.
INCORPORATION OF PIN RETAINER CLIP ON SERVO VALVE.

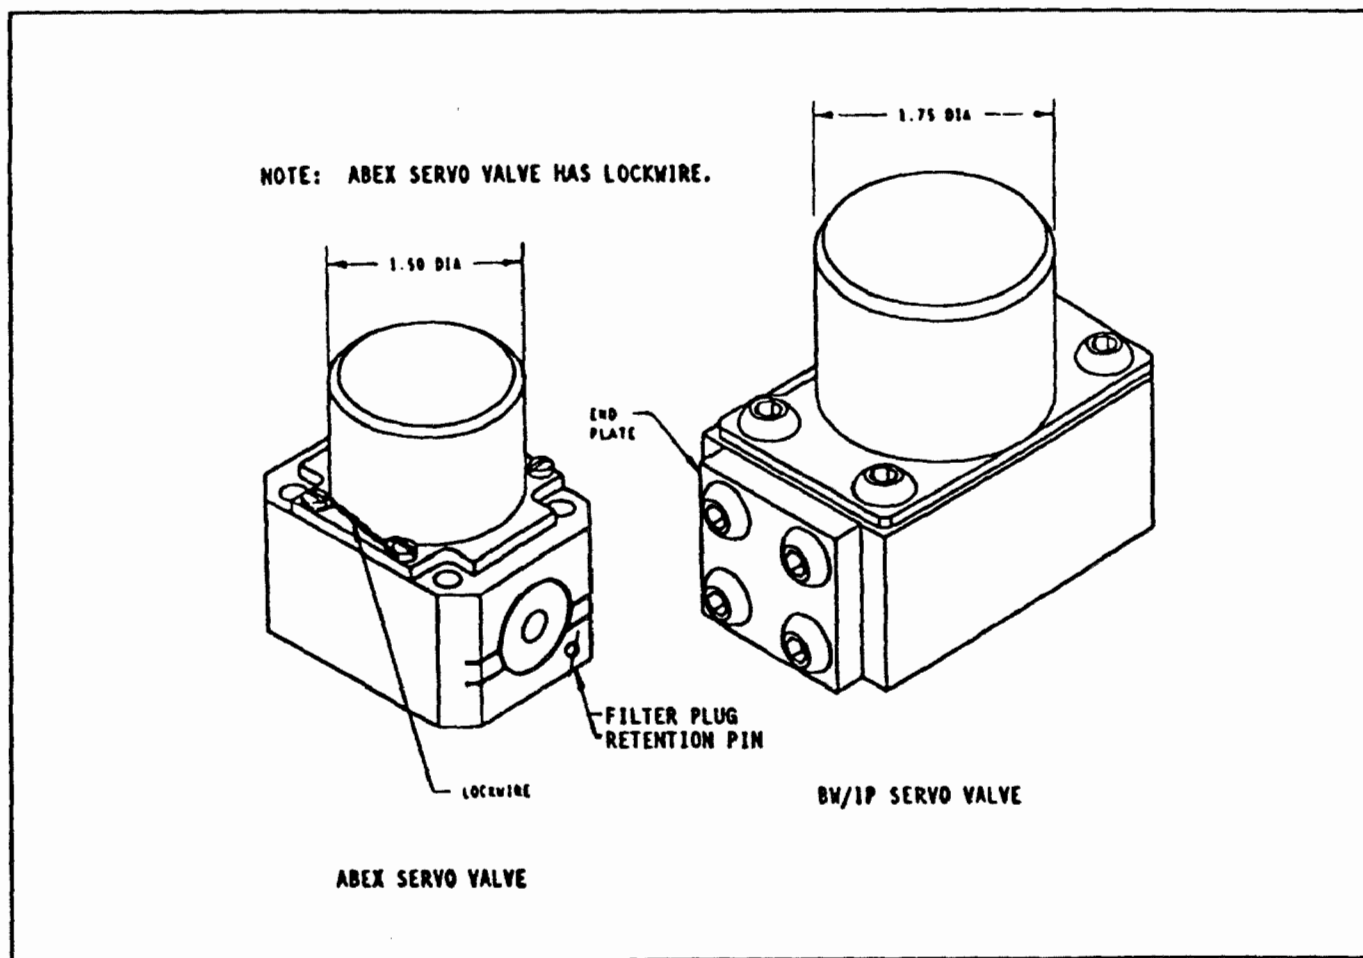
Abex and BW/IP Servo Valves
Figure 1

A. Determine if the servo valve, Part Number 5863057-101 is manufactured by Abex or BW/IP. (See Figure 1 and the servo valve nameplate.)

- (1) If the 5863057-101 servo valve was manufactured by BW/IP, this service bulletin has been accomplished. Operators shall proceed to paragraph 2.E. and reidentify the Actuator accordingly.
- (2) If the 5863057-101 servo valve was manufactured by Abex Aerospace (Vendor Number 75250), operators shall perform an additional check for the servo valve filter plug retention pin and ensure that it is intact per Figure 2. If the filter plug retention pin is missing, operators shall return the Actuator to Parker for accomplishment per paragraph 1.G.(4). If the filter plug retention pin is NOT missing, proceed to the next paragraph.

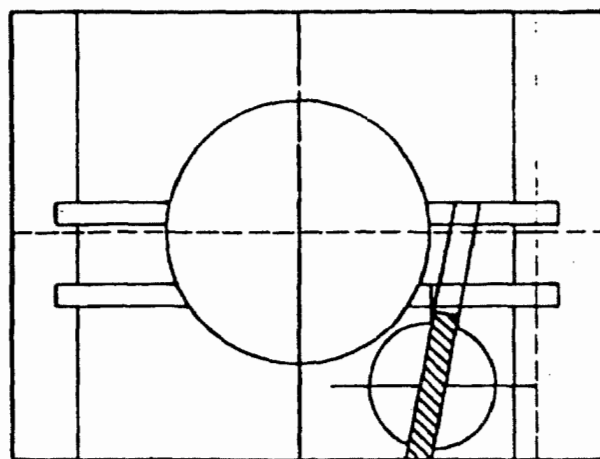
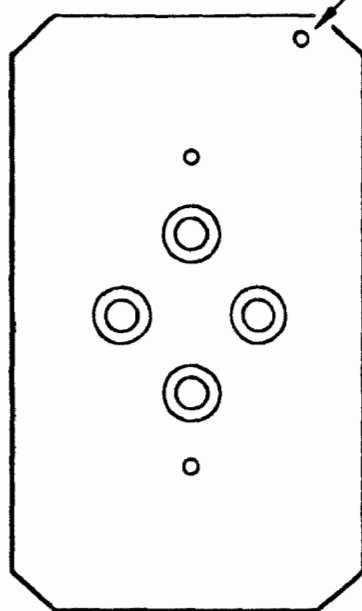
Filter Plug Retention Pin Location
Figure 2

- (1) To ensure retention of the filter plug and retention pin in servo valve, Part Number 5863057-101 (manufactured by Abex Aerospace, Vendor Number 75250). If the retention pin is dislodged, the fuel plug can be ejected from the servo valve body resulting in fuel leakage to the engine system.

- (2) A one-time (non-flight) occurrence (on a similar component) has resulted in the filter plug dislodging which produced fuel leakage. The cause has been determined to be improper pin retention and assembly of the electrohydraulic servo valve. Parker Hannifin Corporation has undergone design and assembly changes in order to eliminate the problem.

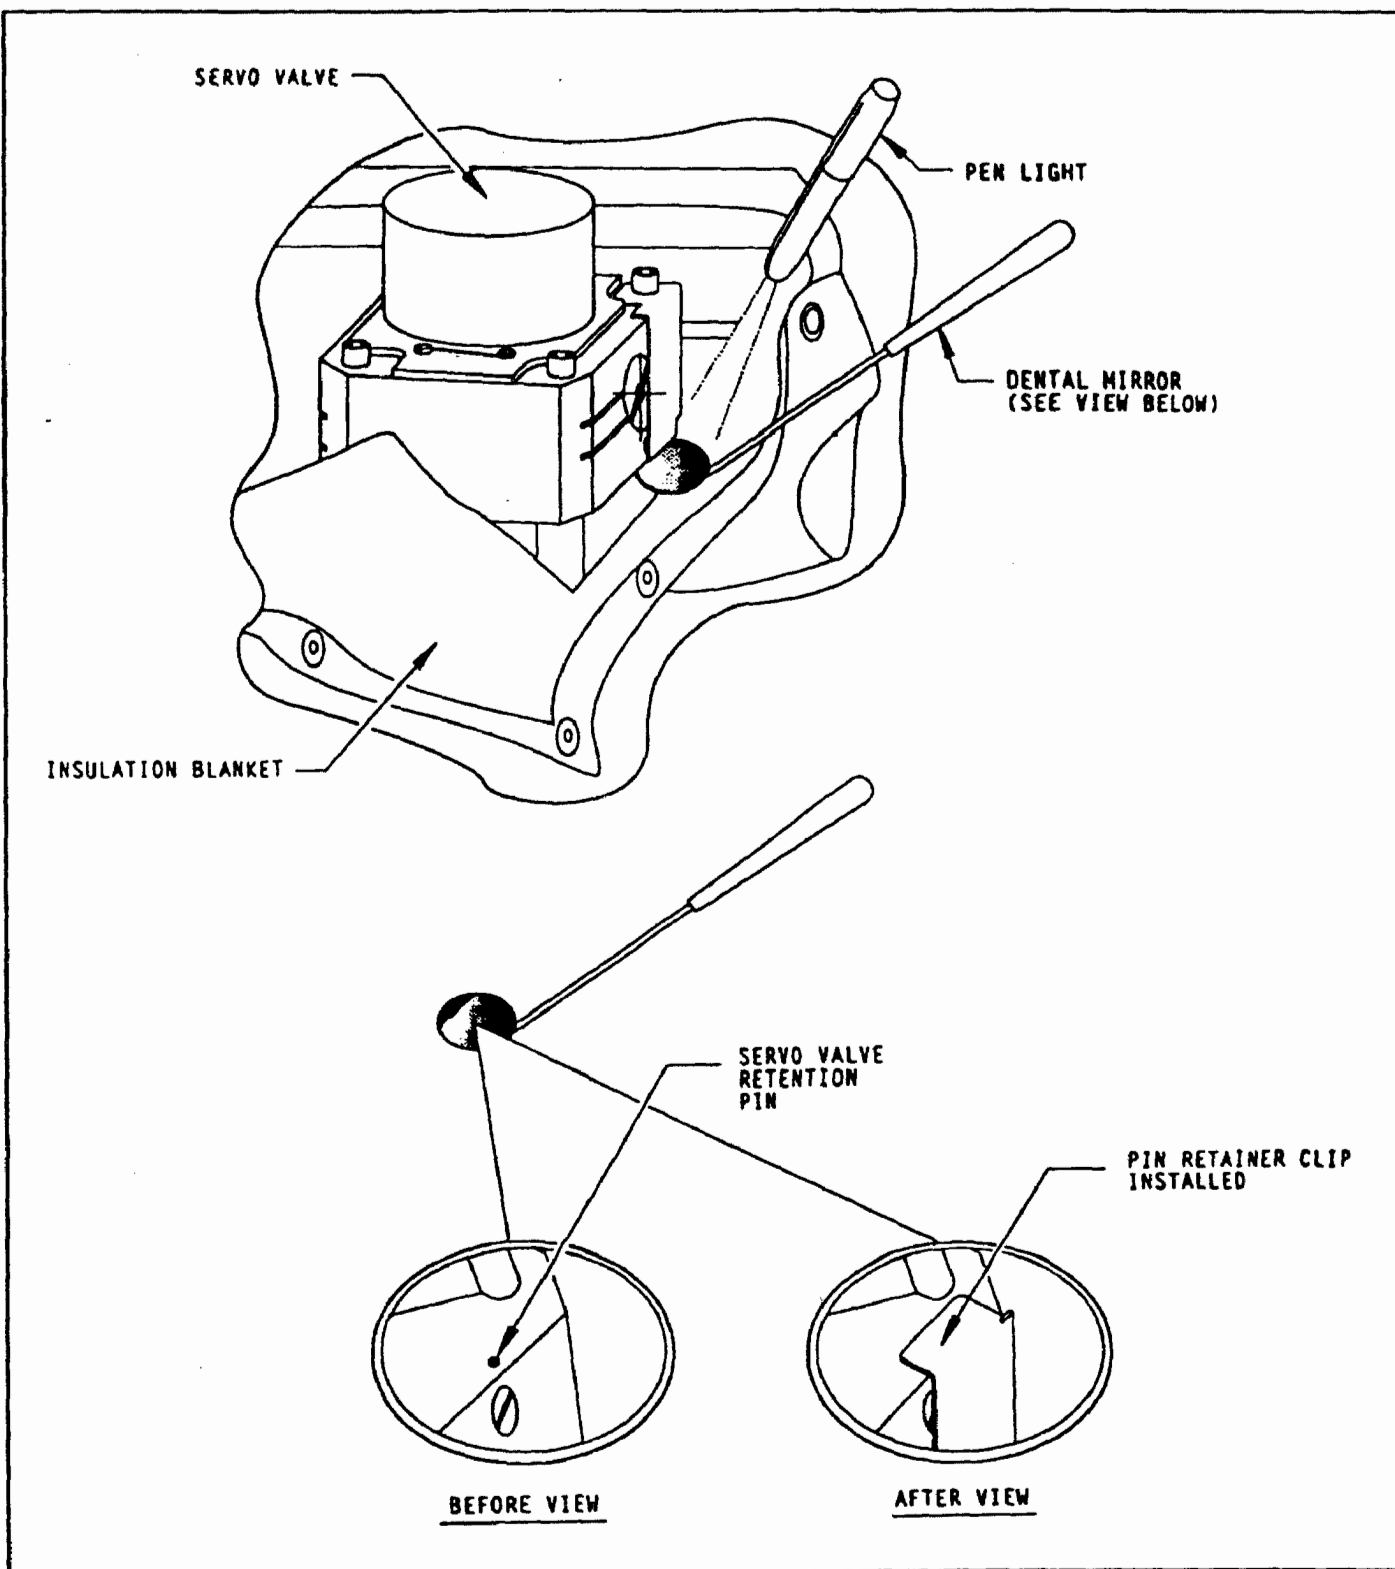
Before and After Visual Inspection
Figure 3

<u>TASK</u>	<u>MAN HOURS</u>
(a) Visual inspection for suspect Abex servo valve per Figure 1.	0.25
<u>NOTE 1</u> : If an Abex servo valve is located, visually check and ensure that the pin is intact per Figure 2 and Figure 3 (Before View). If the filter plug retention pin is missing, return the Actuator to Parker Hannifin Corporation per paragraph 1.G.(4) in this service bulletin. Accomplishment of this service bulletin will be completed by Parker.	
<u>NOTE 2</u> : If a BW/IP servo valve is located, the pin retainer clip installation is <u>NOT</u> necessary. Proceed to paragraph 2.E. and reidentify the Actuator accordingly.

- D. Reinstall screw (110) and torque 20 to 24 in.lb (2.3 to 2.6 Nm). Perform a visual inspection per Figure 3 (After View) in this service bulletin, using a dental mirror (or equivalent) and a pen light.
