AIR - HP COMPRESSOR VARIABLE STATOR VANE ACTUATOR (VSVA) LINEAR VARIABLE DIFFERENTIAL TRANSFORMER (LVDT) SEALING - 3 - MOD.ENG-75-0028

V2500-ENG-75-0028

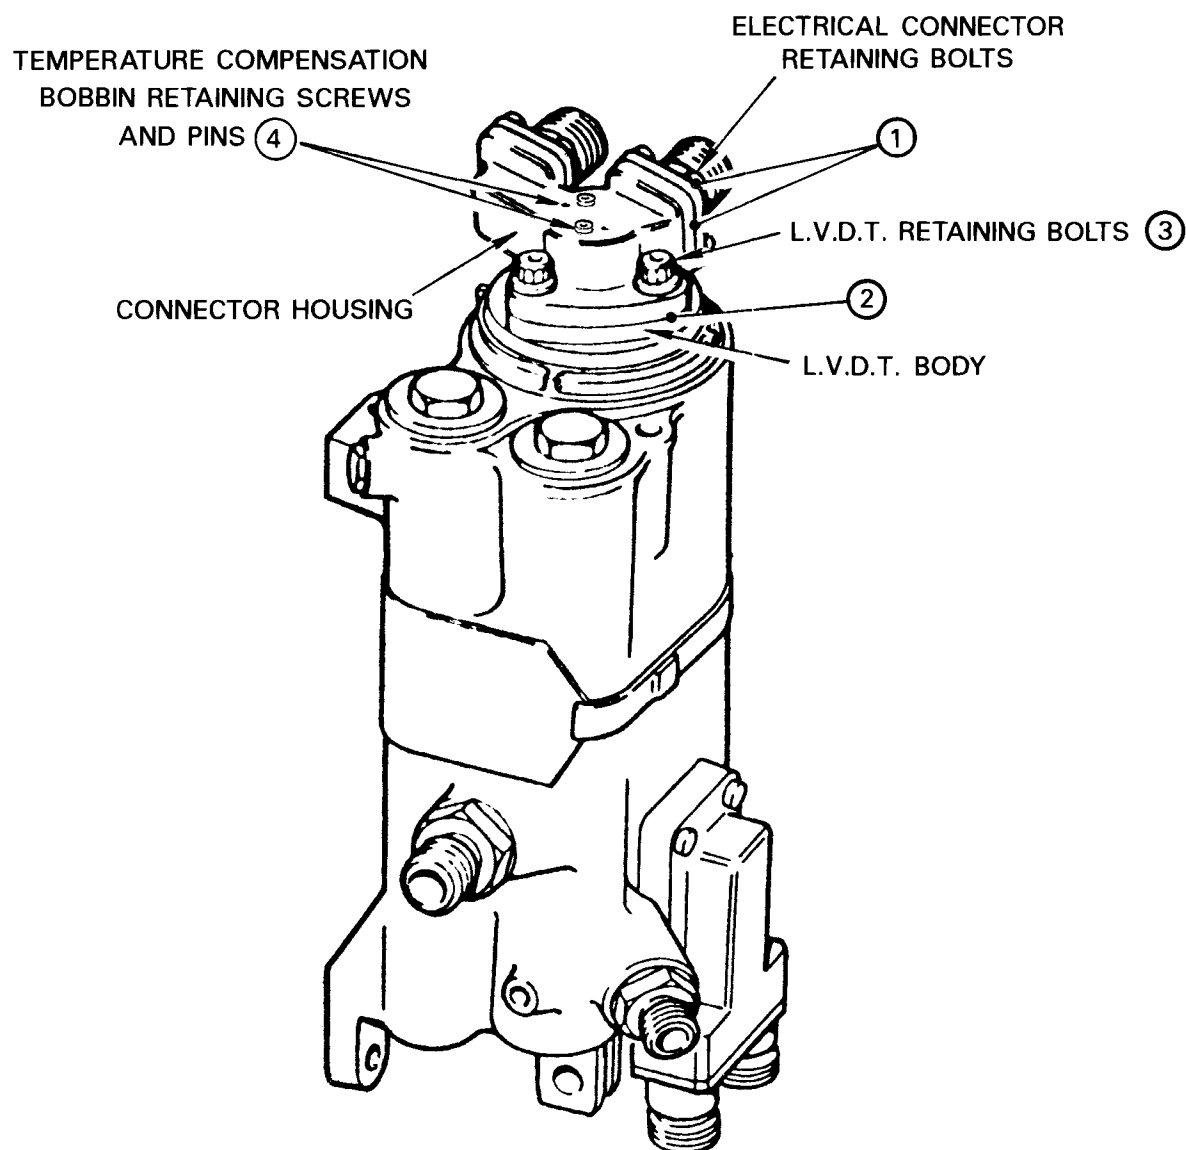
Location of joint faces on VSVA to be sealed
Fig.1

Interfaces have been identified on the variable stator vane actuator (VSVA) linear variable differential transformer (LVDT) which may allow the ingress of fuel into the LVDT, with the potential of adversely affecting the VSVA performance.

- (a) The connectors and the connector housing and the retaining bolts. Refer to Figure 1, Index 1.
 - (b) The connector housing and the LVDT body. Refer to Figures 1 and 2, Index 2.
 - (c) The LVDT retaining bolts and washers (3 off). Refer to Figures 1 and 3, Index 3.
 - (d) Bobbin retaining screws (2 off) and location pins (2 off). Refer to Figure 3, Index 4.
- (4) Ensure that each area is free from grease and dirt.
 - (5) Seal the VSVA LVDT

- (a) When the cleaning agent has evaporated apply Ardrex 3302 to the outside joint areas cleaned above, using a 5 mm soft brush.

- (a) Ensure that a reddish brown coating of the Ardrex 3302 completely covers the specified areas.
- (6) Close the left thrust reverser half by the approved procedures in Reference (1), Chapter/Section 78-32-00, Maintenance Practices.
 - (7) Close the fan cowls by the approved procedures in Reference (1), Chapter/Section 71-13-00, Maintenance Practices.
