AIR - HP/LP TURBINE ACC SYSTEM - ADDITION OF ANTI-ROTATION SLEEVE TO THE HPT/LPT ACC
AIR VALVE - CATEGORY CODE 5 - MOD.ENG-75-0031

V2500-ENG-75-0031

V2500 SERIES ENGINES HPT/LPT ACC AIR VALVE ASSEMBLY, PART NUMBERS 5860016-119 THROUGH 5860016-122. UPGRADE TO 5860016-123 THROUGH -126.

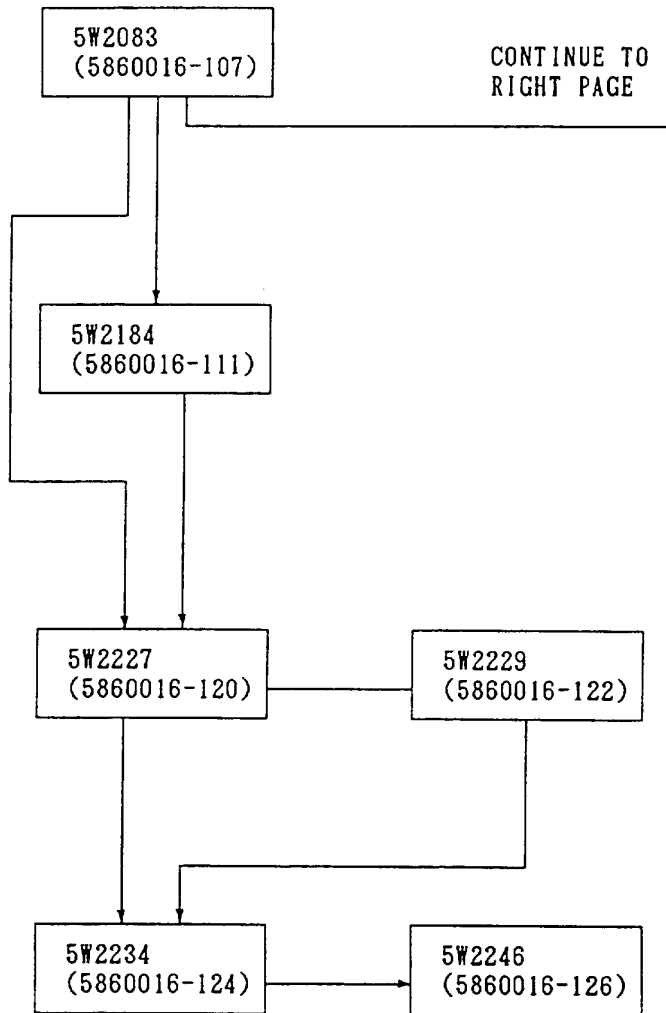
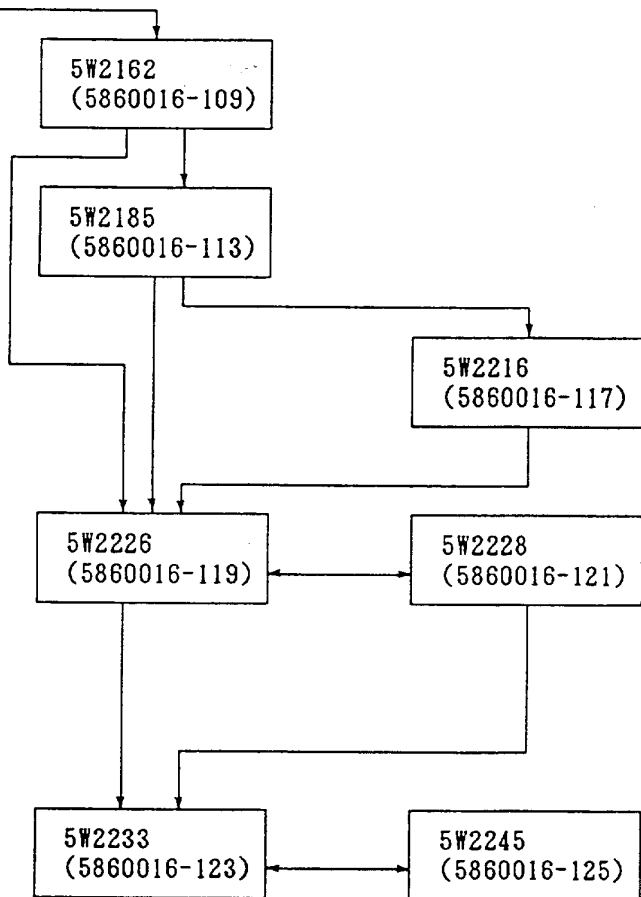
Fig.1 (Sheet 1 of 2)

V2500-ENG-75-0031
ANTI-ROTATION SLEEVE ADDED:
RELATIONSHIP BETWEEN PART
NUMBER AND PLUG POSITION IS
SAME AS V2500-ENG-75-0021

- (a) 5W2233 (Vendor Part Number 5860016-123), 5W2234 (5860016-124), 5W2245 (5860016-125) and 5W2246 (5860016-126) HPT/LPT ACC Air Valve supersede 5W2226 (Vendor Part Number 5860016-119), 5W2227 (5860016-120), 5W2228 (5860016-121) and 5W2229 (5860016-122). A part number family tree chart, Figure 1, shows relationship between the part number and the modifications.
- (b) Shape of sleeve bearing mating position of the valve actuator rod is changed from a right circular cylinder to a rod with parallel faces. A bush with parallel faces is added to the inside of ACC valve tube assembly to prevent rotation of the rod.
