ENGINE - AIR - INCORPORATE A CHAMFER OF THE ACAC INLET/OUTLET DUCT LUG - CATEGORY CODE
8 - MOD.ENG-75-0033

V2500-ENG-75-0033

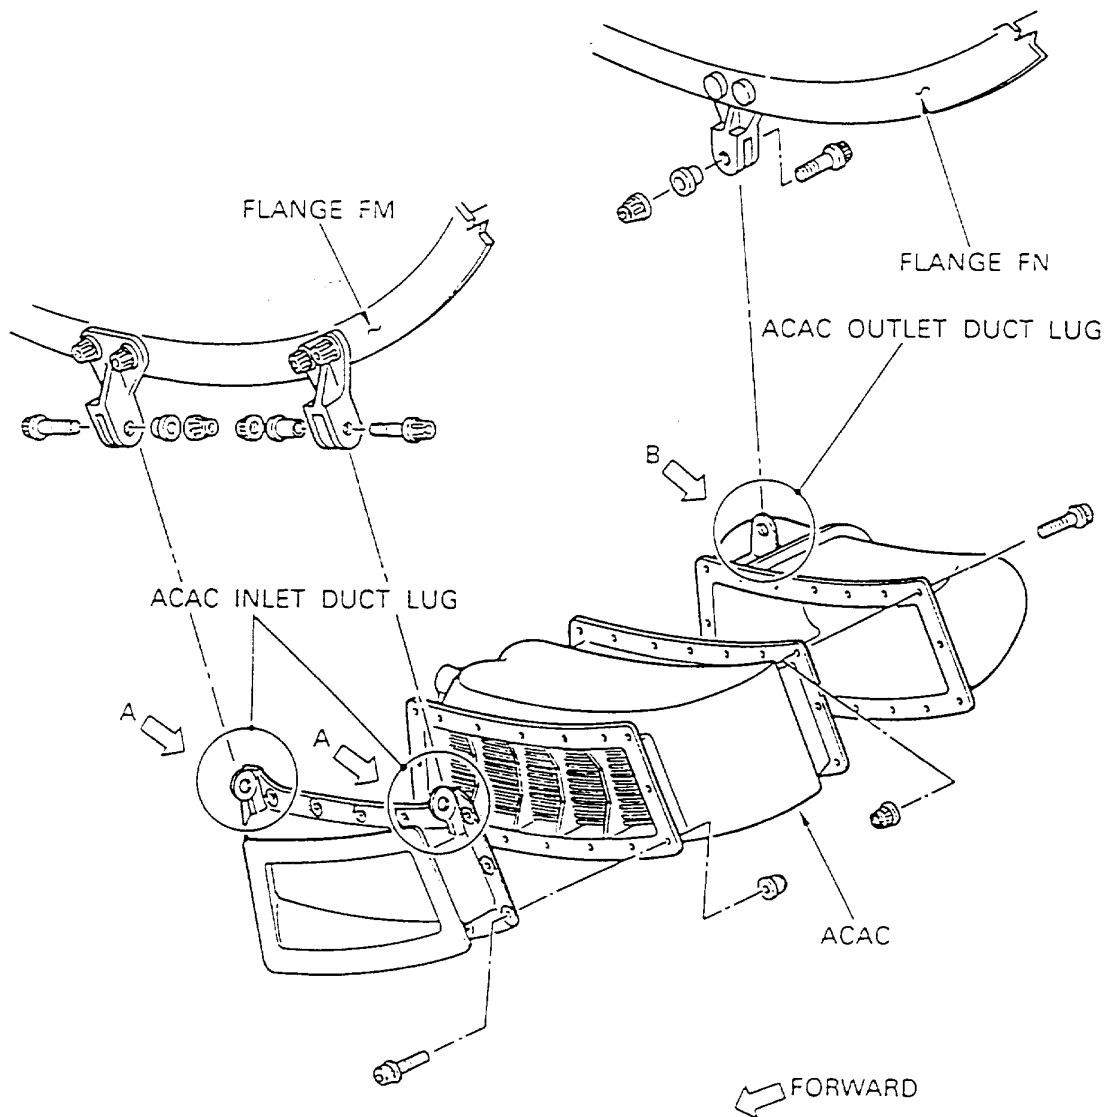
ACAC INLET/OUTLET DUCTS – LOCATION OF ALTERATION
Fig.1

An interference between ACAC Inlet Duct and ACAC Mount Bracket may occur under the worst manufacturing tolerances.

The condition was observed when an engine was assembled and a review shows that same condition may occur at ACAC Outlet Duct.

- (1) To rework the lug of ACAC Inlet and Outlet Ducts in accordance with Figures 1 and 2.

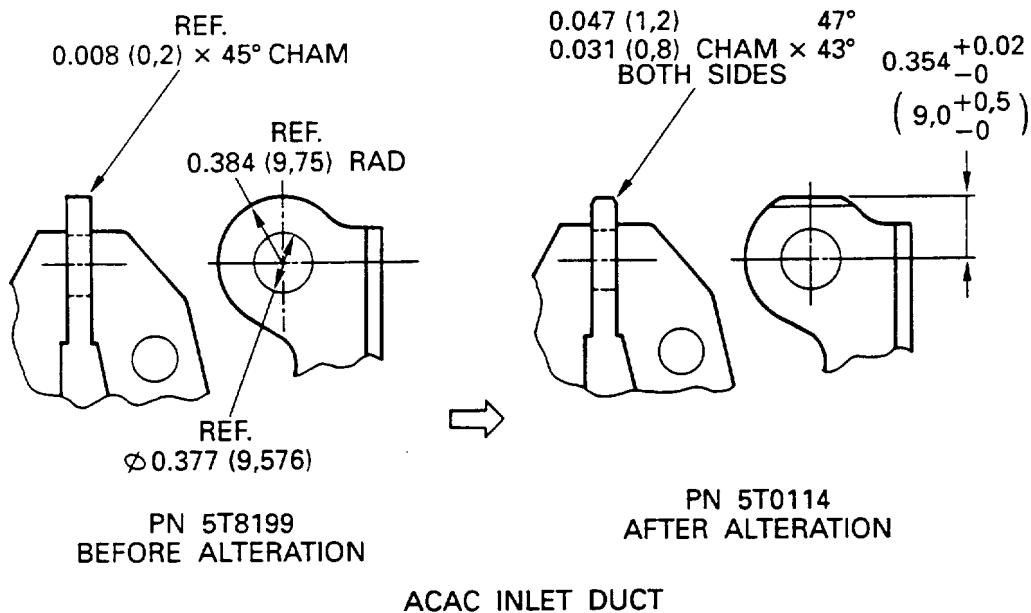
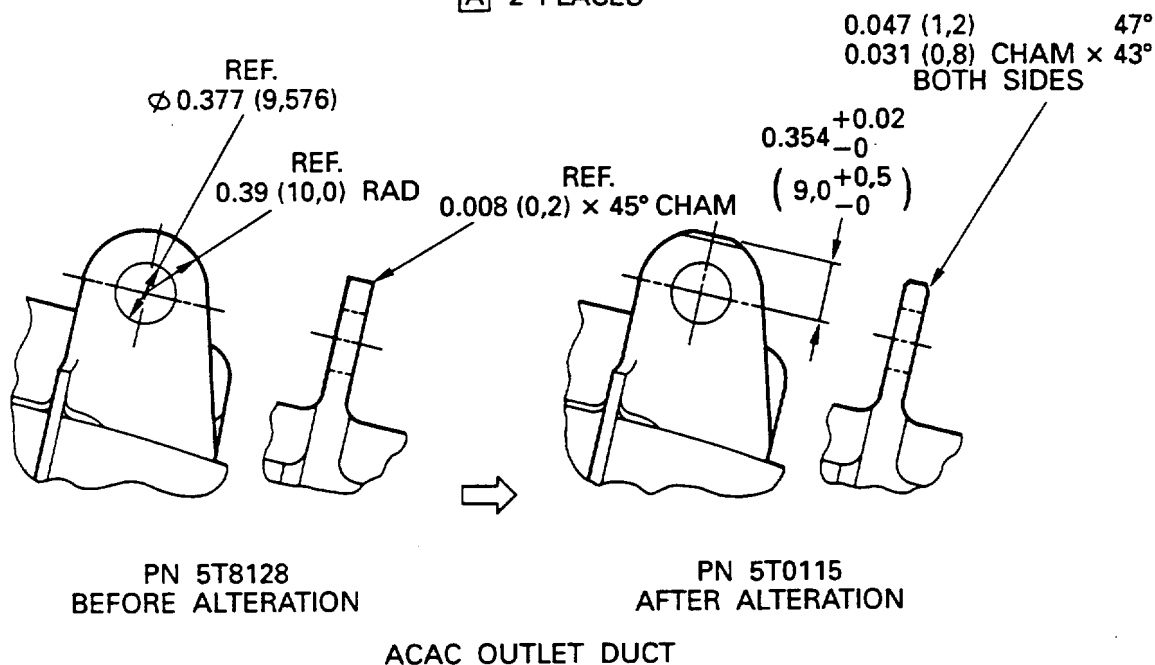
ACAC INLET/OUTLET DUCTS – BEFORE AND AFTER ALTERATION
Fig.2

Larger chamfer is given to the shoulders of the lugs of ACAC Inlet and Outlet Ducts.

Length from center of hole to edge of lug is reduced to give clearance between the parts (See figure 2).
