ENGINE - AIR - REPLACE THE HP COMPRESSOR VARIABLE STATOR VANE ACTUATOR BRACKET ASSEMBLY
- CATEGORY CODE 6 - MOD.ENG-75-0034

V2500-ENG-75-0034

SERVICE BULLETIN

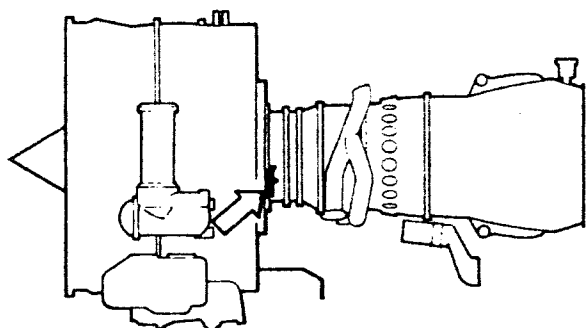
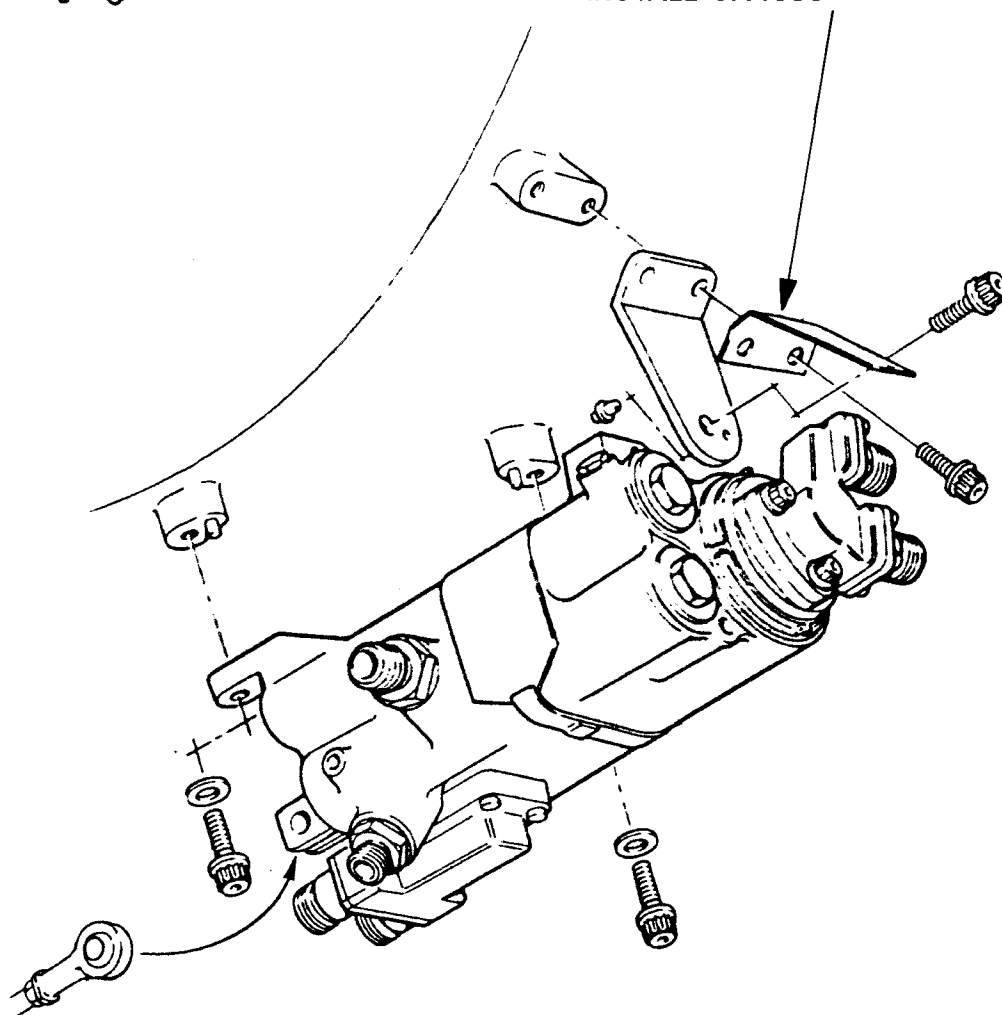
Location of the bracket assembly
Fig.1

Limited clearance between a harness support clip and the inner wall of the 'C' duct.

Service Bulletin V2500-ENG-72-0132 repositioned the EEC harness to run outboard of the electrical disconnect for the BSBVA actuator. This, in turn, necessitated the rotation of the harness support clip at clip point 5745 to face outboard instead of inboard. This may result in limited clearance between the clip and the inner profile of the 'C' duct.

The existing bracket which supports a raceway at clip point 5746 and the EEC harness at clip point 5745 is replaced with a new bracket which is shorter. This change increases the clearance between clip point 5745 and the 'C' duct. The bracket also feature a lip to provide positive orientation of the clip and ensure clearance between the master BSBVA actuator harness disconnect and the EEC harness loom.

REMOVE 5W8366 OR 6A4672 AND
INSTALL 6A4659

- (1) Install the 6A4659 support bracket by means of approved procedures. Refer to A320 Aircraft Maintenance Manual.
