## SERVICE BULLETIN

ENGINE - AIR - REVISE THE ORIENTATION OF CLIPPING POINT CP5560 - CATEGORY CODE 7, 6 -  
MOD.ENG-75-0035

V2500-ENG-75-0035

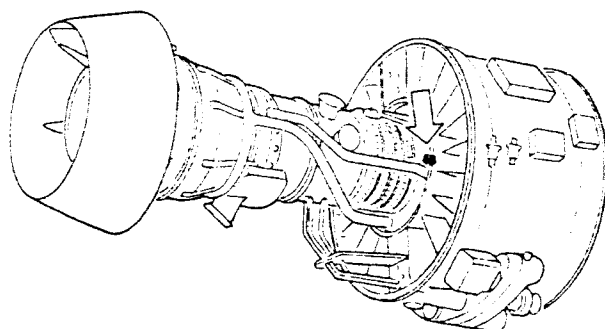
Location of the harness bracket and clipping point CP5560  
Fig.1

REMOVE  
5W1086  
WASHER

REMOVE 4W0103 BOLT AND  
INSTALL 4W0102 BOLT

REMOVE 5W2153 HARNESS BRACKET AND  
INSTALL 6A5650 HARNESS BRACKET

REMOVE AS21017 BOLTS (2 off) AND  
INSTALL 4W0178 BOLTS (2 off)

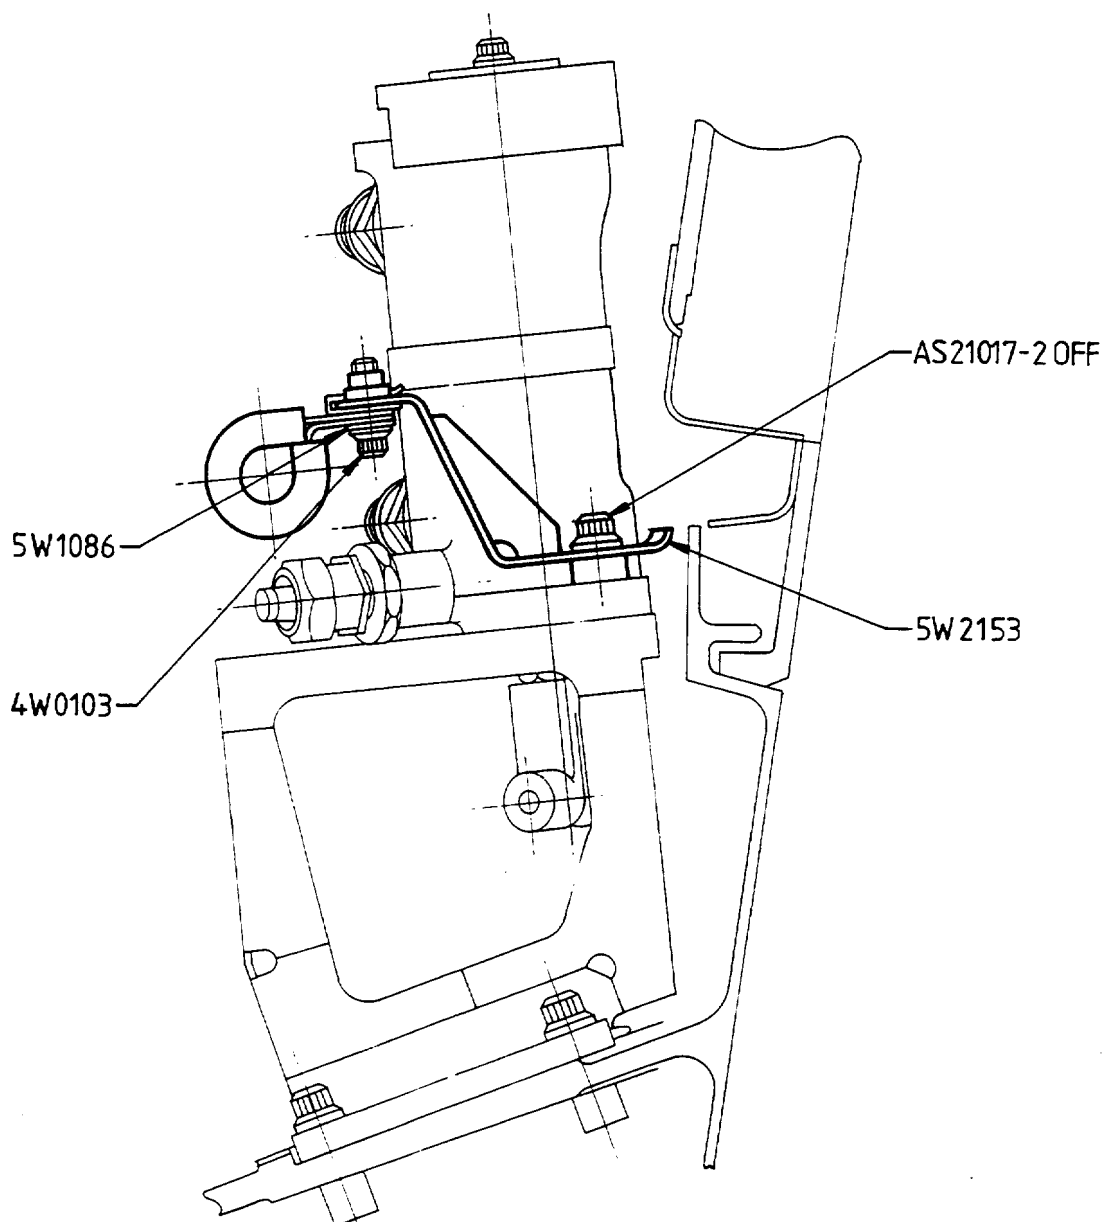
View on arrow AA (see Figure 2) - Before alteration  
Fig.3

Limited clearance between the support bracket for harness clipping point CP5560 and the inner fan frame has been reported on engine build of the V2500-A5.

During build of the V2500-A5 first production engine it was highlighted that a possible interference could exist between the EEC harness clip support bracket for CP5560 and the inner frame.

- (1) Remove the bolt, the nut and the washer from clipping point CP5560. Refer to Figure 3.
- (2) Remove the two bolts that attach the 5W2153 harness bracket to the B.S.B.V. slave actuator. Remove the bracket. Refer to Figure 3.
- (3) Install the new 6A5650 harness bracket on to the B.S.B.V. slave actuator using the two new 4W0178 bolts. Torque the bolts to 85 to 105 lbfin (10 to 12 Nm). Refer to Figure 4.
- (4) Assemble clipping point CP5560 using the nut removed in step B.(1) and the new 4W0102 bolt (do not install the washer removed in step B.(1)). Torque the bolt to 36 to 45 lbfin (4 to 5 Nm). Refer to Figure 4.

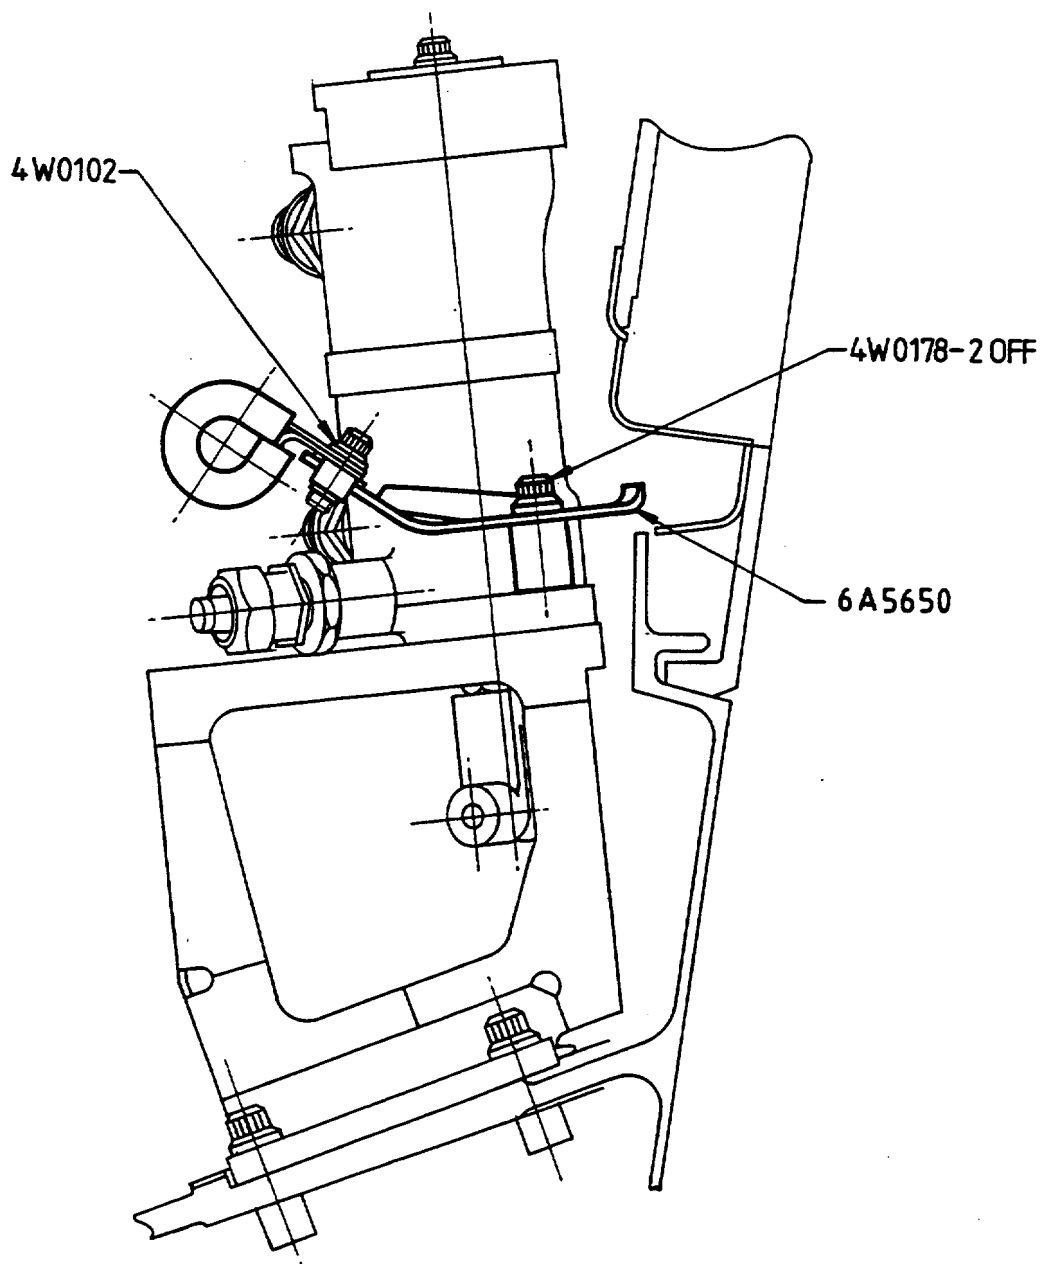
View on arrow AA (see Figure 2) - After alteration  
Fig.4

Design analysis has confirmed that the new bracket assembly will provide sufficient clearance between CP5560 and the inner fan frame to prevent the possibility of a foul.
