ENGINE - AIR - INCORPORATE A REVISED SOLENOID SUPPORT BRACKET TO PROVIDE IMPROVED CLEARANCES BETWEEN BRACKET AND FAN CASE ASSEMBLY - CATEGORY CODE 6 - MOD.ENG-75-0036

V2500-ENG-75-0036

## SERVICE BULLETIN

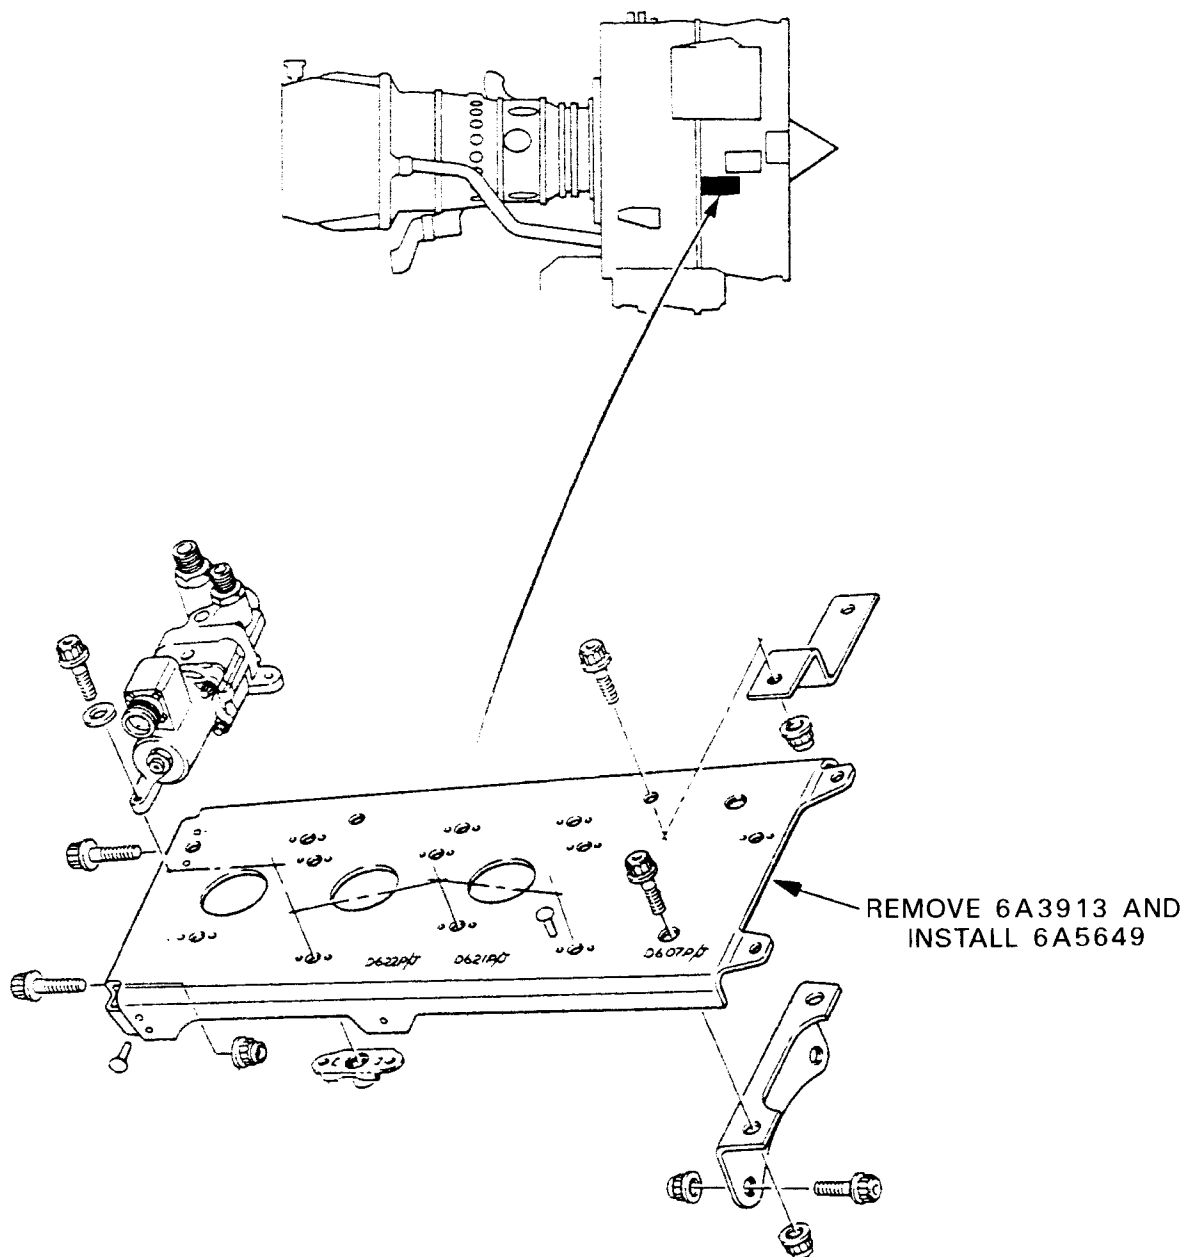
Location of bracket  
Fig.1

It was also highlighted that the clearance between the clips which are supported from the air bleed valve solenoid mounting bracket and the fan case was inadequate.

The increased diameter of the fan case on the V2500-A5 engine compared to that on the V2500-A1 engine has resulted in the clearance between the clips and fan case being reduced.

- (1) Assemble the new or re-identified 6A5649 bracket assembly, mounting bleed valve solenoids by use of approved procedures, Engine Manual, 72-00-32 Installation 02.

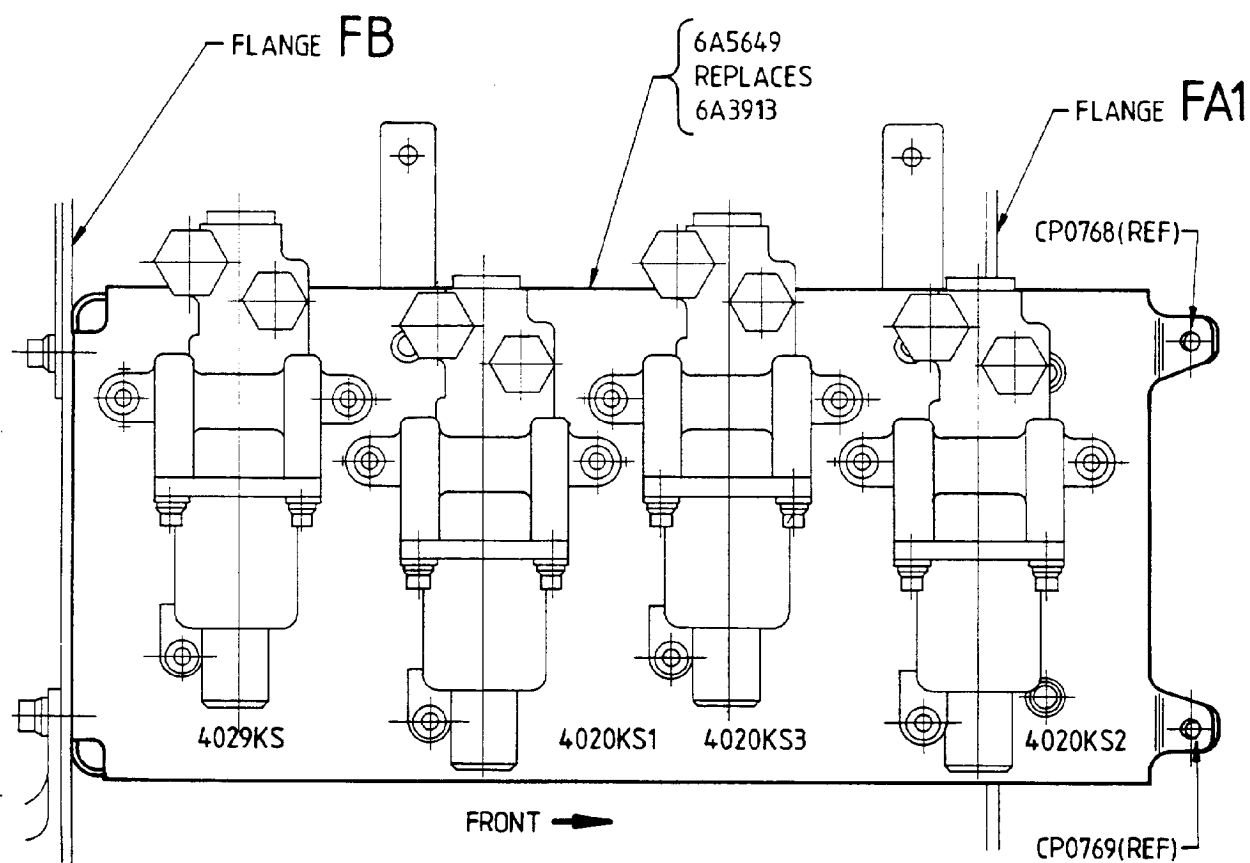
View on solenoid mounting bracket Before and after alteration  
Fig.2

This Service Bulletin introduces a modified bleed valve solenoid mounting bracket with functional identification numbers etched adjacent to the 4 solenoids. The clipping lugs (for CP0768 and CP0769) are set at an angle of 25 degrees minimum instead of 20 degrees minimum.

Existing brackets can be reworked by cancelling the 'D' markings and etching on the new identification numbers, and by manipulating the lugs to achieve the revised angular position.

Procedure	Supplementary Information
(a) Find the clip points CP0768 and CP0769	See Fig. 2
(b) Adjust the lugs to the revised angular position of 25 degrees minimum	See Fig. 2 Use basic workshop tools
(c) Cancel the existing functional identification numbers and identify with the new functional identification numbers	See Fig. 2 Use vibro-engraving equipment. Refer to SPM TASK 70-09-00-400-501
(d) Cancel the existing part number and re-identify with the new part number	Use vibro-engraving equipment. Refer to SPM TASK 70-09-00-400-501 Existing          Re-number 6A3913          6A5649
