AIR - HP COMPRESSOR STAGE 7 AND STAGE 10 BLEED VALVES - INTRODUCTION OF AN IMPROVED  
CENTER BUSH - 4 - MOD.ENG-75-0040

V2500-ENG-75-0040

**SB Number 75-28**

**Introduction of Improved Material Bush on HP7 and HP10 Bleed Valves  
DUNLOP MODIFICATION E586 (HP7 Bleed Valve) and E587(HP10 Bleed Valve)**

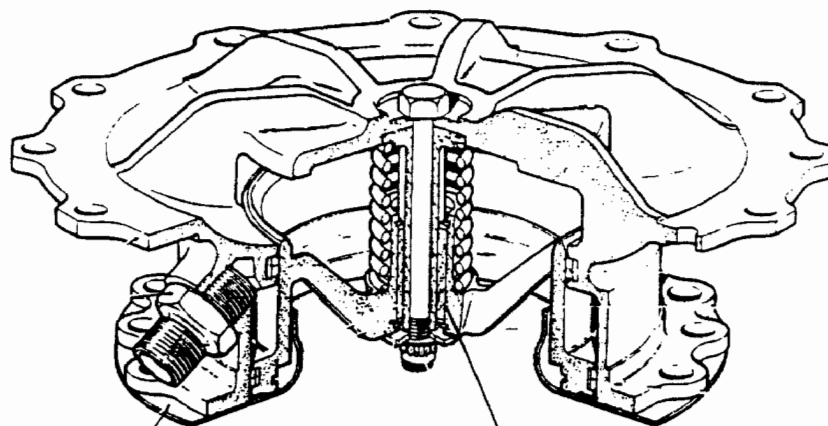
The reason for the problem is the presence of water affecting the existing carbon bush material.

Shroud (HP10 Bleed Valve Only)      Split Bush PN ACO45618  
HP7 Bleed Valve Pre Mod E586  
HP 10 Bleed Valve Pre Mod E587

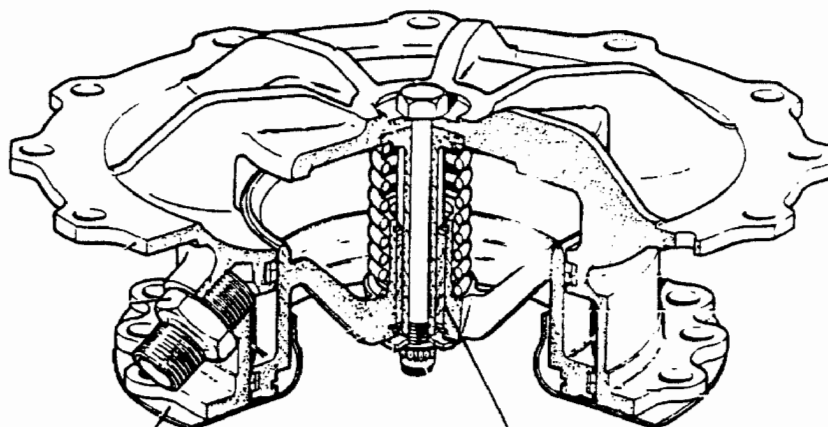
Shroud (HP10 Bleed Valve Only)      Split Bush PN ACO47056  
HP7 Bleed Valve Post Mod E586  
HP 10 Bleed Valve Post Mod E587

- (1) The procedures introduced by this Service Bulletin are as follows:-
  - Disassembly of HP7 & HP10 Bleed Valves
  - Re-work of valve stem ACO45615
  - Replacement of Triple Seal Assembly DAS2485-1256
  - Replacement of Triple Seal Assembly DAS2505-1225
  - Introduction of modified Bush ACO47056 in lieu of ACO45618
  - Replacement of Nut AS20625
  - Replacement of Rivet AS46791-411 (HP10 Bleed Valve only)
  - Assembly of modified Bleed Valves
  - Re-identification of Bleed Valves
- (2) Refer to figure 1 for pre and post mod configuration of the bleed valves
