International Aero Engines

SERVICE BULLETIN

<u>ENGINE - AIR - TO ANNOUNCE THE INTRODUCTION OF A SPACER AT CLIPPING POINT CP2423 (No.4 BEARING SCAVENGE VALVE AIR SERVO TUBE) - CATEGORY CODE 7 - MOD.ENG-75-0042</u>

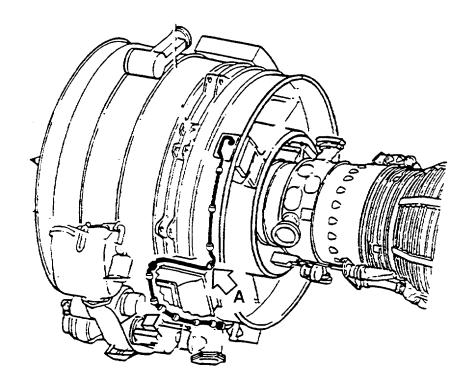
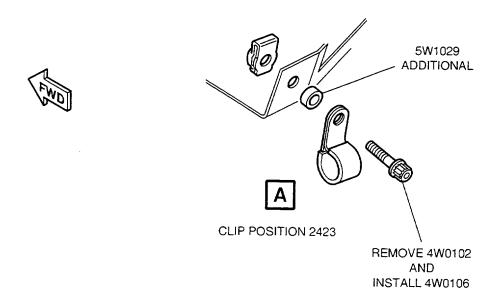
Location of clipping point 2423 Fig.1

Possible misalignment of the No.4 bearing scavenge valve air servo tube with the support bracket at CP2423.

- (1) Locate the No.4 bearing scavenge valve our servo tube clipping point (CP2423) and remove the existing bi-hex bolt (4W0102). Refer to Figures 1 and 2.
- (2) Install the new spacer (5W1029) between the air tube clipping point and the support bracket. Install the new longer bi-hex bolt (4W0106) and torque to 36 to 45 lbfin. (4 to 5 Nm).

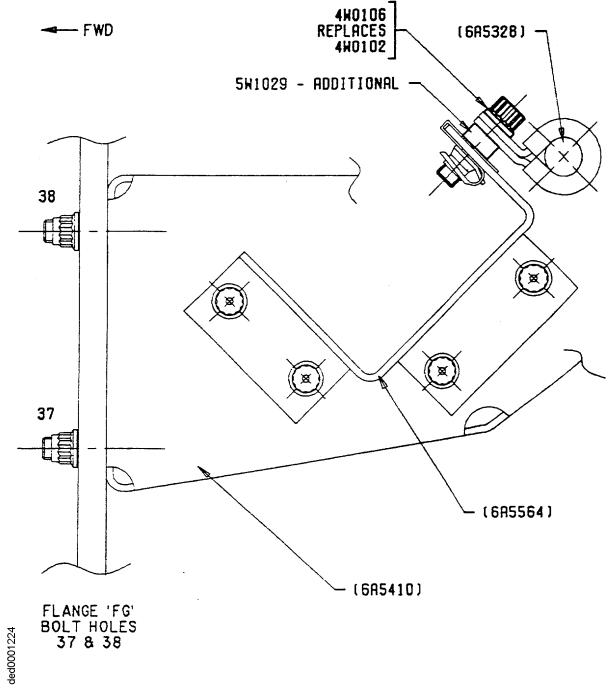
Clipping point 2423 - Befor and after alteration Fig.2

- (1) This Service Bulletin introduces a 5 mm spacer at CP2423, positioned between the support bracket and the pipe clip.
- (2) A longer bolt is introduced to accommodate the additional spacer.
