ENGINE - AIR - INTRODUCE A NEW BRACKET AT CLIPPING POINT 5560 - CATEGORY CODE 7 -  
CATEGORY CODE 6 - MOD.ENG-75-0044

V2500-ENG-75-0044

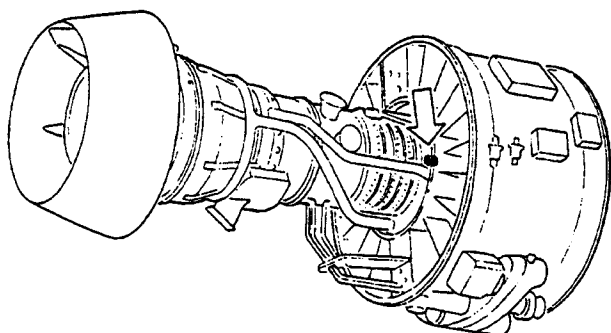
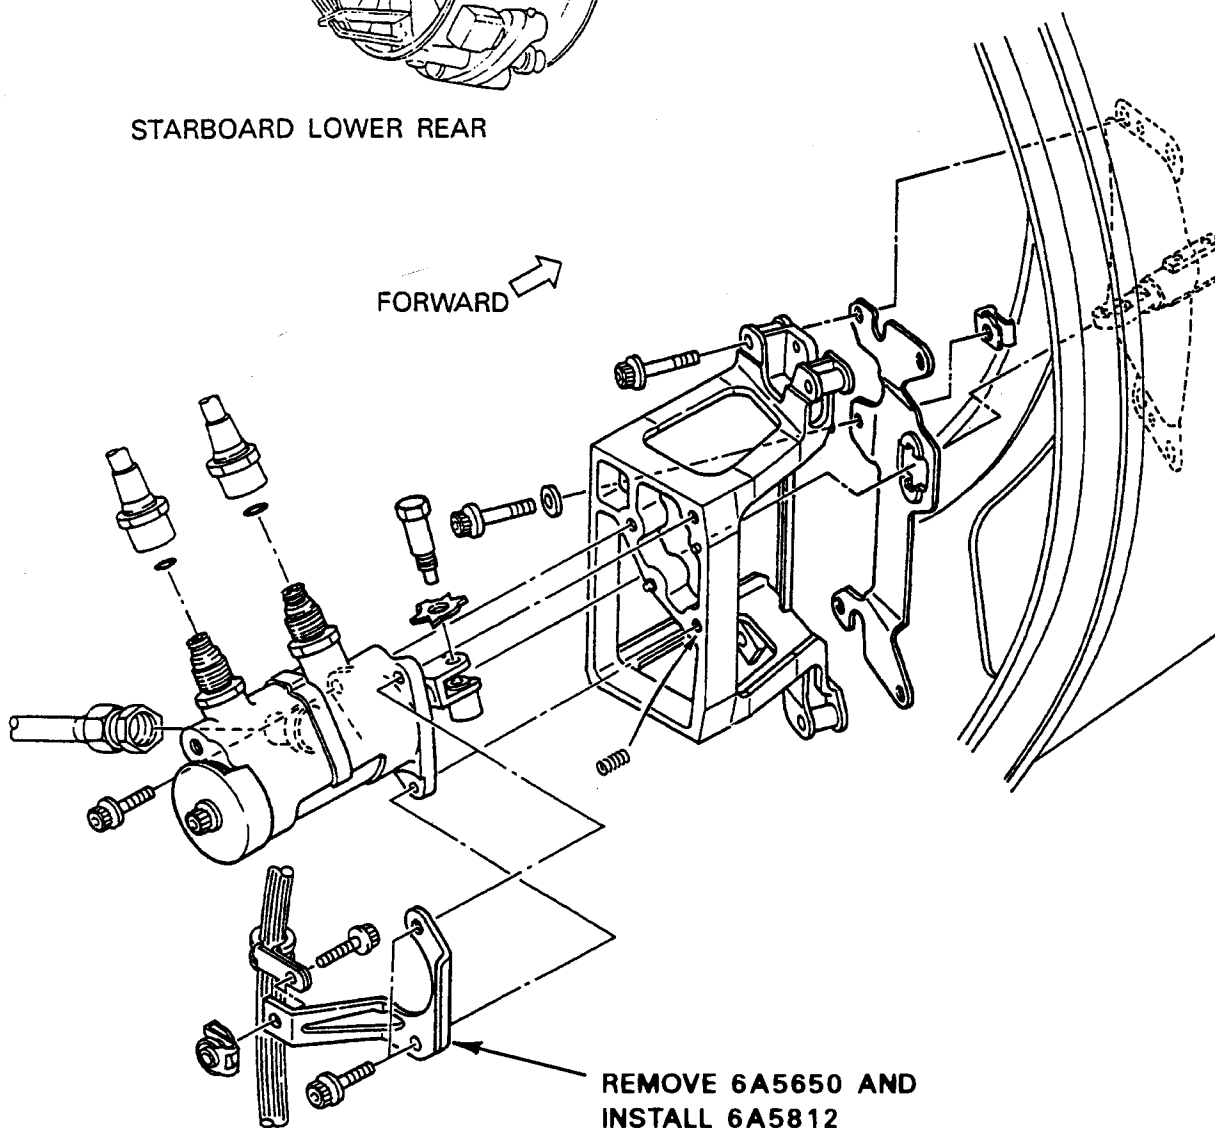
There is insufficient clearance between the support bracket and harness clip at clipping point 5560.

Location of harness bracket  
Fig.1

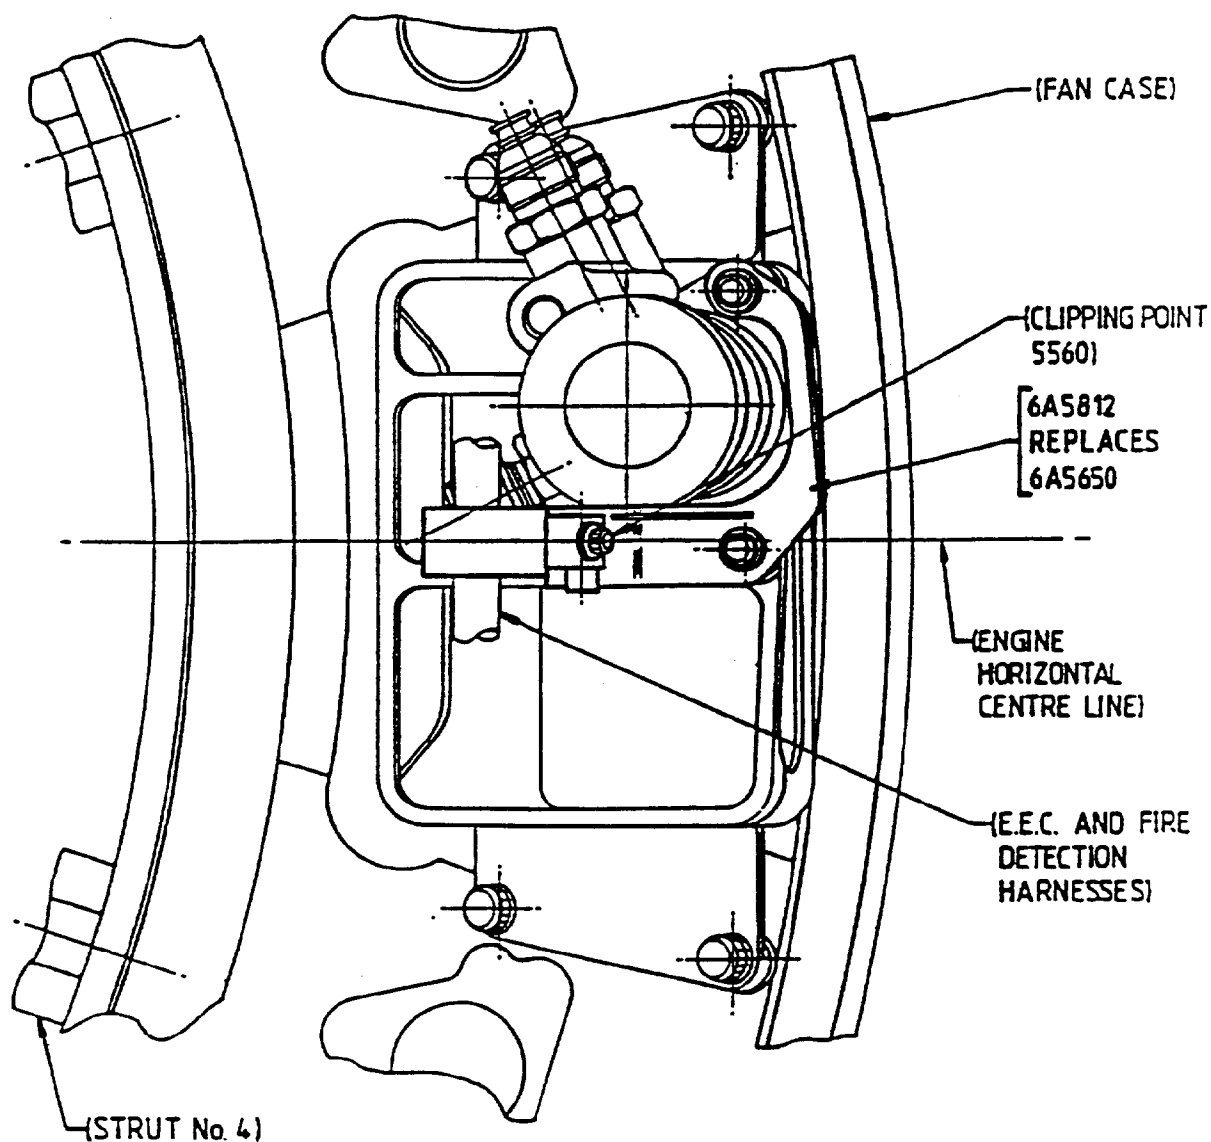
View on fan frame at B.S.B.V. slave actuator showing location of modified bracket -  
Before and after alteration  
Fig.2

This Service Bulletin introduces a new support bracket to provide increased clearance for the clip. Existing brackets can be reworked.

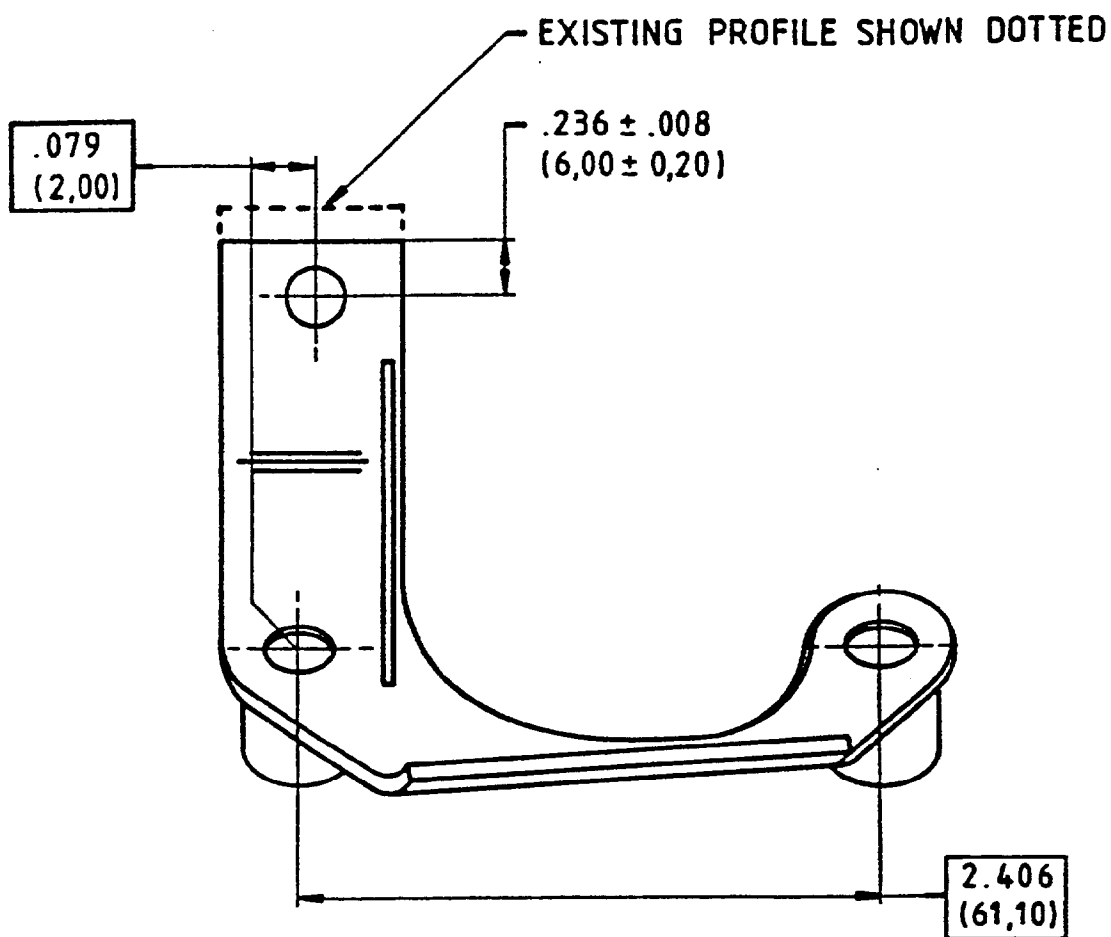
View showing reworking of existing brackets  
Fig.3

PROCEDURE	SUPPLEMENTARY INFORMATION
(a) Chemically clean the support bracket	Refer to SPM TASK 70-11-03-300-503 Use chemical cleaning equipment.
(b) Mark the rework area	Refer to Figure 3. Use a locally manufactured template with a scribing tool
(c) Remove the unwanted material	Refer to Figure 3. Use standard workshop equipment
(d) Remove burrs and break sharp edges	Use standard workshop equipment
(e) Visually examine and measure the dimensions of the support bracket	Refer to Figure 3. Use standard workshop equipment
(f) Cancel the existing part number and identify with the new part number	Refer to SPM TASK 70-09-00-400-501, SUBTASK 70-09-00-400-001. Existing                      Re-number 6A5650                      6A5812  Use vibro-engraving equipment

INCHES (MILLIMETRES)  
REMOVE BURRS AND BREAK SHARP EDGES
