SERVICE BULLETIN

AIR - BEARING COMPARTMENT COOLING HPC AIR BLEED TUBES - ADDITIONAL CLIPPING FOR CORE
TUBES - SERVO AIR TO HANDLING BLEED SOLENOID VALVES - CATEGORY CODE 4 -
MOD.ENG-75-0049

V2500-ENG-75-0049

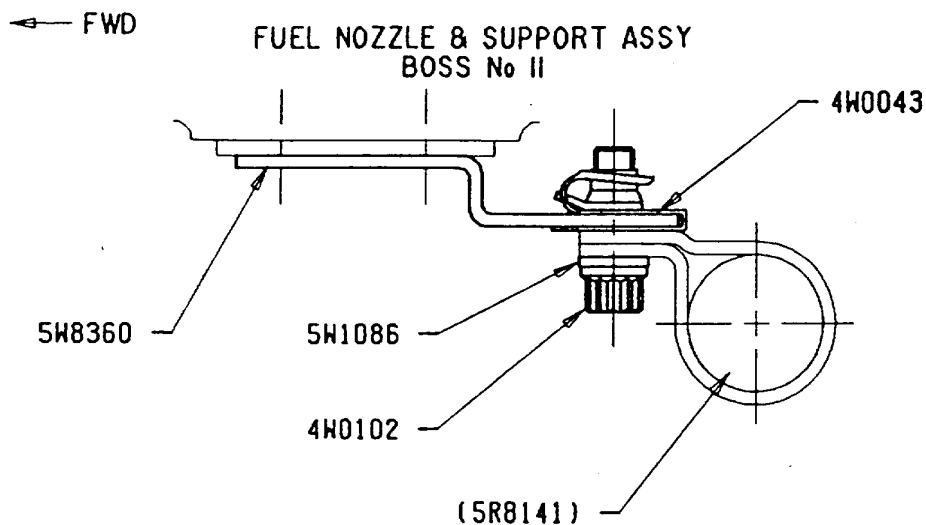
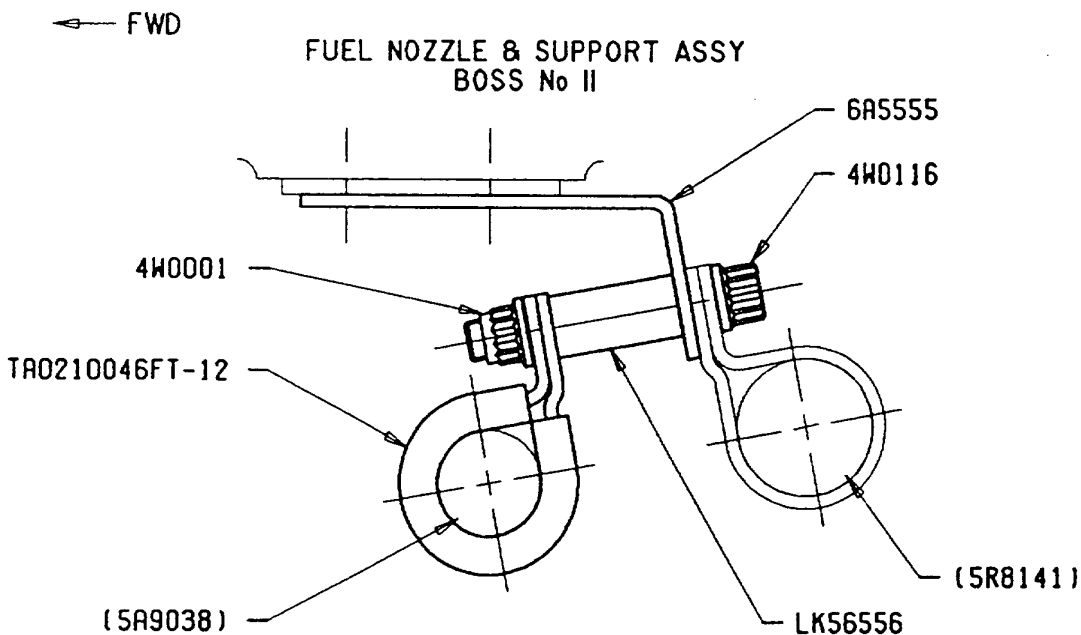
Clipping point 5224 - Before and after alteration
Fig.4

Loosening of the coupling nut on the air supply tube to the handling bleed solenoid valves can occur.

- (1) Find clipping points 5224 and 5529. Refer to figures 1 and 2.
- (2) Disassemble clipping point 5224, remove 4W0102 bolt, 5W1086 washer, 5R8141 tube and the 4W0043 clipnut from the 5W8360 bracket. Refer to figure 4.
- (3) Cut lockwire and remove the MS9573-13 bolts (2 off) and remove 5W8360 bracket from the No.11 fuel spray nozzle.
- (4) Disassemble clipping point 5529, remove the 4W0001 nut, 5W1086 washer, 4W0104 bolt and the 5W1086 washer. Refer to figure 5.

- (1) Install the new 6A5555 bracket to the No.11 fuel spray nozzle using MS9573-13 bolts (2 off). Torque the bolts to 65 to 85 lbfin (7,3 to 9,6 Nm). Safety the bolts with V02-141 lockwire, as instructed in the A320 Aircraft Maintenance Manual, TASK 70-40-11-911-012. Refer to figures 3 and 4.
- (2) Re-assemble existing clipping point 5224. Install new TA0210046FT12 clip to 5A9038 tube. Install new 4W0116 bolt to 5R8141 tube clip, 6A5555 bracket, LK56556 spacer, TA0210046FT12 clip and the 4W0001 nut. Torque the nut to 36 to 45 lbfin (4 to 5 Nm). Refer to figures 3 and 4.
- (3) Re-assemble existing clipping point 5529. Remove harness clip, rotate and reinstall to harness. Install new 4W0114 bolt to harness clip, LK67295 spacer, 5R8040 tube, 5A9060 tube and the 4W0001 nut. Torque the nut to 36 to 45 lbfin (4 to 5 Nm). Refer to figures 3 and 5.
