## SERVICE BULLETIN

AIR - HPC BLEED AIR TUBES - INTRODUCTION OF TUBES WITH CLIPPING LUGS TO SUPPORT  
RE-ROUTED EBU FIRE DETECTION RAIL - CATEGORY CODE 6 - MOD.ENG-75-0050

V2500-ENG-75-0050

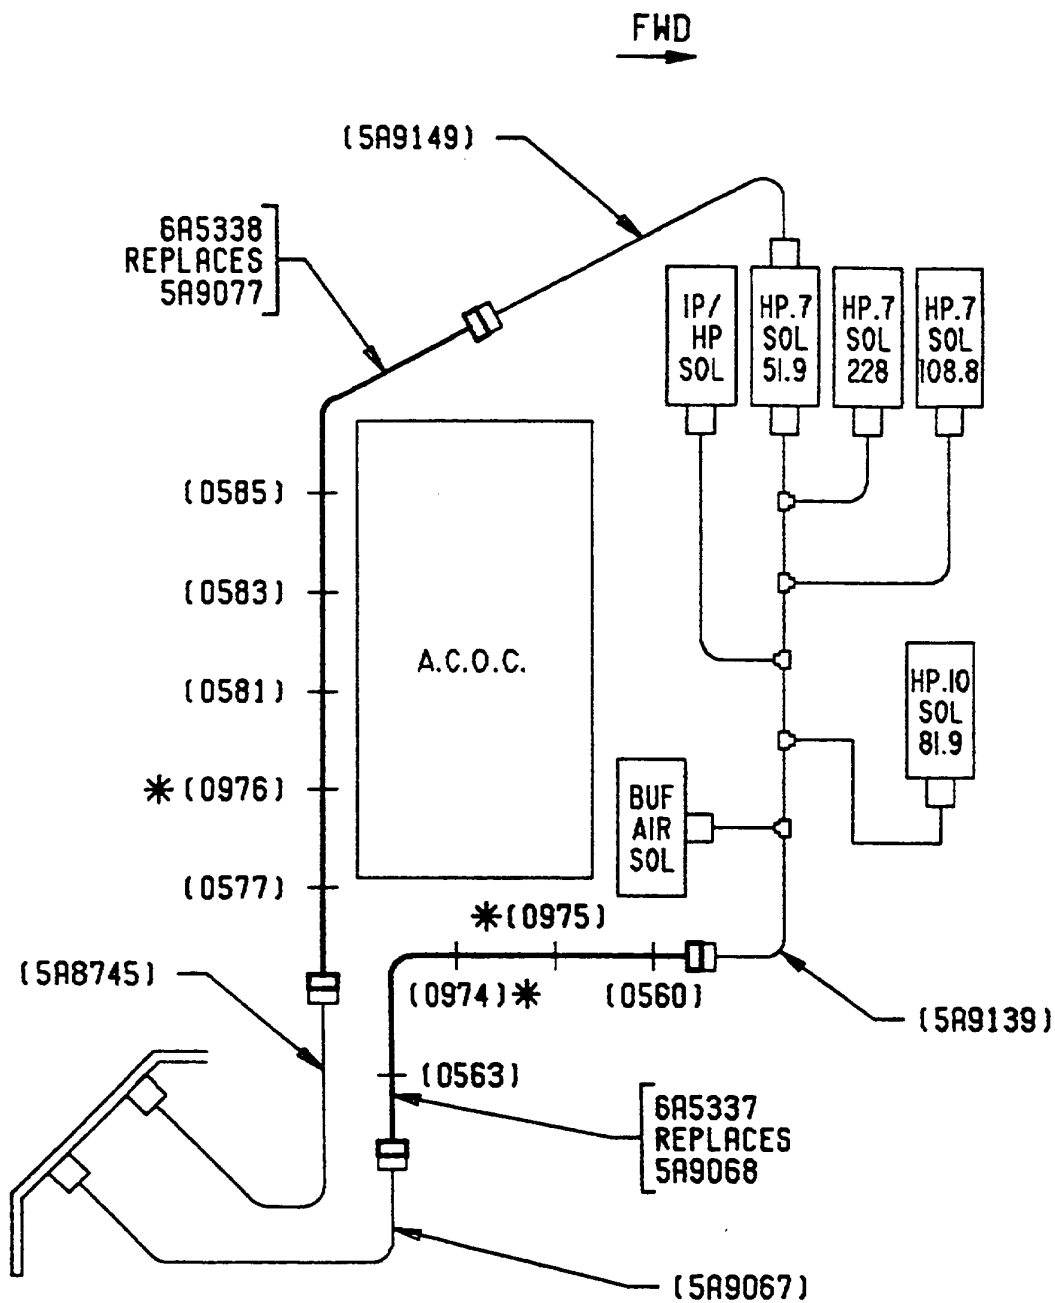
Schematic view of HP compressor bleed air tubes - Before and after alteration  
Fig.2

- (1) In the buffer air supply line from the bifurcation panel to the air bleed solenoid valves, the centre tube has two clip support lugs added.
- (2) In the air supply line from the HP7 solenoid valve (51.9 deg.) to the bifurcation panel, the centre tube has one clip support lug added.

\*ADDITIONAL EBU CLIPS

- (1) Install the 6A5337 and 6A5338 air tube assemblies in accordance with approved procedures, Engine Manual, Task 72-00-32-420-003-A00 and Task 72-00-32-420-003-B00. Refer to Figure 1 and Figure 2.
